# Defective Plumbing Installation

Collingwood.

**Report Date:** 25 July 2023

**Date of Inspection:** 18<sup>th</sup> July 2023

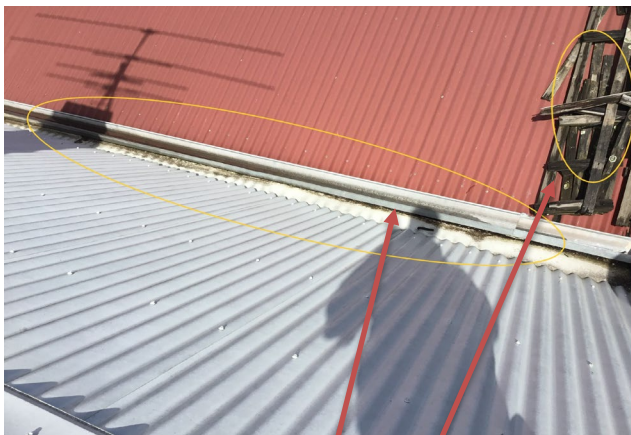
- 5.1 Debris from the roof replacement has been left in the boxgutter and on the neighbour's roof. This debris has not been disposed of by the roof installer as part of their installation. There has also been a large amount of roof debris left by the plumber in the ceiling.

1. (RN Plumb. Photo) Roofing contractor has left a lot of rubbish on the roof.

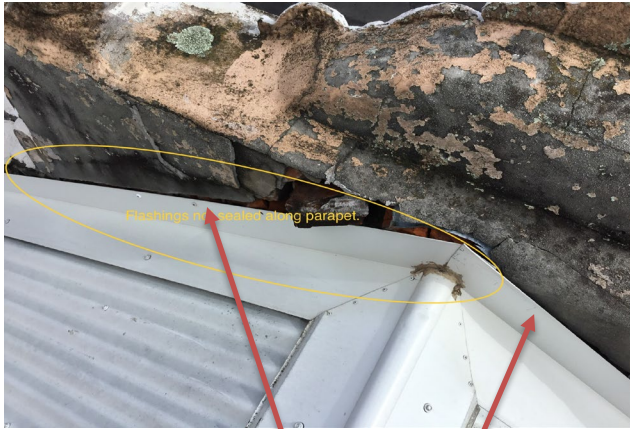
**5.2 The soaker flashing on the front parapet has not been overflashed in accordance with the Deemed to Satisfy Standard SA HB39:2015, figure 8.4(A). (Refer Appendix 3) The rectification will require the following work;**

**2. (RN Plumb. Photo) The apron flashing has not been installed correctly.**

- 5.2.1** The flashing removed, and the uneven render/mortar on the brickwork removed from the parapet.
- 5.2.2** The flashing replaced with fixings @ max. 500mm spacing.
- 5.2.3** An overflashing installed, such as a step flashing or a chased flashing.
- 5.2.4** Replace the render/mortar above the flashing.

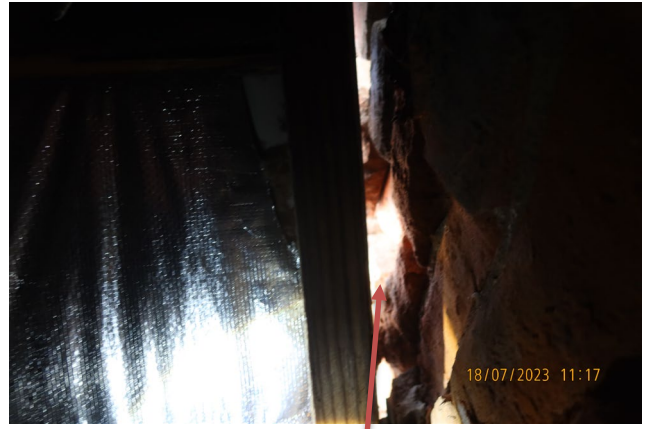
**3. The apron parapet flashing has not been installed correctly.**

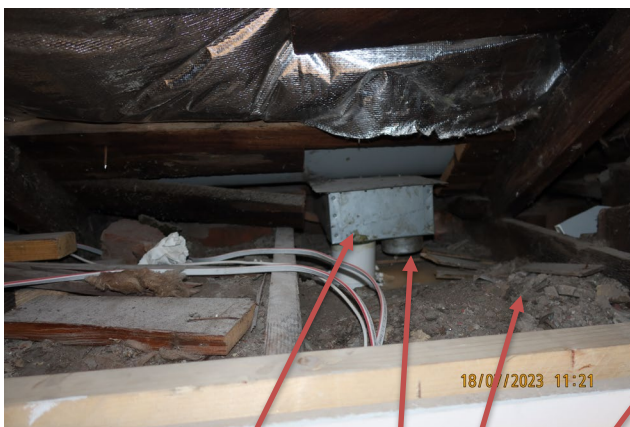
**5.3 A non-conforming sump has been installed in the boxgutter in the front of the chimney. This sump is defective as follows;**

- 5.3.1** The sump has not been set into the boxgutter correctly.
- 5.3.2** The overflow from the base of the sump has not been extended into the open, as required by the Deemed to Satisfy Standard SA HB39. The overflow is discharging into the ceiling of the residence.

- 4. The nonconforming sump and overflow.**
- 5. The sump, the downpipe and the overflow will need to be replaced with conforming sump, downpipe, and overflow.**
- 6. Note the rubbish left by the plumber in the ceiling.**

The sump, the downpipe and the overflow from the sump will need to be removed and reinstalled in accordance with Deemed to Satisfy Standard SA HB39:2015 figure 5.3.1. (b), clause 5.3,1 (b)(Overflow provision). Refer to Appendix 3.

The reworking of the sump, the downpipe and the overflow will require the removal and replacement of the ceiling and also the recently installed ceiling boxing for the downpipe.

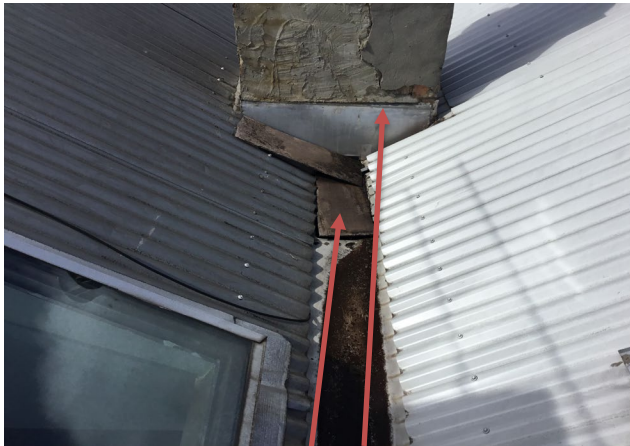
**5.4 The chimney flashing is defective as it has not been overflashed correctly and it lacks fixings.**

8. (PN Plumb photo) The chimney has not been flashed correctly, note rubbish that has been left in the boxgutter.

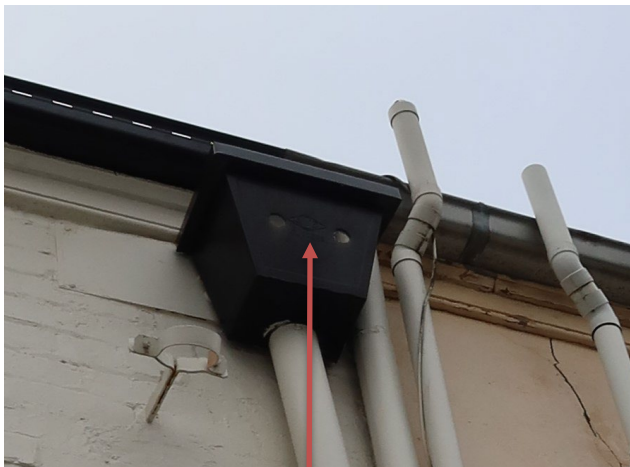
**5.5 The rear rainhead overflow is too high and it is also undersized.**

9. The rainhead overflows are undersized and too high.

5.5.1 The rainhead will need to be replaced and a conforming overflow installed.

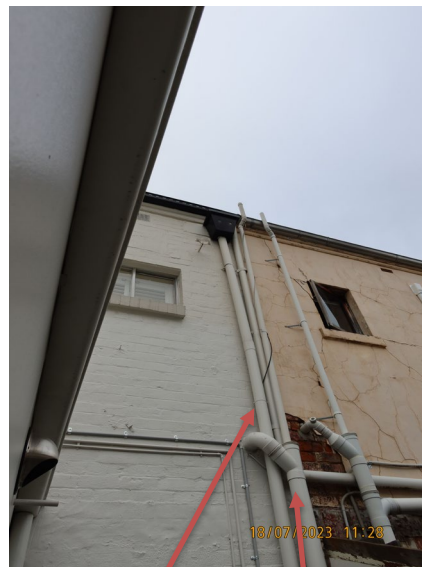
10. The downpipes are required to be supported at maximum 2000mm spacings. This applies to all the relevant downpipes etc.

**5.6 The downpipes on the front and the rear of the residence lack clipping. The downpipes are required to be clipped at maximum 2000mm spacing.**
