## Roof Inspection Report

**Property Address:** [REDACTED] McKinnon VIC 3204

**Inspection Date:** 30-April-2025

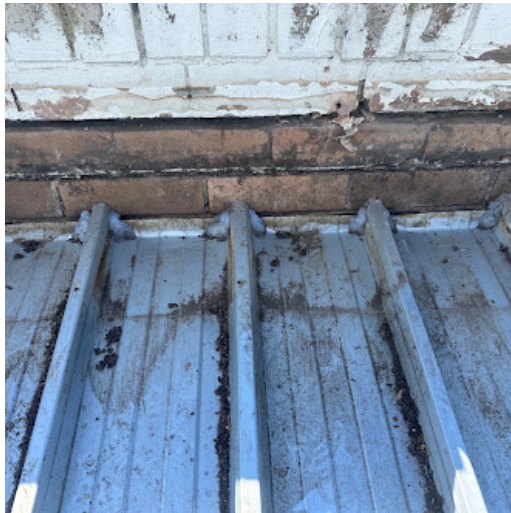
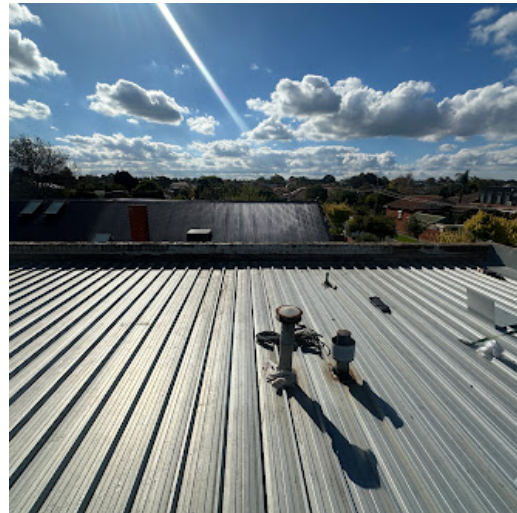
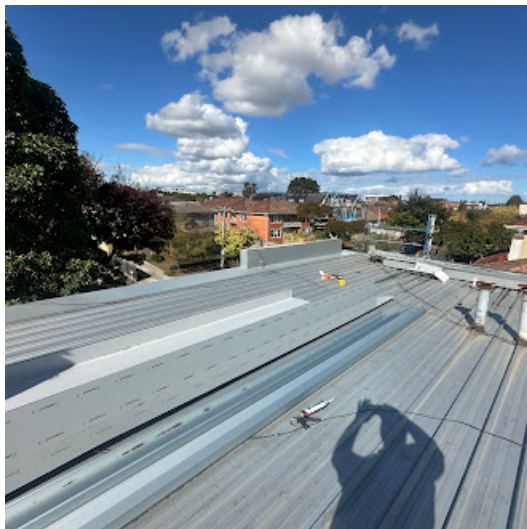
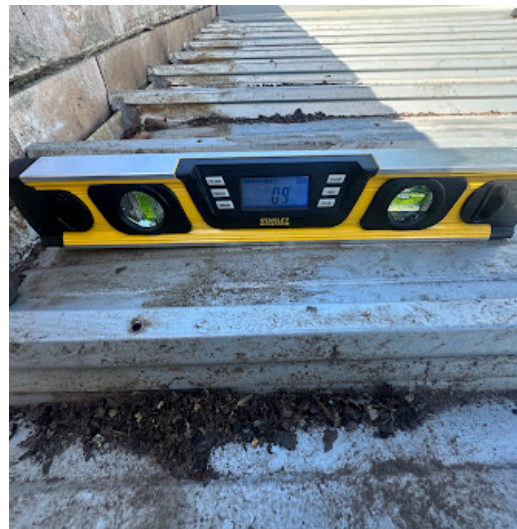
- The roof pitch was measured at approximately 0.8 degrees in some areas and as low as 0.1 degrees in others, falling significantly below the minimum requirement of 1 degree for metal roofs as per AS/NZS 3500.3 (Plumbing and Drainage – Stormwater Drainage).
- The trays are leaning backward, causing water to pool and resulting in visible staining and debris accumulation. This indicates poor initial installation and inadequate timber framing to support proper falls.
- The roof's base metal thickness is likely insufficient (less than 0.48 mm) to support such a low pitch, exacerbating water retention issues.

- Existing flashings were found to be inadequately extended, allowing wind-driven rain to penetrate under and over the trays. Previous attempts to mitigate this with silicone have been insufficient.
- Some flashings show gaps and rivets that create vulnerabilities for water ingress and condensation-related corrosion.

- Multiple penetrations (e.g., flues and vents) are cut through the ribs of the roof trays, disrupting water flow and causing pooling behind them. Approximately eight flues were identified as problematic due to their size and placement.
- No back flashings are present to redirect water around these penetrations, leading to water retention and potential leaks.

- The roof's "bouncy" nature suggests inadequate structural support, likely due to improper timber framing or insufficient purlin spacing.
- Previous repairs, such as silicone applications and rivets, do not meet the standards outlined in SA HB 39:2015 (Installation Code for Metal Roof and Wall Cladding) and AS/NZS 3500.3.

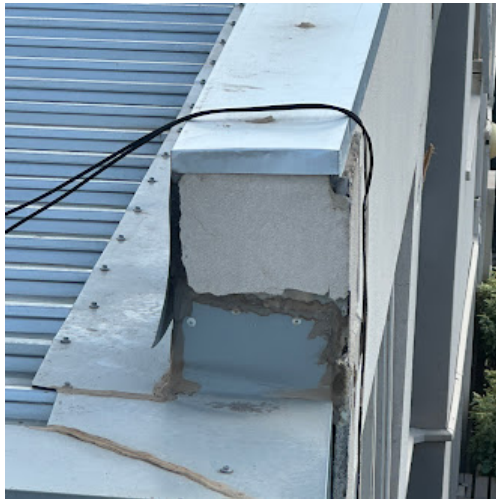
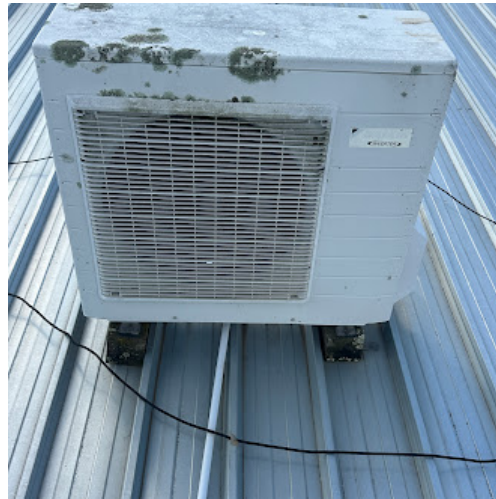
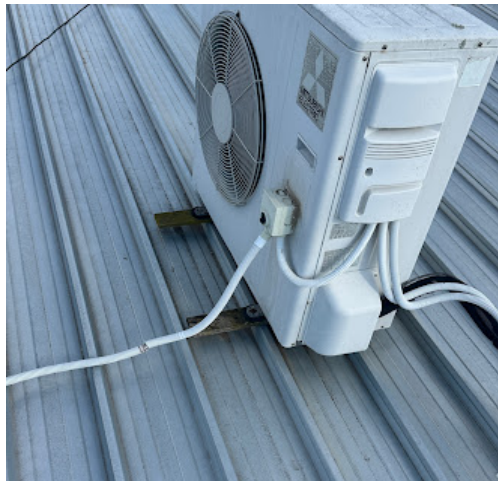
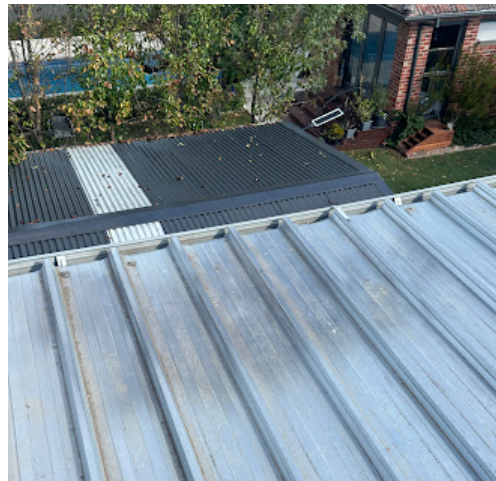
- A fascia is pulling away from the edge, potentially causing noise due to wind movement. This suggests improper fixing or material degradation.
- The noise may also be caused by loose sheeting, indicating poor installation or wear over time.

- Some penetrations (e.g., vents) are supported by inadequate materials, such as 10 mm fence palings screwed into the rib, which are insufficient for heavy units (e.g., 40 kg). This violates proper installation practices under SA HB 39:2015.
- Timber supports laid in trays (rather than across them) block water flow, causing pooling and accelerating corrosion, particularly on a zinc roof.

- End flashings are poorly installed, with some “flapping around” and others sealed inadequately.
- Capping appears substandard, increasing the risk of water ingress.

- Signs of spraying or shading on the roof suggest possible attempts to mask issues, which may indicate underlying problems.
- The rainhead and remaining flashings, while not currently leaking, are of similar poor quality to those in Section 1, suggesting future risks.
