# Roofing Inspection Report

**Property:** Bundalaguah Primary School, [REDACTED] Bundalaguah, VIC 3851

**Date of Inspection:** April 16, 2025

**Prepared by:** Holymess Repairs

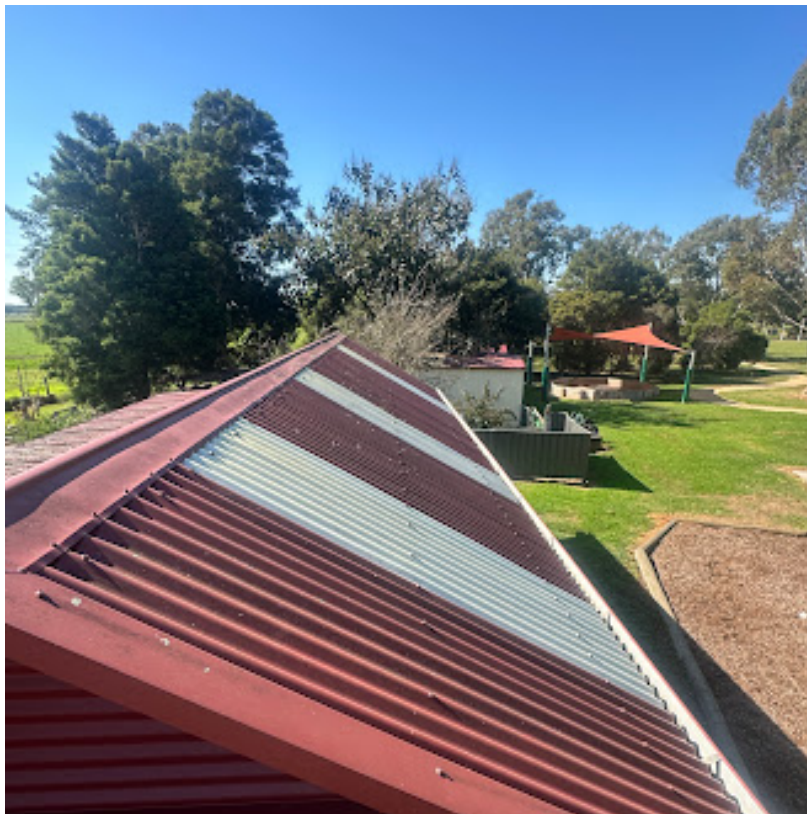
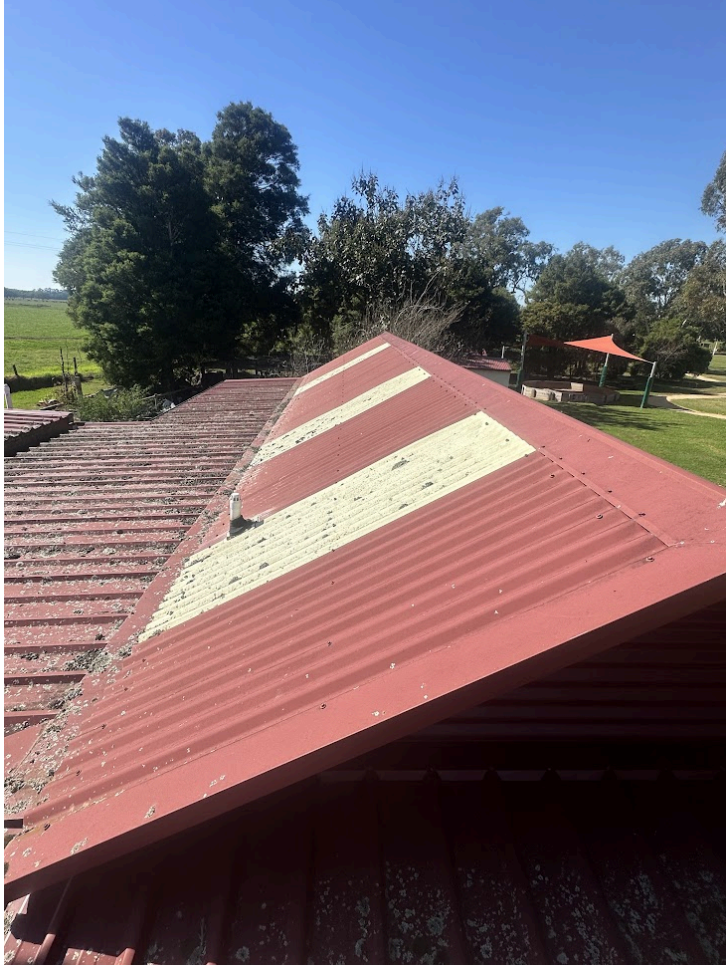
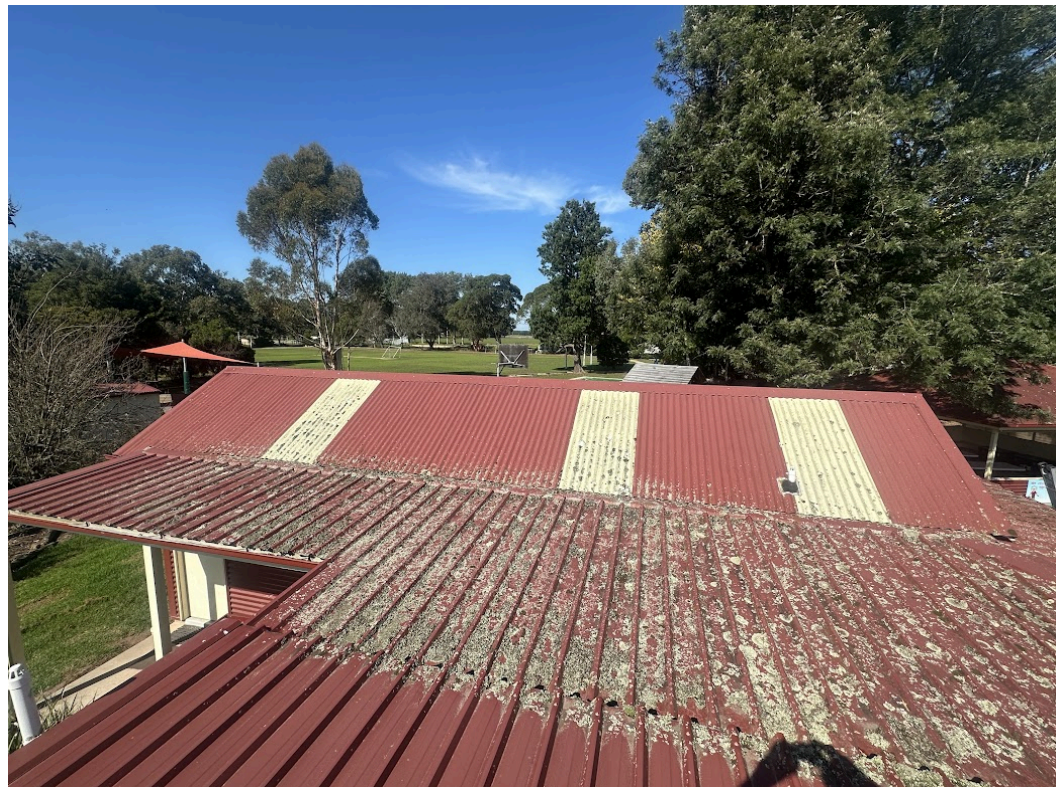
### 1. Newer Toilet Block

- **Polycarbonate Sheets:** The sheets are in good condition, but one sheet is cracked, and the rubber seals are perishing. A large hole is missing a rubber seal, and the sealant around a vent pipe is deteriorating.
- **Screws:** Screws securing the polycarbonate sheets are aging and should be replaced to prevent leaks.
- **Gutter and Downpipe:** The gutter lacks overflow provisions, which is non-compliant with NCC Part E3. A single 90mm downpipe is sufficient but could benefit from an inspection opening.
- **Apron Flashing:** The apron flashing extends less than the recommended 150mm, though no leaks were observed.
- **General Condition:** The roof requires a high-pressure clean (soft pressure for polycarbonate) to remove dirt and debris.

**Compliance Notes:** The lack of gutter overflows violates NCC Part E3P1, which requires roof drainage systems to manage extreme rainfall events. The apron flashing does not meet the recommended 150mm extension per AS/NZS 3500.3, though it is functional.

**Description:** Clean the roof (soft pressure for polycarbonate), replace the cracked polycarbonate sheet, replace all rubber seals and screws, reseal the vent pipe, install rainheads with overflows at the downpipe, and repair the damaged downpipe with an inspection opening.

**Recommendation:** I recommend **Option 1** for its comprehensive approach, ensuring compliance and longevity. However, if budget constraints are significant, **Option 2** addresses critical issues at a lower cost, though you should plan for additional maintenance soon.

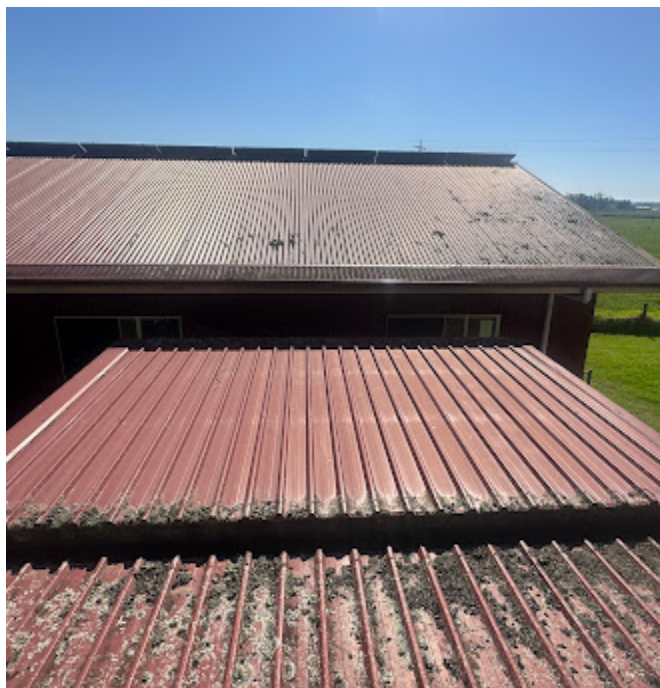
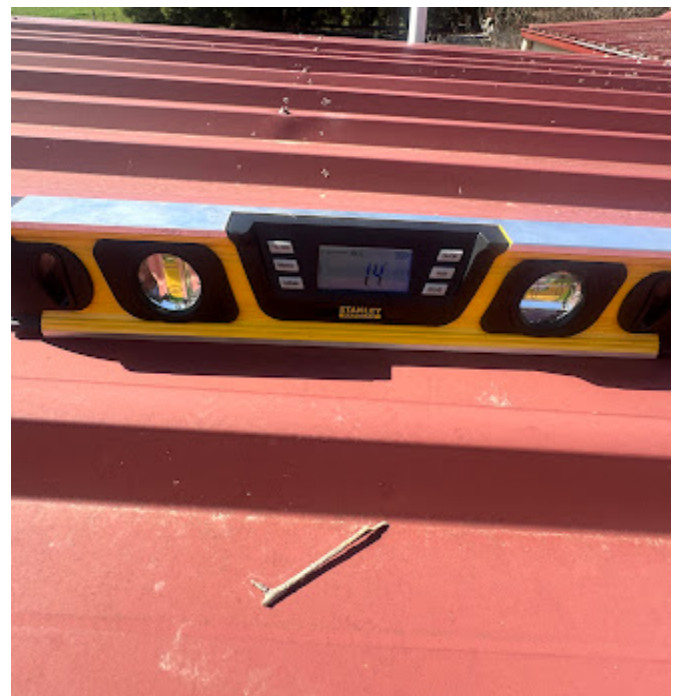
## 2. Older Toilet Block

- **Roof Pitch:** The roof pitch is approximately 1.4–1.5 degrees, below the minimum 3 degrees required for a 0.42mm BMT trim deck profile (SA HB 39). This poses a risk of water pooling and leaks.
- **Flashings:** Some flashings cover only one rib, whereas best practice (SA HB 39) recommends covering at least two ribs for stability and to prevent twisting.
- **General Condition:** The roof is structurally sound but non-compliant due to the pitch issue.

**Compliance Notes:** The roof pitch does not meet SA HB 39 requirements for the profile, risking non-compliance with NCC Part E3P2, which mandates adequate drainage.

**Description:** Replace the trim deck roof with a 0.48mm BMT clip-lock profile (suitable for 1-degree pitch), install new flashings covering two ribs, and add a rainhead with overflow to the gutter.

**Recommendation:** I strongly recommend **Option 1** for its compliance and durability. If budget is a concern, **Option 2** is viable but less future-proof. **Option 3** is not advised due to significant risks.

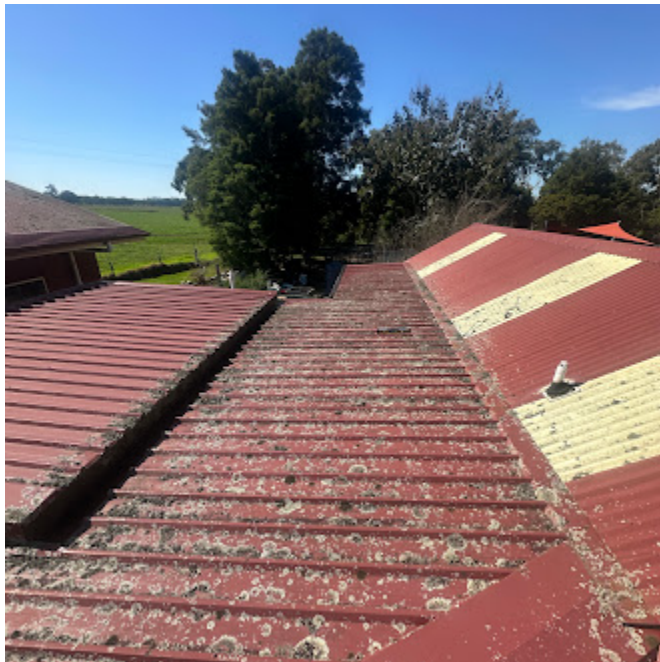
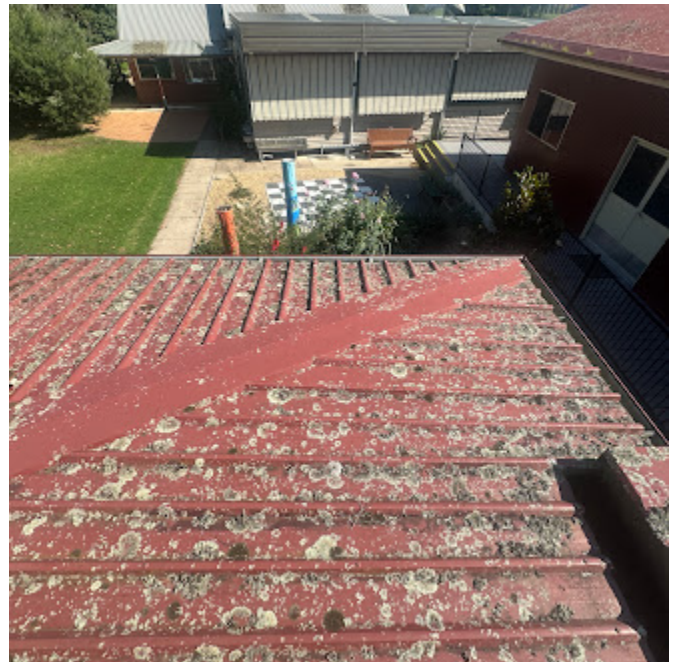
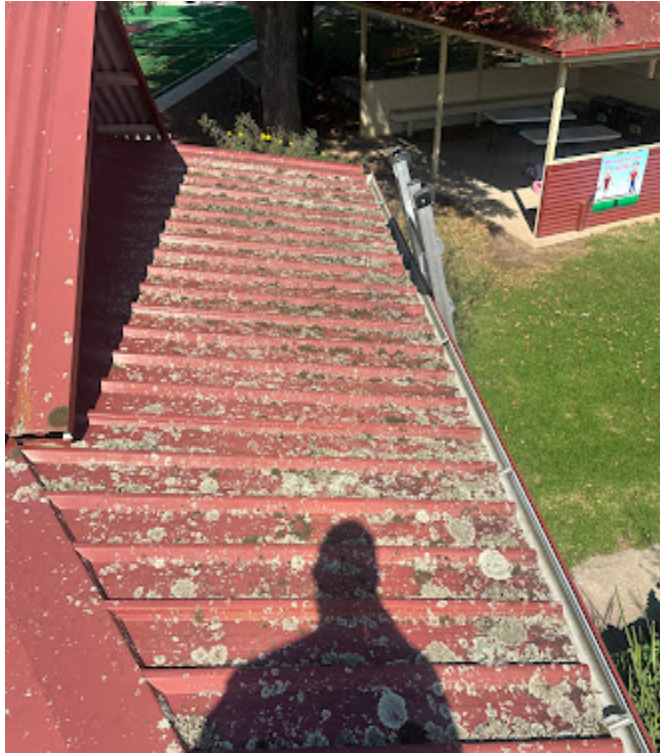
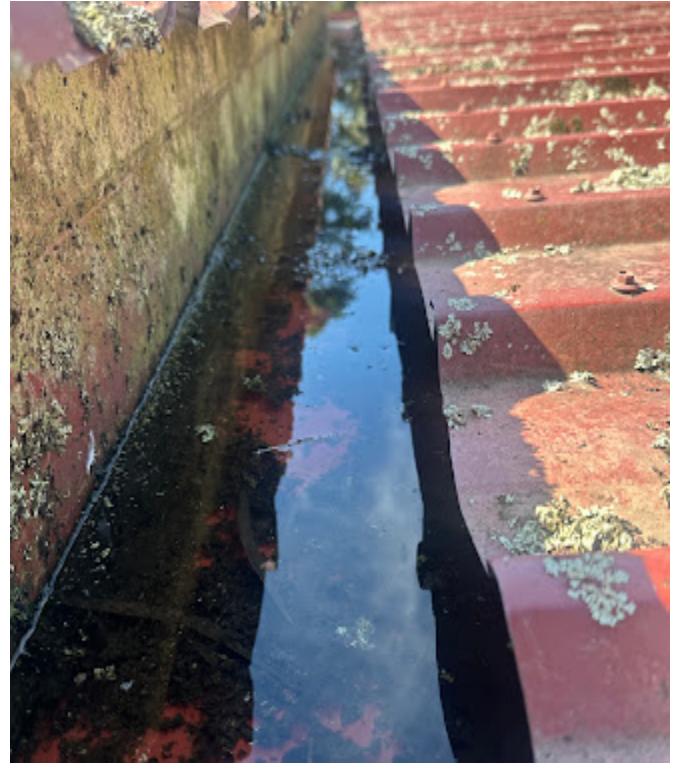
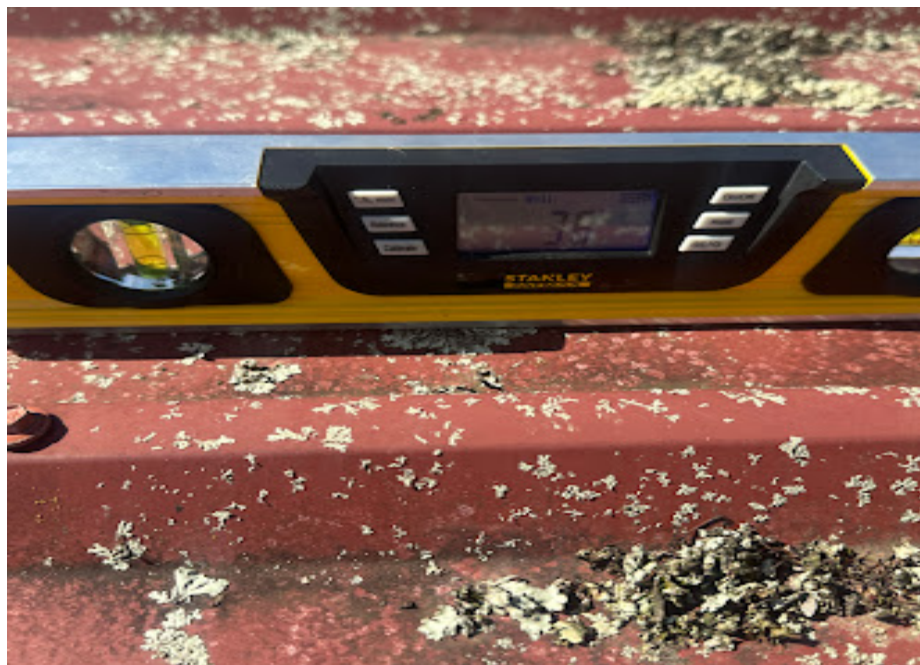
### 3. Walkway Roof

- **Pitch:** The roof pitch is 4 degrees, which is compliant and sufficient for water runoff.
- **Box Gutter:** The box gutter is level, causing water to pool, and lacks overflow provisions, which is non-compliant. It does not meet the minimum dimensions (200mm bottom, 100mm top) per AS/NZS 3500.3.
- **Rainhead:** The rainhead is blocked and lacks an overflow, violating NCC Part E3P1.
- **Roof Sheets:** The ends of the sheets are not turned down, increasing the risk of water ingress via capillary action.
- **General Condition:** The roof is dirty, with debris in trays, and requires a high-pressure clean.

**Compliance Notes:** The box gutter and rainhead issues contravene NCC Part E3P1–E3P4, which require adequate stormwater disposal and overflow provisions.

**Description:** Lift the roof, replace the box gutter with a compliant design (200mm bottom, 100mm top, correct fall), install a rainhead with overflow, turn down sheet ends, clean the roof, and repair damaged downpipes with inspection openings.

**Recommendation:** I recommend **Option 1** for its compliance and reliability. **Option 2** is a budget-friendly alternative but carries maintenance risks. **Option 3** is not advised.

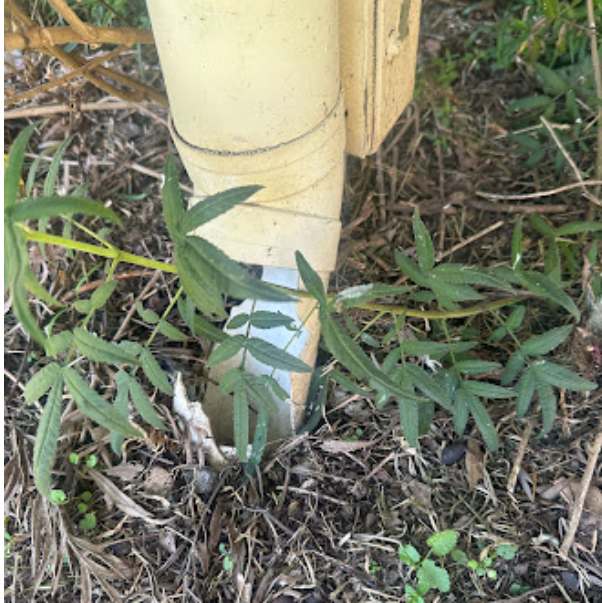
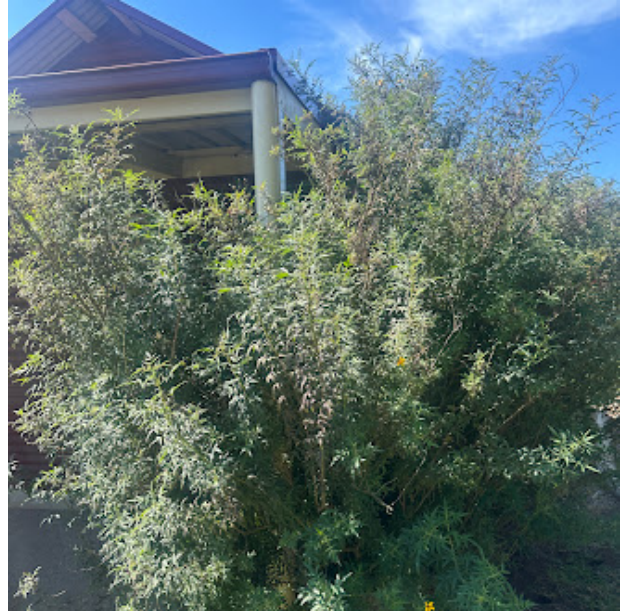
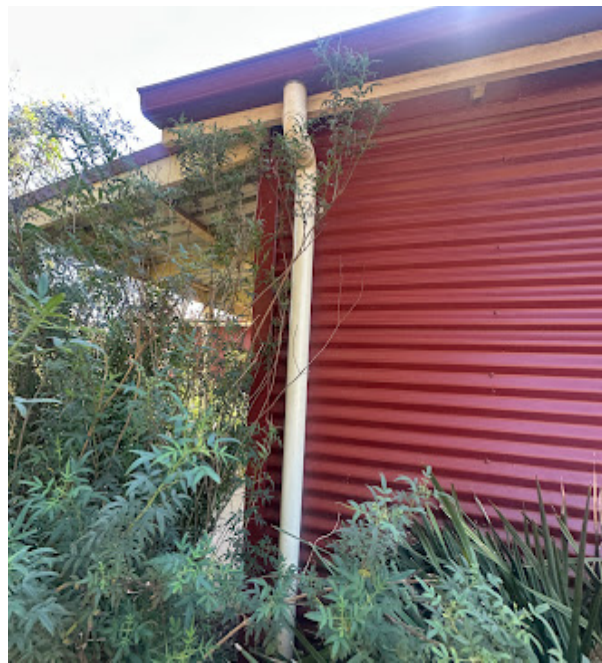
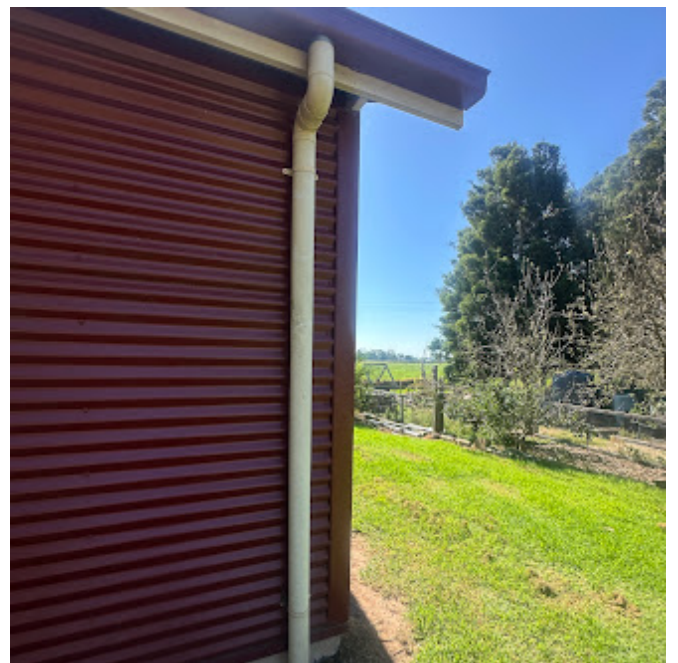
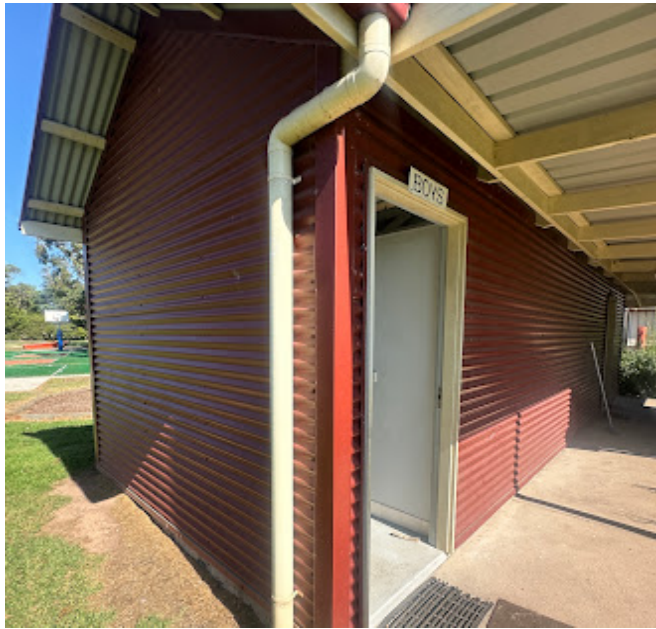
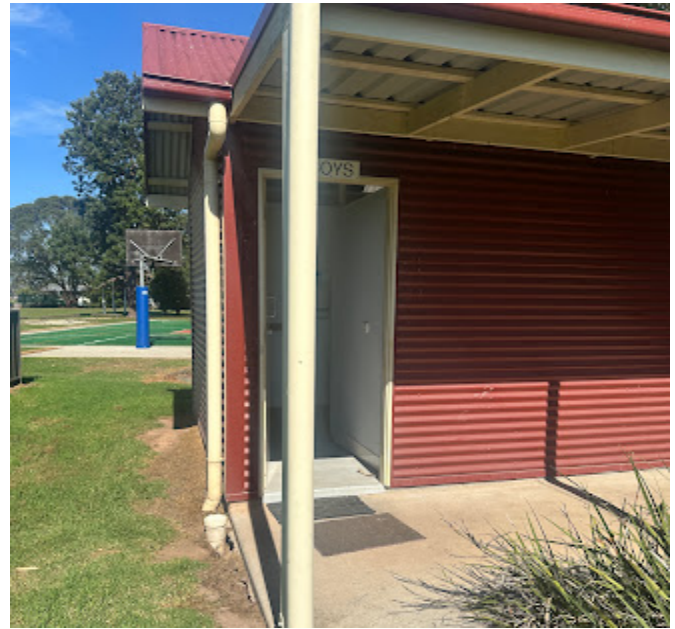
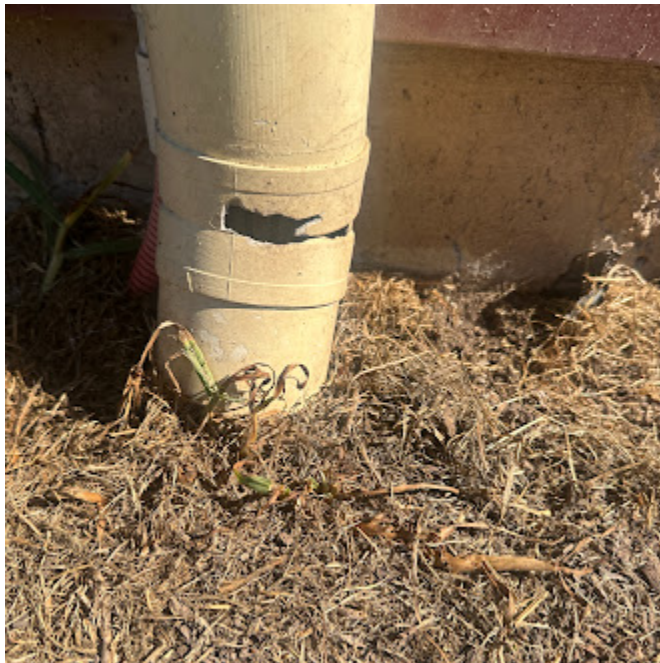
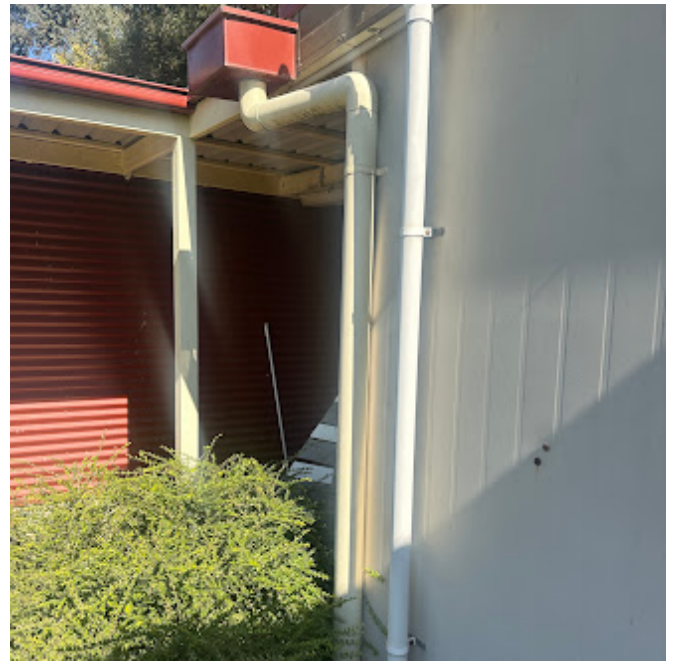
#### 4. Downpipes (Across All Sections)

- **Quantity and Size:** Six 90mm downpipes are sufficient for the roof area, meeting AS/NZS 3500.3 sizing requirements.
- **Condition:** Two downpipes are damaged (likely from whipper snippers) and require repair. None have inspection openings, which are recommended for maintenance.
- **Compliance Notes:** While functional, the lack of inspection openings and overflow provisions (e.g., via rainheads) does not fully align with best practices under AS/NZS 3500.3 for maintenance access.

**Description:** Repair two damaged downpipes, install 45-degree inspection openings with pop-off caps on all six downpipes, and ensure rainheads with overflows are added where needed.

**Recommendation:** **Option 1** is preferred for maintenance and compliance. **Option 2** is a minimal fix but less effective.
