# Roofing Inspection Report

**Property:** Bairnsdale Primary School, [REDACTED] Bairnsdale, VIC 3875

**Prepared by:** Holymess Repairs

**Date:** 17 April 2025

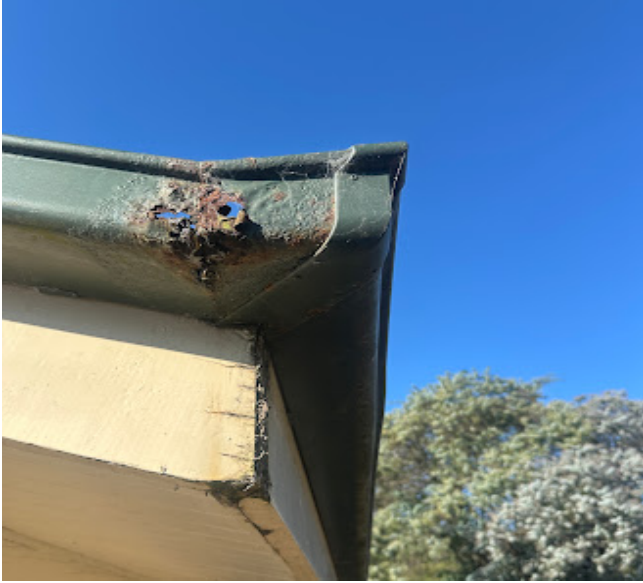
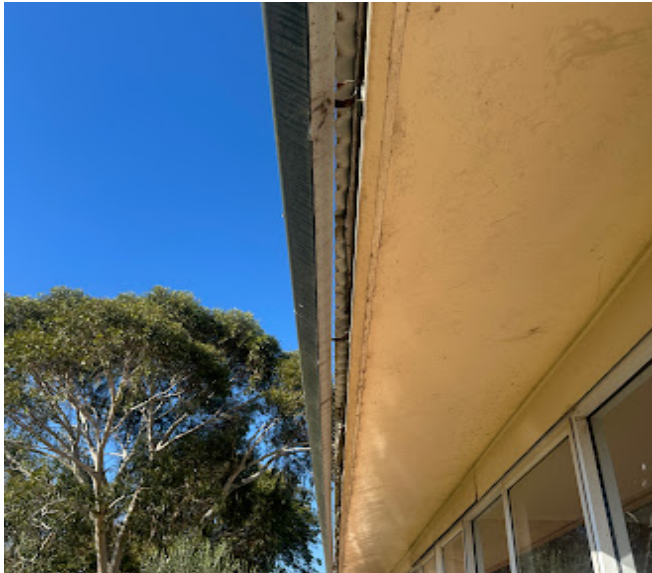
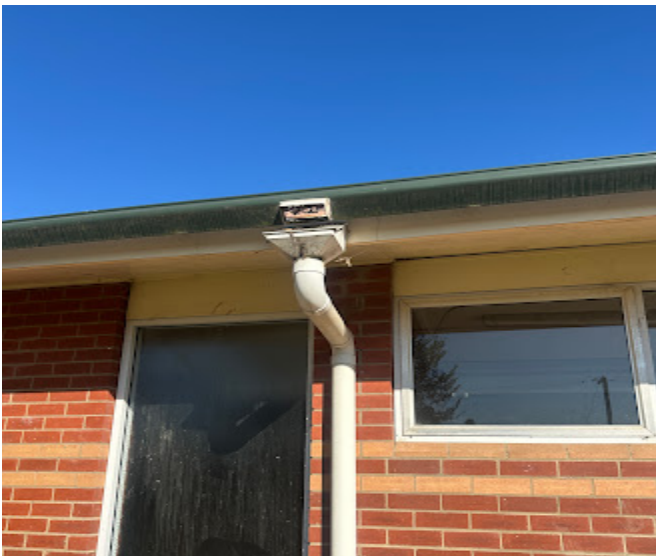
## Gutters

- **Rusted Gutter Section:** A corner section of the gutter is rusted, likely due to water pooling from inadequate falls or blockages [,].
- **Dislodged Gutter Brackets:** Gutters on one side have detached from their brackets, possibly due to improper securing or disturbance during cleaning. This has caused misalignment and ineffective water flow.
- **Leaf Eater System Issues:** While leaf eaters are installed to reduce debris, one downpipe pop is missing, and some are undersized (90 mm pop into a 100 mm pipe), reducing efficiency.
- **Lack of Overflow Provisions:** The gutters lack overflow mechanisms, which is non-compliant with *AS/NZS 3500.3* and increases the risk of water ingress during heavy rain [,].
- **Tree Debris:** Overhanging gum and pine trees contribute to significant leaf litter, exacerbating blockages and requiring regular maintenance.

- Replace rusted gutter corner with new Colorbond steel guttering (*SA HB 39* compliant).
- Reattach dislodged gutters with new brackets and screws, ensuring proper falls.
- Install a 90 mm downpipe pop to replace the missing component.
- Remove rocks and debris from the roof.
- Inspect and monitor rusted screws during gutter cleaning.

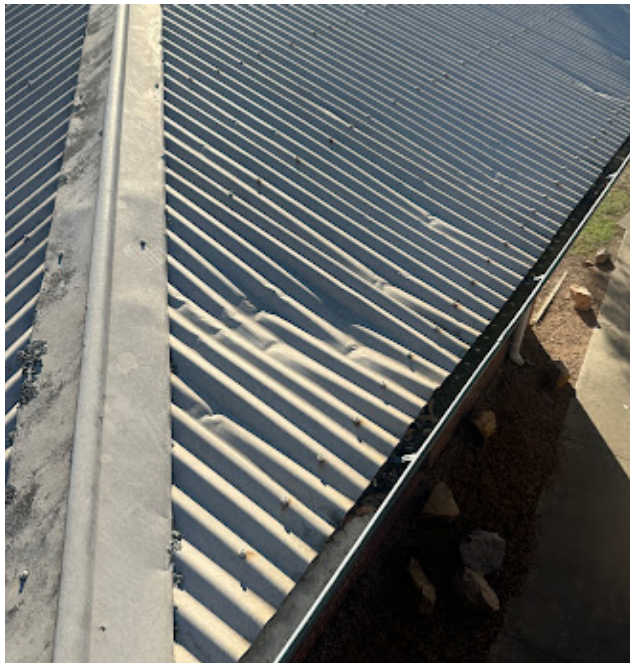
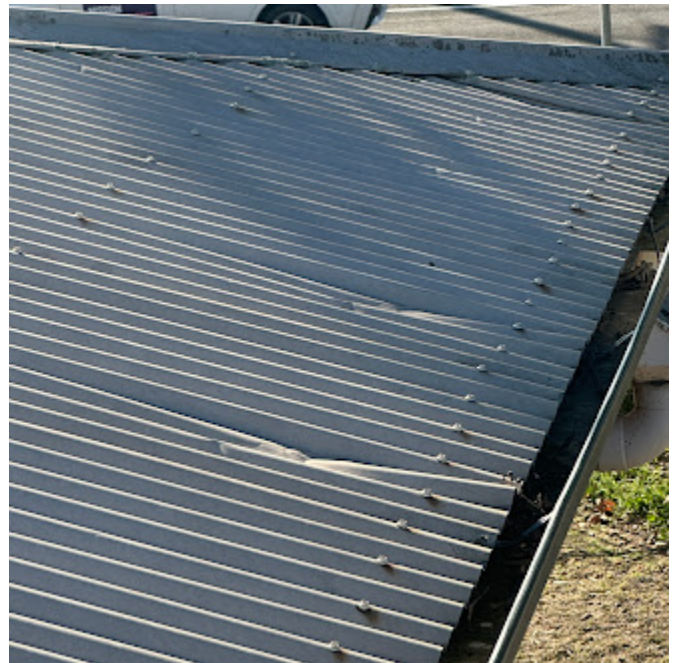
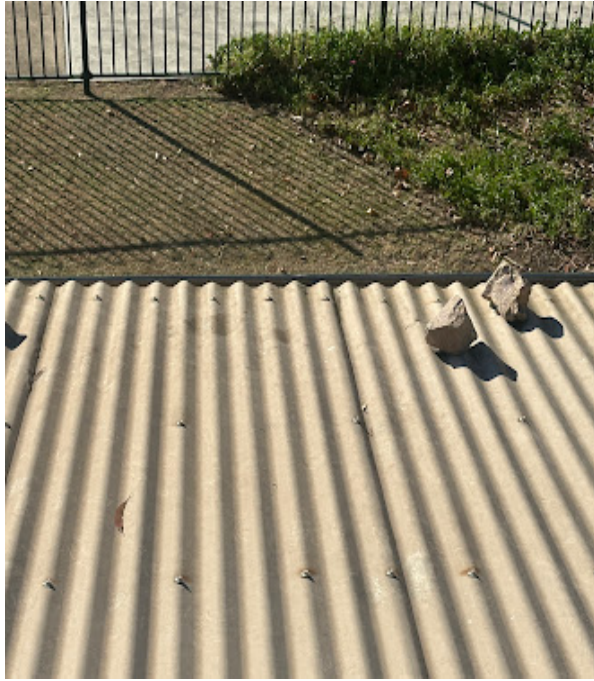
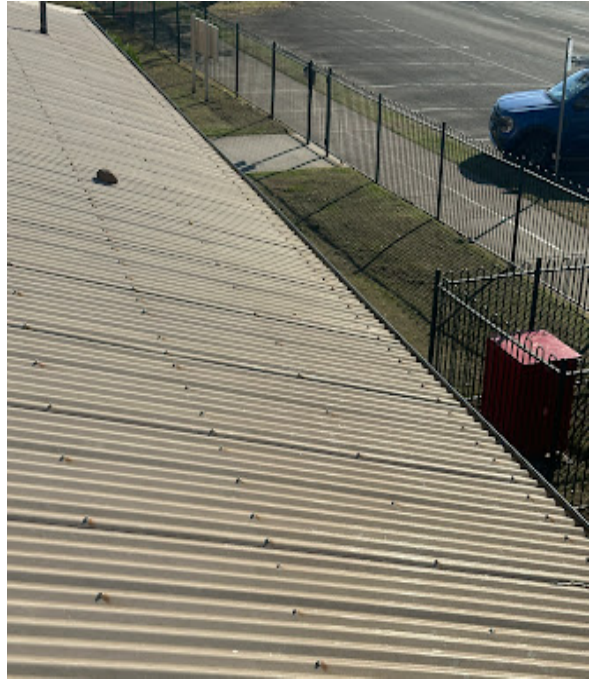
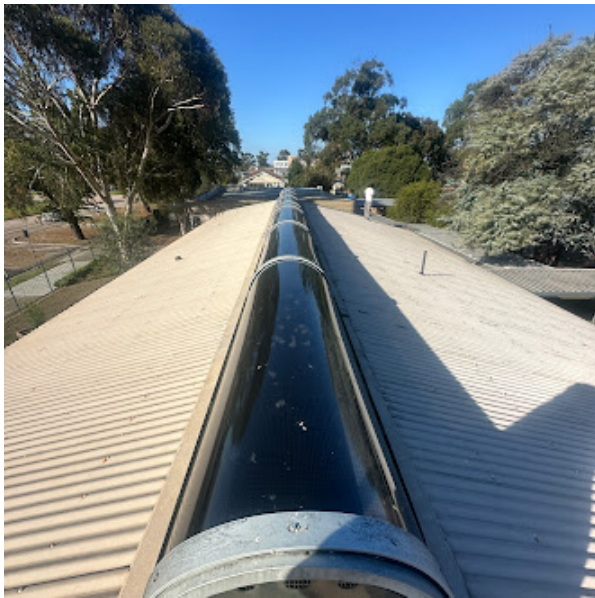
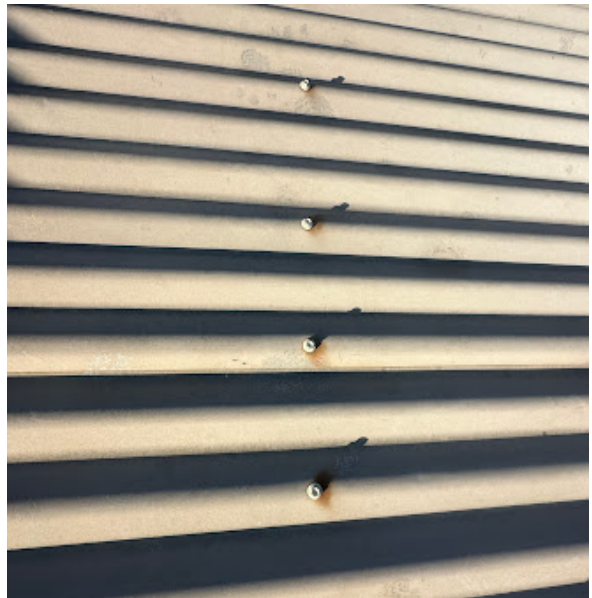
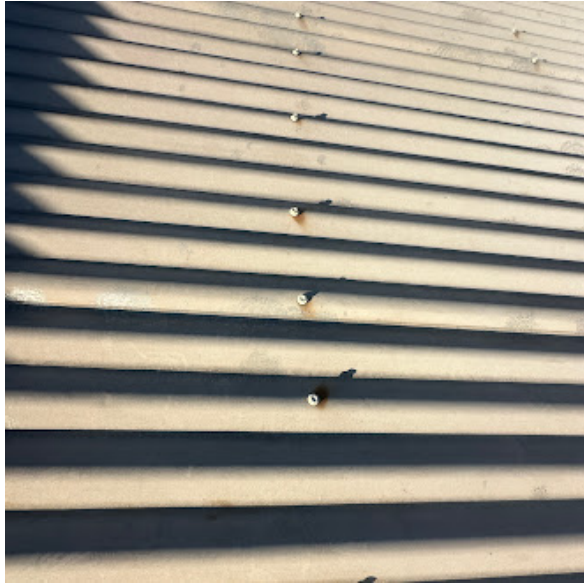
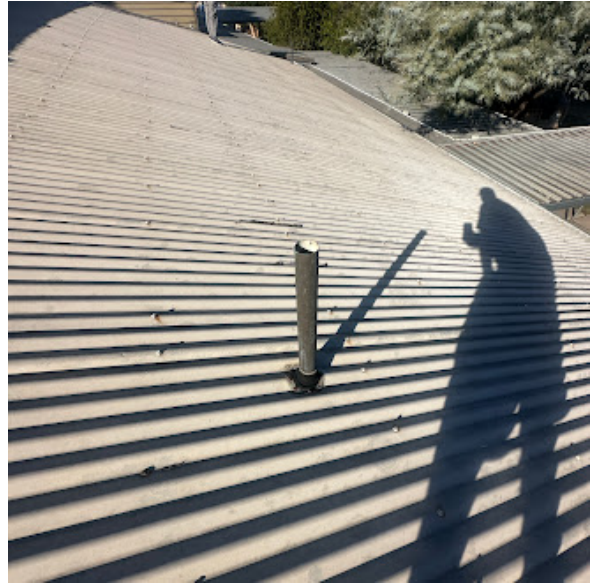
## Roof

- **Dented Roof Sheets:** Roof sheets along the ridge line are dented, likely from children climbing or throwing objects. This poses a safety risk if sheets dislodge or debris falls [].
- **Rusted Screws:** Many screws show surface rust, indicating potential long-term corrosion. The screws are a different color from the roof, suggesting past repairs or painting.
- **Damaged Vents:** Two roof vents have missing or damaged cowls, allowing vermin ingress and reducing ventilation efficiency [].
- **Debris on Roof:** Rocks and other debris on the roof pose a safety hazard and could damage the roof surface if not removed.
- **Skylight Seals:** Rubber seals on the skylights show signs of shrinkage and moss buildup, indicating potential future leaks if not resealed.

- All repairs from Option 1.
- Replace dented polycarbonate skylight sheets with new, untinted sheets to improve safety and aesthetics.

- Replace all gutters with new Colorbond steel gutters, ensuring proper falls and overflow provisions (*AS/NZS 3500.3*).
- Install leaf guard systems (e.g., Leaf Eater Advanced) to minimize debris buildup.
- Replace all rusted screws with corrosion-resistant, color-matched screws (*SA HB 39*).
- Reseal polycarbonate skylight rubber seals to prevent leaks.
- Replace damaged vent cowls to restore ventilation and prevent vermin ingress (*NCC Volume One*).
- Remove roof debris and implement a quarterly maintenance plan, including gutter cleaning and rust inspections.
