# HolyMess Pty. Ltd.

## Roof Inspection Report

**Property Address:** [REDACTED] St Kilda VIC 3182

**Date of Inspection:** 06 May 2025

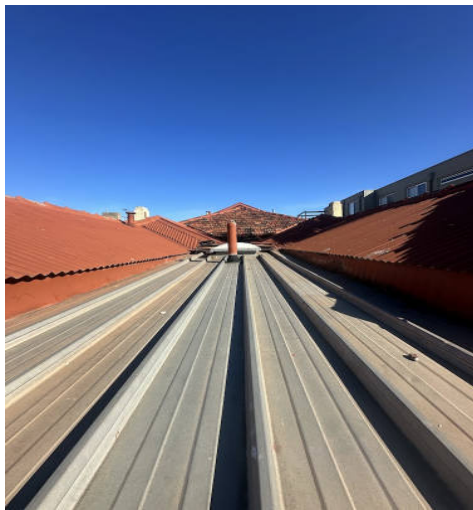
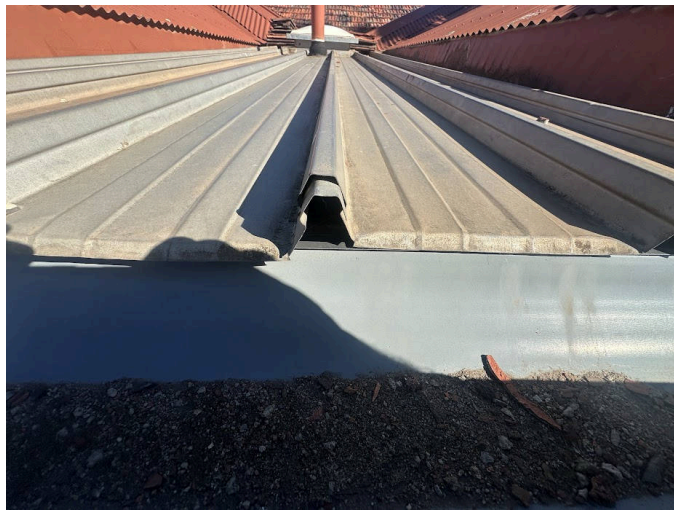
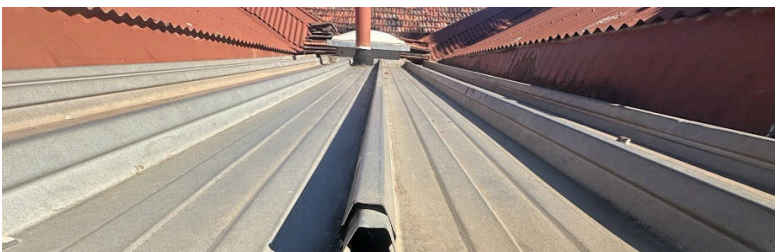
## Flat Deck Roof

- The flat roof has adequate fall and a suitable profile for water runoff.
- A penetration (dectite) blocks an entire tray, reducing the roof's lifespan by impeding water flow.
- Roof sheets are short, with less than the required 50 mm overhang into gutters (AS 1562.1:2018).
- Concrete tiles on the flat deck roof are incorrectly positioned, interrupting water flow from the box gutter.
- A plastic flashing extends the roofline where tiles are short, which is suboptimal and not durable.
- Access is unsafe without a ladder bracket or tower, limiting close inspection (Work Health and Safety Regulation 2011, Regulation 305).

- Short sheets and tiles violate AS 1562.1:2018 and BCA Volume Two, Clause V2.2.1 (minimum 50 mm overhang).
- Improperly positioned tiles risk pooling and water ingress, contravening NCC Volume Two, Part H4.2.
- Lack of safe access breaches Work Health and Safety Regulation 2011, Regulation 305.

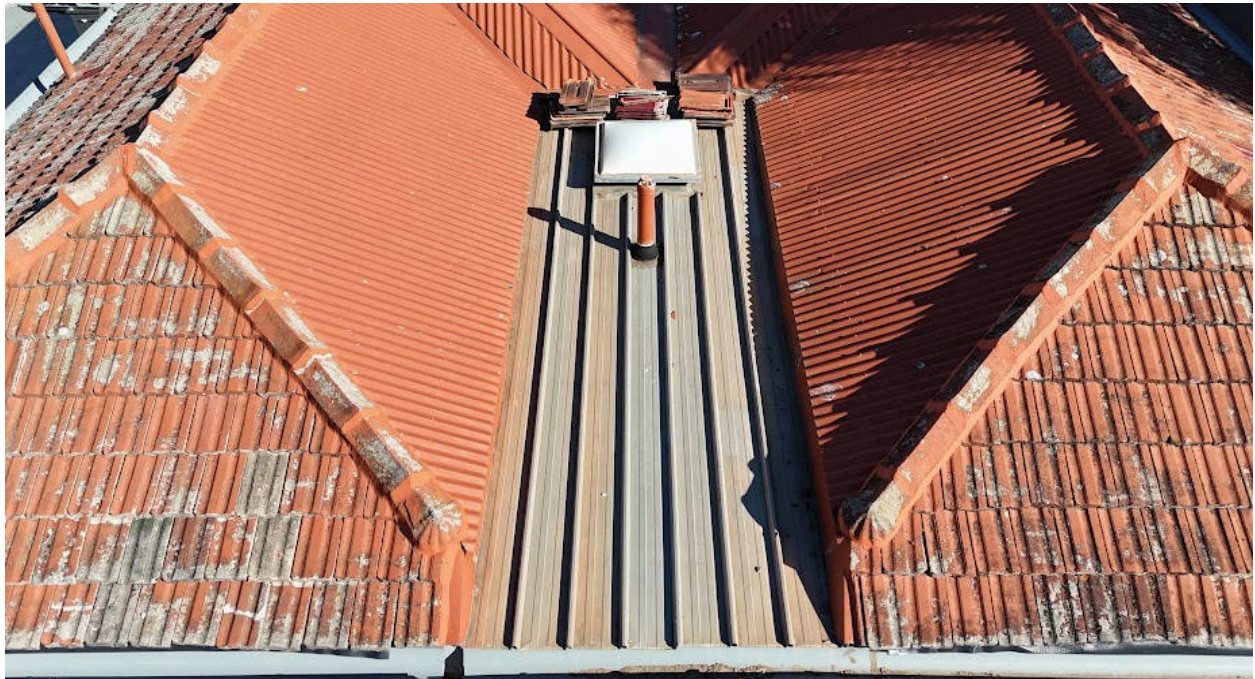
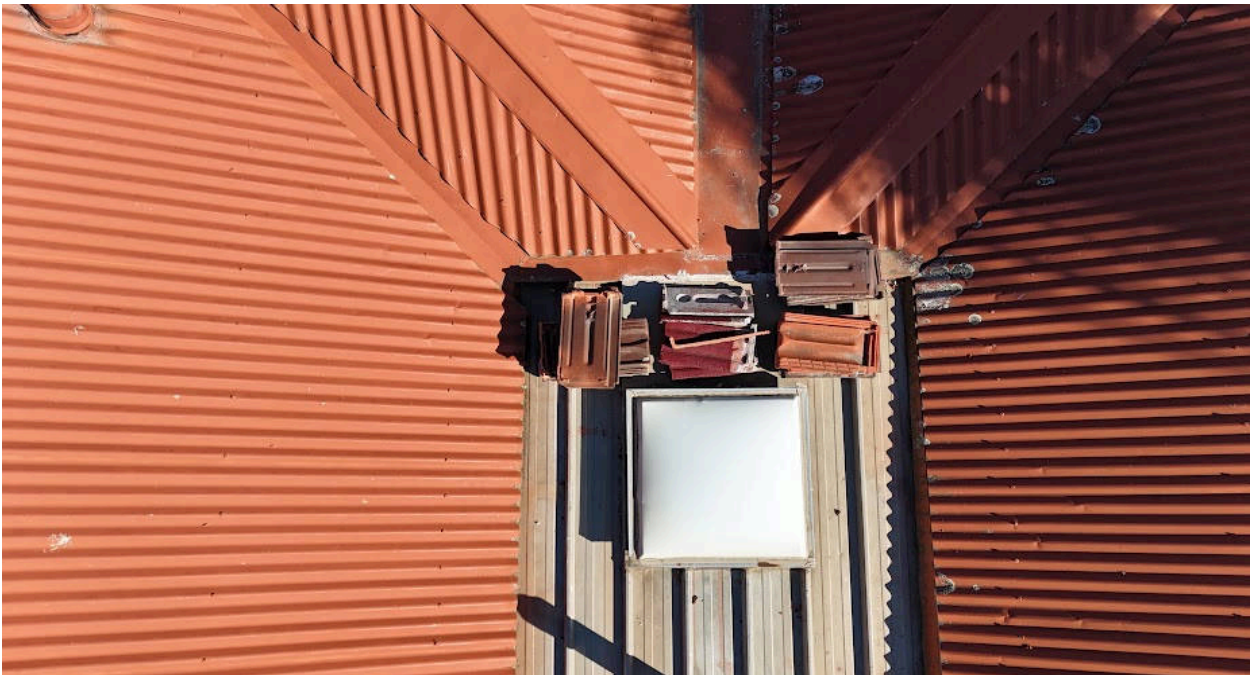
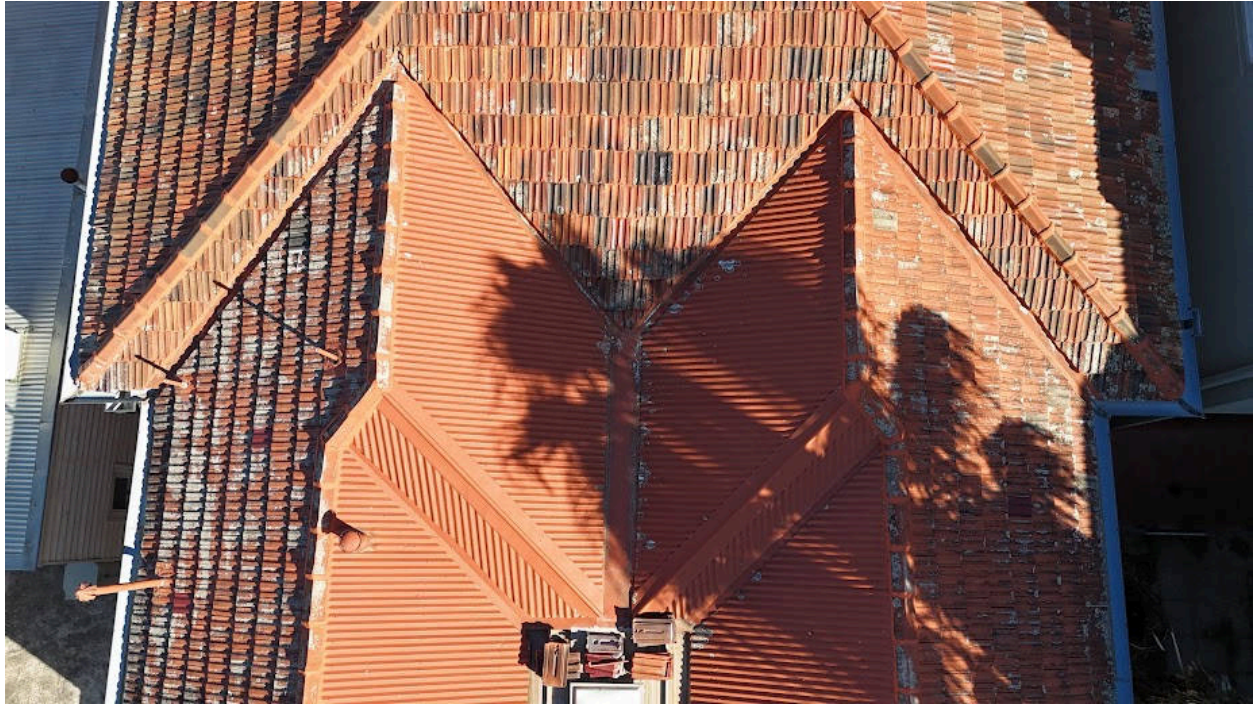
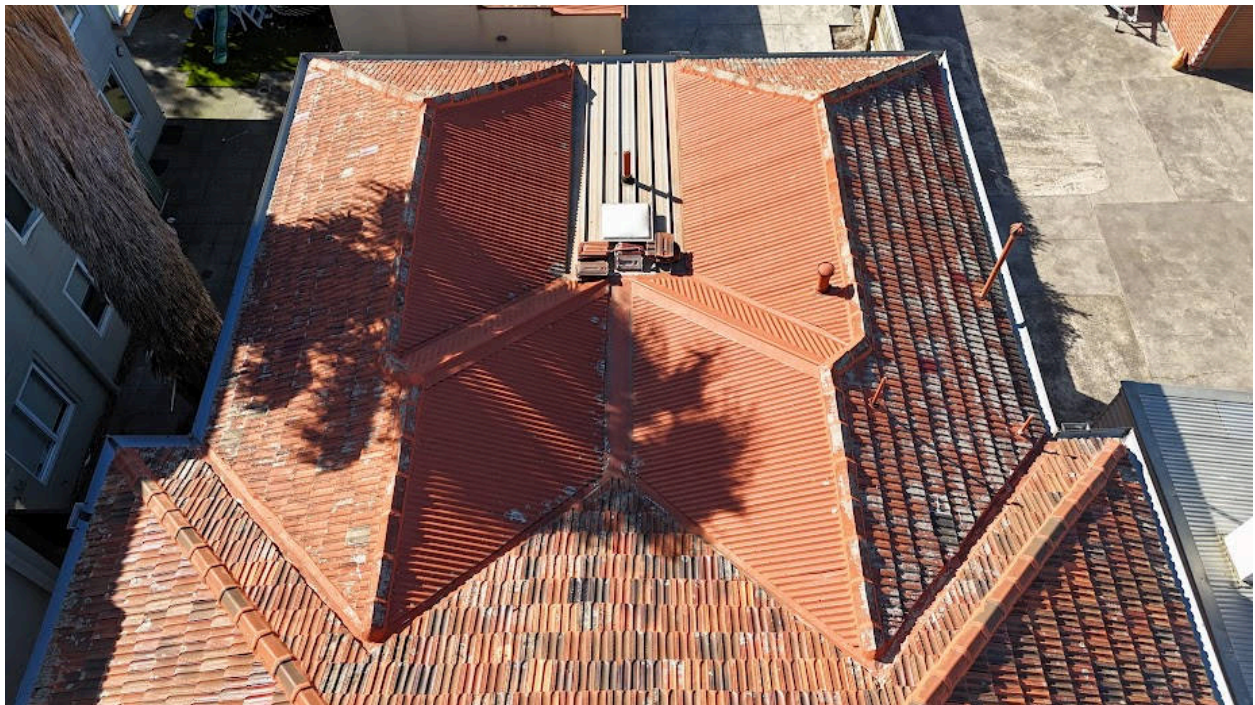
## Rear Roof

The rear roof consists of a concrete tile on the external and a metal roof internally. There are valleys running into a box colour that then disperse onto a flat deck roof. There are spare tiles in front of the box scanner. This will interrupt the flow of water and cause pooling. The metal roof itself is in fair condition. The concrete tiles are in poor condition and are starting to break down to sand and cement. These tiles are also short running into the gutter and a plastic flashing has been installed to extend the roof line into the gutter.

- Comprises concrete tiles externally and a metal roof internally, with valleys feeding into a box gutter and onto the flat deck roof.
- Concrete tiles are in poor condition, breaking down into sand and cement, and are short, requiring plastic flashing to extend into the gutter.
- Spare tiles in front of the box gutter interrupt water flow, causing pooling.
- The metal roof is in fair condition with no immediate issues.

- Short tiles and plastic flashing do not meet AS 2050:2018 or BCA Volume Two, Clause V2.2.1.
- Pooling risks water ingress, violating NCC Volume Two, Part H4.2.

- Replace short concrete tiles on the rear roof with new tiles, ensuring a 50 mm overhang into gutters (AS 2050:2018, BCA Volume Two, Clause V2.2.1).
- Reposition spare tiles on the flat deck roof to prevent pooling and replace short sheets with compliant lengths.
- Replace slipping lead flashings on the front lower roof with new lead or colorbond flashings.
- Install a ladder access point to the flat deck roof for safe maintenance (Work Health and Safety Regulation 2011, Regulation 305).
- Seal rain heads and clean gutters/downpipes.
- Screw down garage roof sheets and replace heavily rusted sheets, reusing existing flashings.

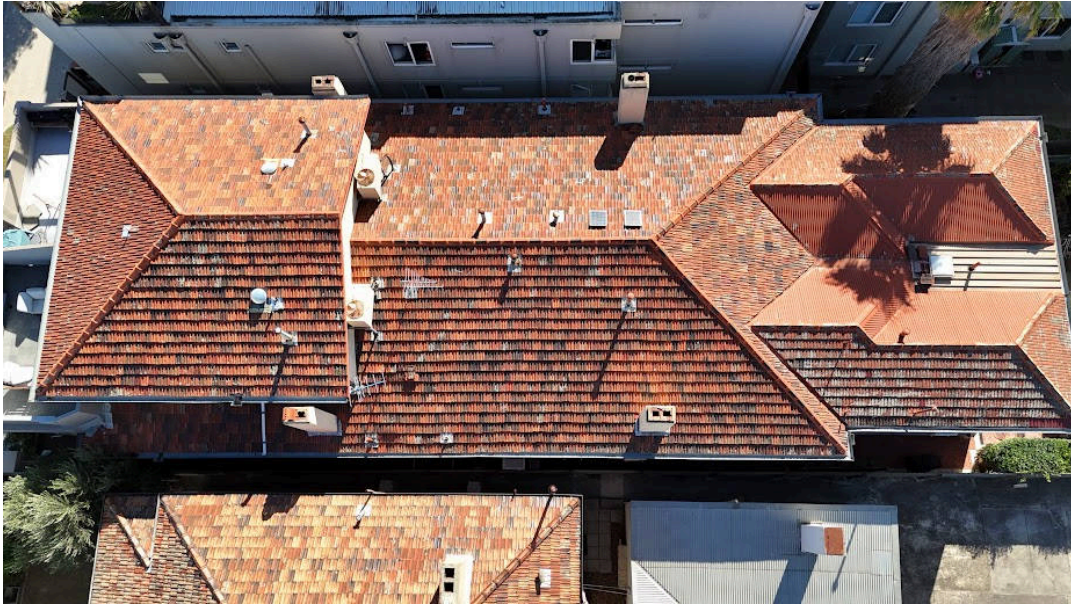
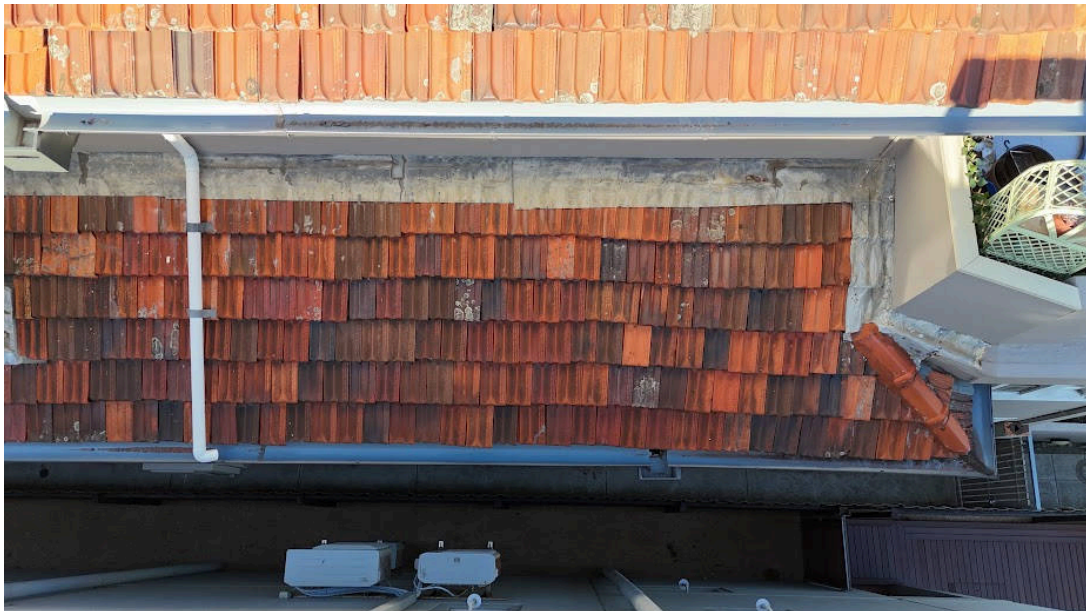
## Front Lower and Upper Roof

The lower roof to the original building has terracotta tiles. These tiles are in fair condition with no breaks found on this roof. The lead flashings on this building are shifting and are in poor condition.

- Both roofs have terracotta tiles in fair condition with no breakages.
- Lead apron flashings on the front lower roof are slipping and in poor condition, risking water ingress.
- No signs of water ingress currently, but flashings require attention.

- Slipping lead flashings risk non-compliance with AS 2050:2018 and NCC Volume Two, Part H4.2 (weatherproofing).

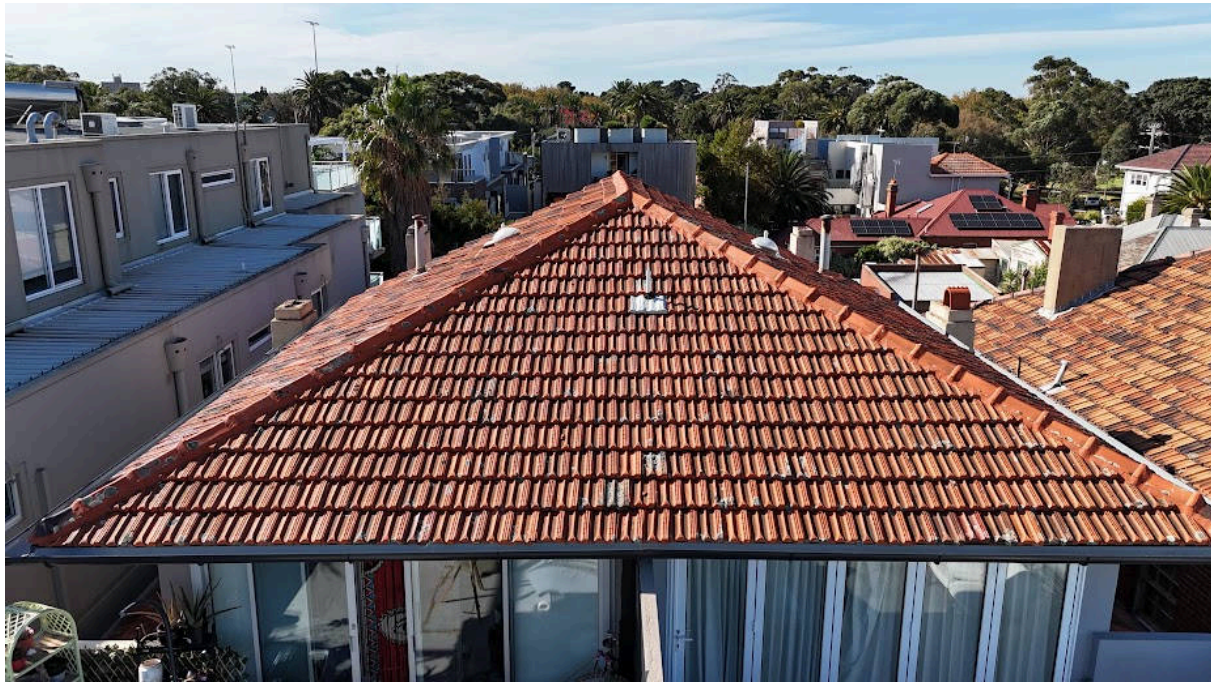
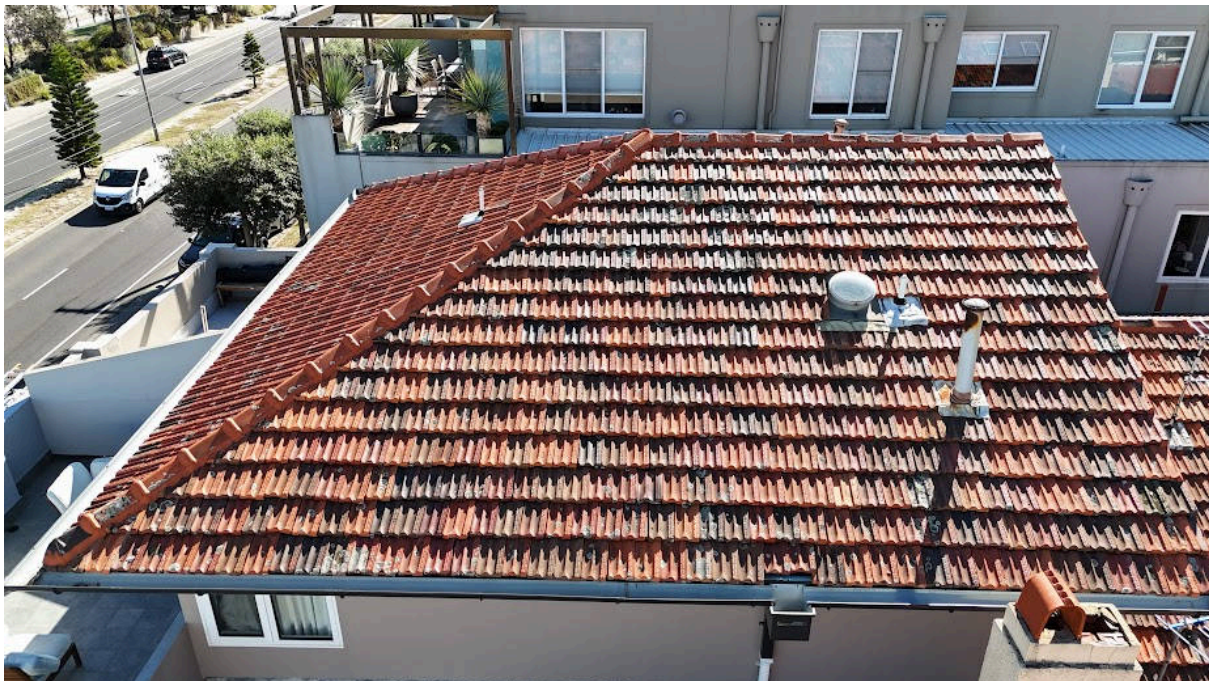
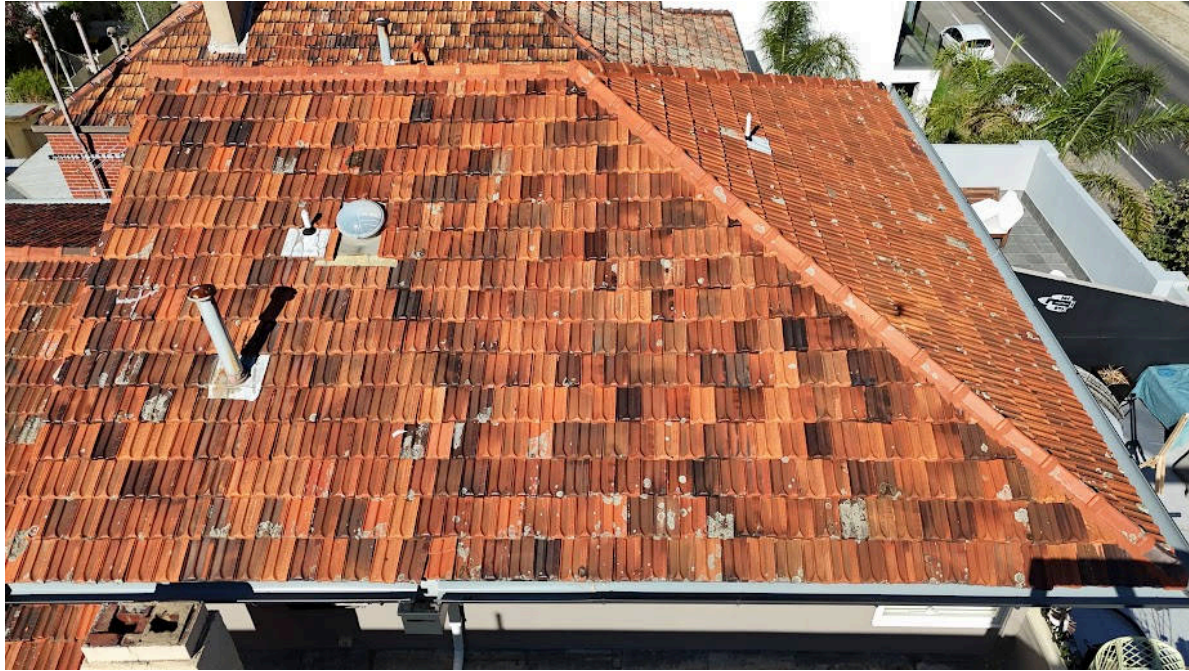
The upper roof is also terracotta tile and is in fair condition. No brakes were found on this roof.

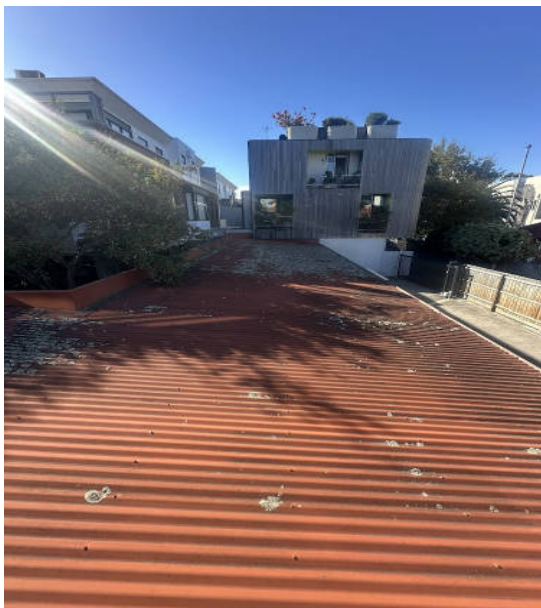
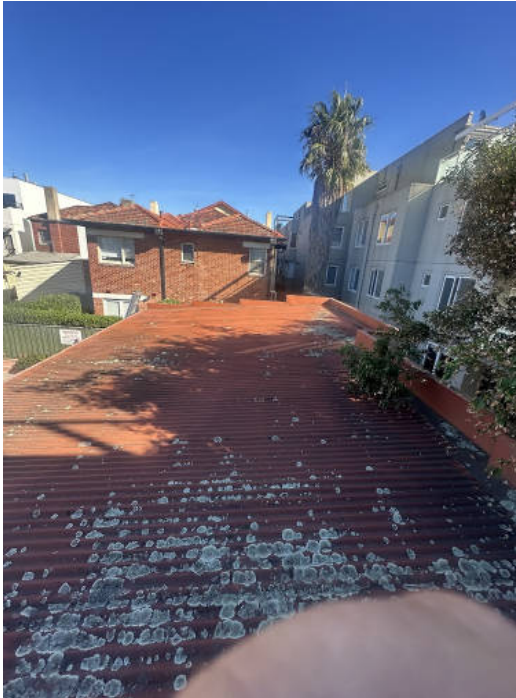
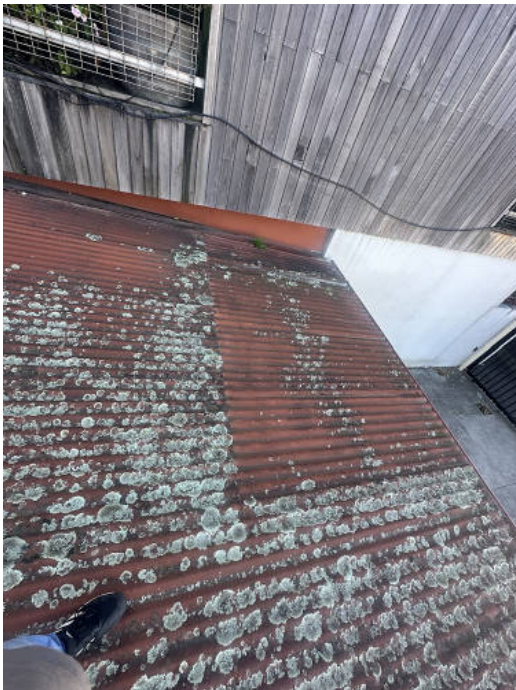
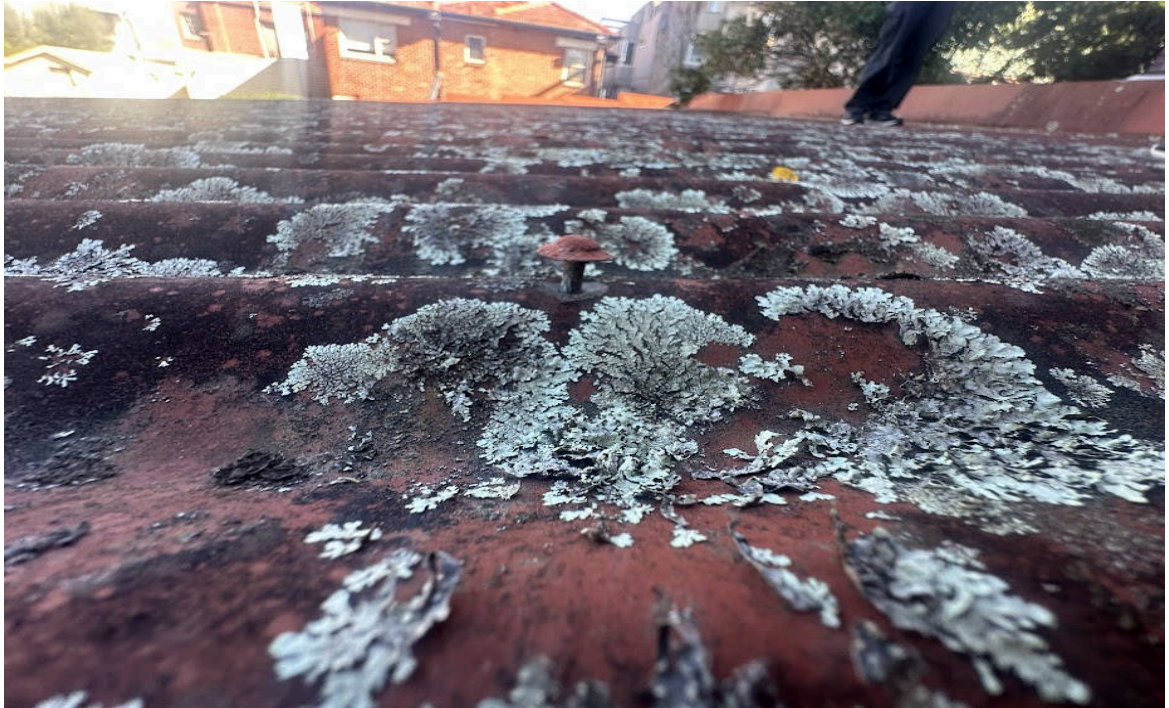
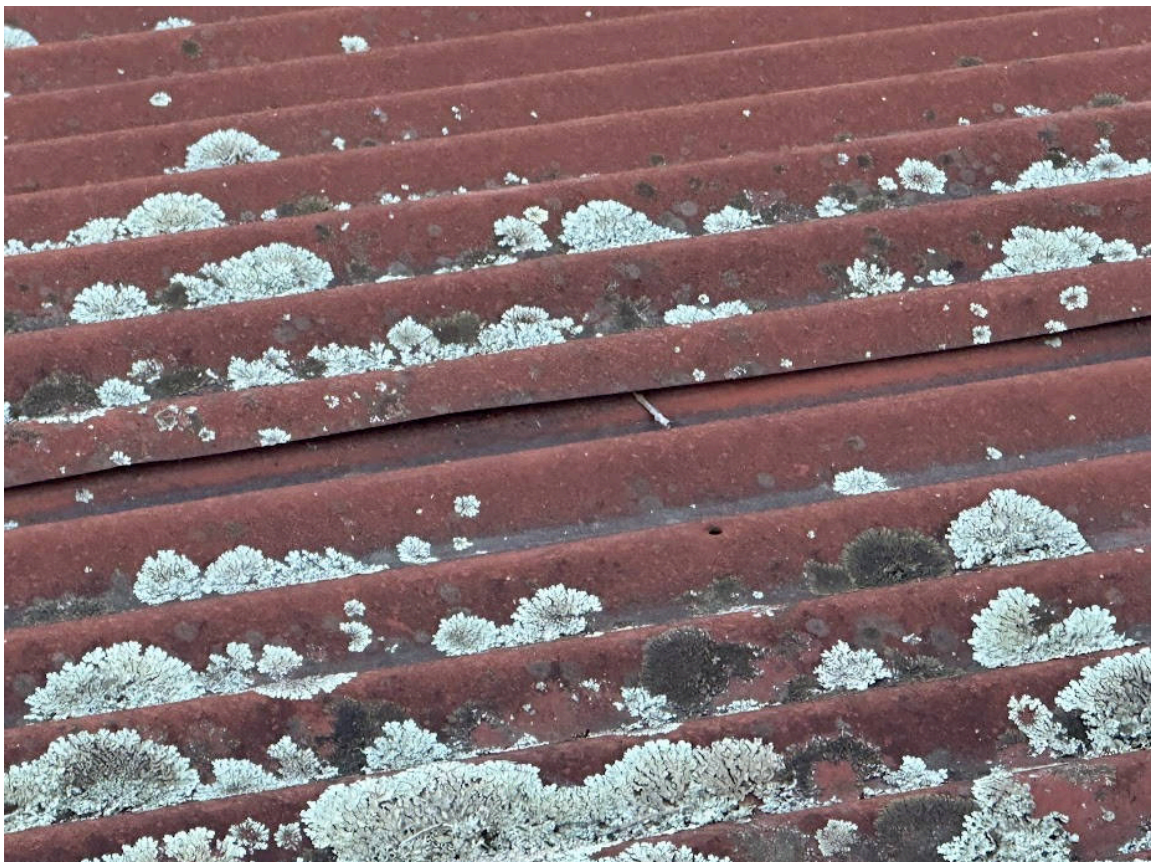
## Garages

- Condition:
  - The garage roof is over 50 years old, with corrugated sheets showing surface rust and moss buildup.
  - Some sheets have been screwed down, reducing gaps, while others have popping nails, causing bounce and separation.
  - Flashings appear reusable but are not original to the roof's age.
  - The frame is structurally sound, with close rafters and sufficient battens.
- Compliance Issues:
  - Popping nails and rusting sheets risk water ingress, contravening NCC Volume Two, Part H4.2.
  - Lack of safe access for maintenance breaches Work Health and Safety Regulation 2011, Regulation 305.
