## Roof Inspection Report

**Property Address:** [REDACTED] Box Hill VIC 3128

**Date of Inspection:** 08 May 2025

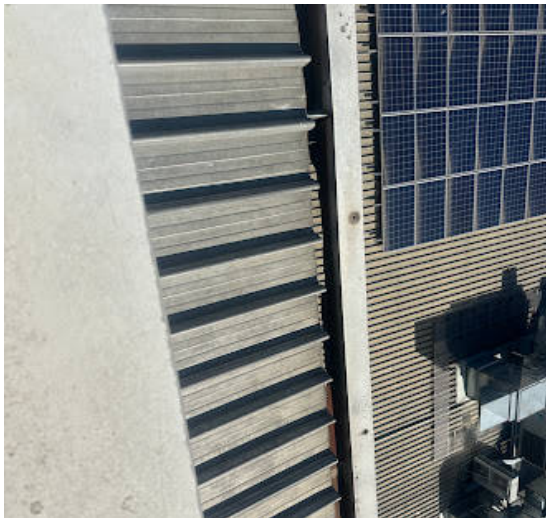
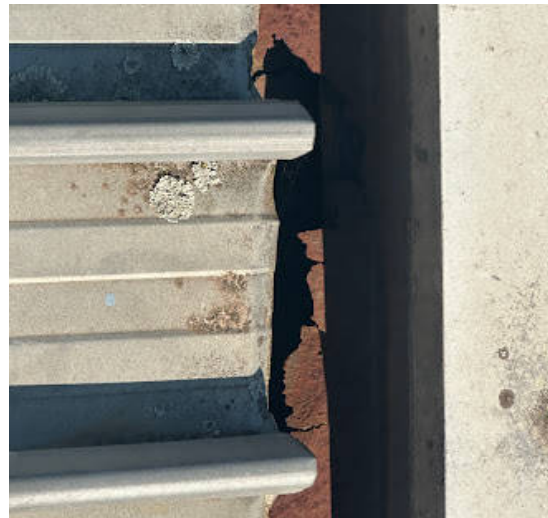
## **Right-Hand Side Awning and Box Gutter:**

- The box gutter is heavily rusted and lacks downpipes, allowing water to enter the eaves (non-compliant with AS 3500.3:2021).
- The awning has a 10° fall, posing access challenges for repairs, requiring EWP for safety (WHS Regulation 2011, Clause 299).

- **Description:** Replace rusted box gutters with new Colorbond steel gutters, ensuring compliant overflows and downpipes (AS 3500.3:2021, Clause 4.2). Clean and coat adjacent trays with anti-corrosion paint.
- **Pros:**
  - Permanent solution, compliant with NCC and AS 3500.3:2021.
  - Prevents leaks and structural damage.
  - Enhances roof longevity.
- **Cons:**
  - Significant upfront cost.
  - Requires EWP and coordination for safe access.
- **Risks:**
  - Minimal, as this addresses all issues comprehensively.
  - Delaying replacement risks gutter collapse and water ingress.

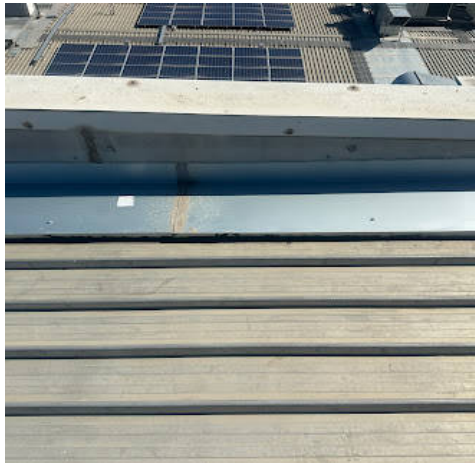
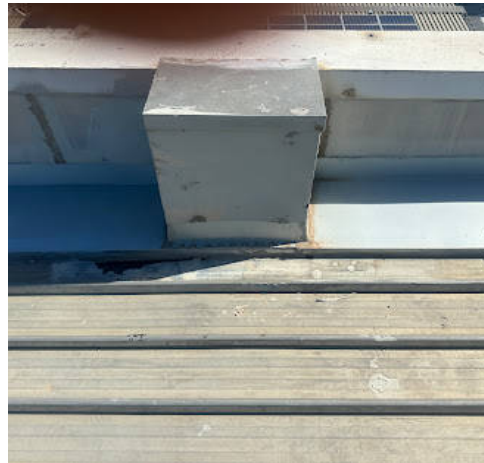
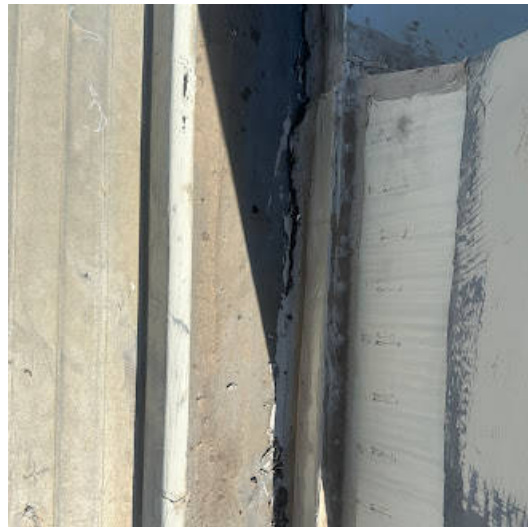
## **Right-Hand Side Apron Flashing:**

- Newly installed apron flashing is poorly executed, lacking coverage over an additional rib, leading to water pooling and rust (AS 1562.1:2018, Clause 3.4).

- Excessive sealant use indicates multiple repair attempts, which are not a permanent solution (NCC F1P1).

- **Description:** Remove the existing flashing and install new Colorbond flashing, extending over an additional rib, as per AS 1562.1:2018, Clause 3.4. Seal with compliant butyl rubber sealant.
- **Pros:**
  - Ensures long-term weatherproofing (NCC F1P1).
  - Prevents rust and leaks, extending roof lifespan.
  - Compliant with BCA and Australian Standards.
- **Cons:**
  - Higher upfront cost than temporary fixes.
  - Requires EWP for safe access, adding to costs (WHS Regulation 2011).
- **Risks:**
  - Minimal, as this is a permanent solution.
  - Delaying replacement risks further rust and water ingress.

- **Description:** Clean and reseal the existing flashing with high-quality silicone sealant as a temporary measure.
- **Pros:**
  - Cost-effective for clients on a tight budget.
  - Quick to implement, minimizing disruption.
- **Cons:**
  - Temporary fix, lasting 1–2 years, not compliant with BCA long-term standards.
  - Does not address underlying rust, which may worsen.
- **Risks:**
  - Ongoing leaks and corrosion, leading to higher costs later.
  - Non-compliance with NCC F1P1, risking VBA enforcement.

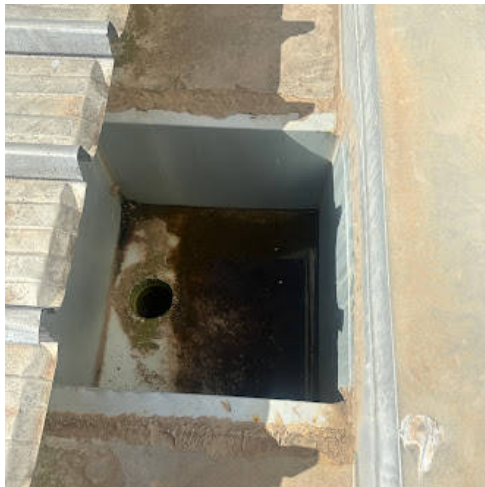
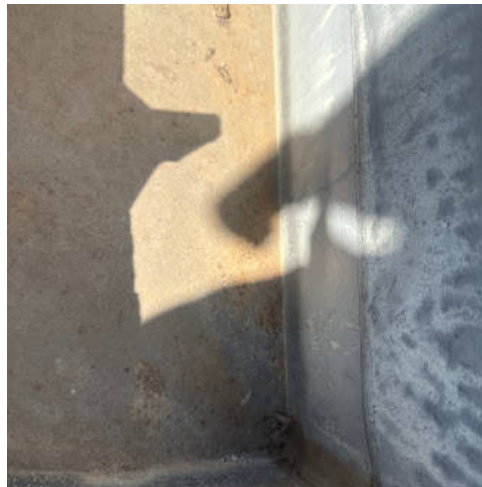
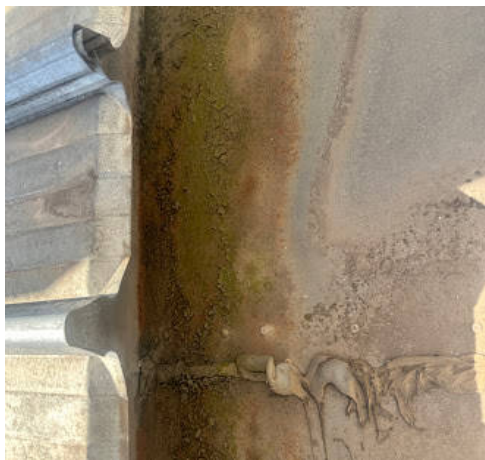
## Box Gutter Behind Services and Stairwell:

- Heavy rust in the box gutter and adjacent trays requires replacement (AS 3500.3:2021).
- Poor flashing design allows water to pool, risking leaks (BCA Volume Two, Part 3.5.1).

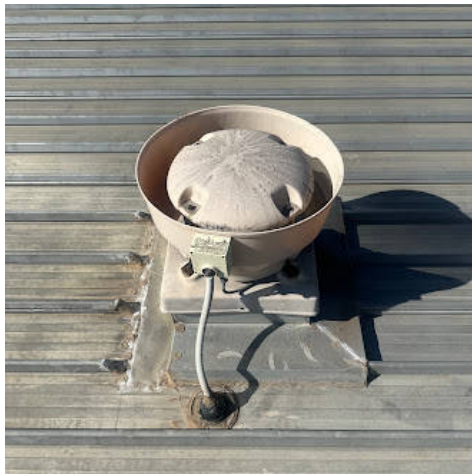
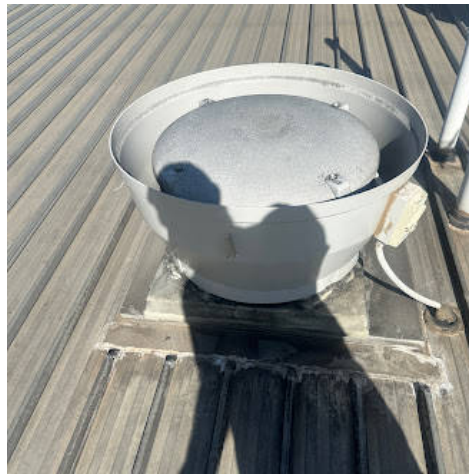
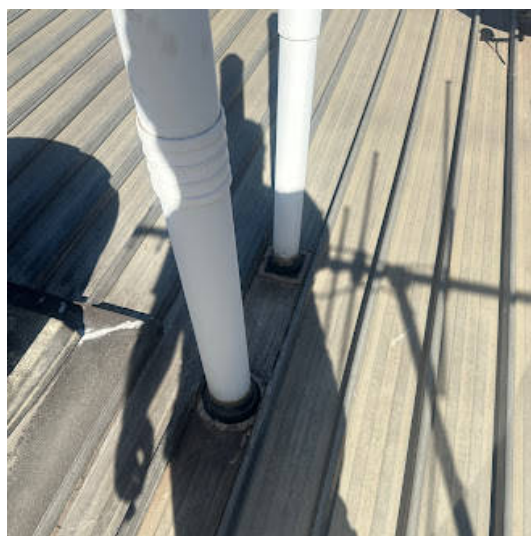
## Penetrations on Left-Hand Side:

- Penetrations rely on poorly applied silicone, which is deteriorating and non-compliant with BCA weatherproofing standards.
- Lack of back flashing increases the risk of rust and leaks (AS 1562.1:2018).

- **Description:** Install Colorbond back flashing over ribs, directing water away from penetrations, as per AS 1562.1:2018, Clause 3.4.
- **Pros:**
  - Permanent, compliant solution (NCC F1P1).
  - Prevents leaks and rust.
- **Cons:**
  - Higher cost than resealing.
  - Requires skilled installation.

- **Description:** Clean and reseal penetrations with high-quality silicone.
- **Pros:**
  - Cost-effective and quick.
  - Temporarily reduces leak risk.
- **Cons:**
  - Lasts 1–2 years, not compliant with BCA long-term standards.
  - Does not prevent rust progression.
- **Risks:**
  - Ongoing leaks and corrosion, leading to costly repairs.
  - Non-compliance with NCC F1P1.

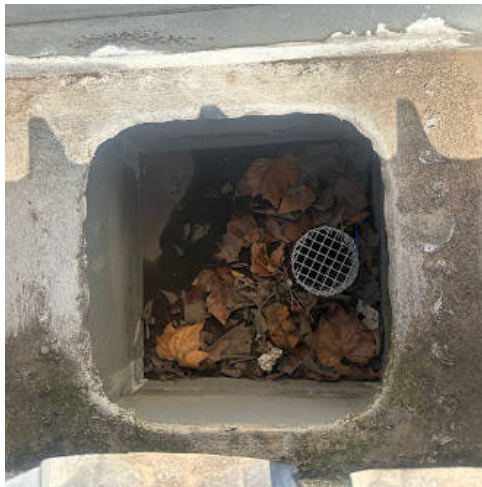
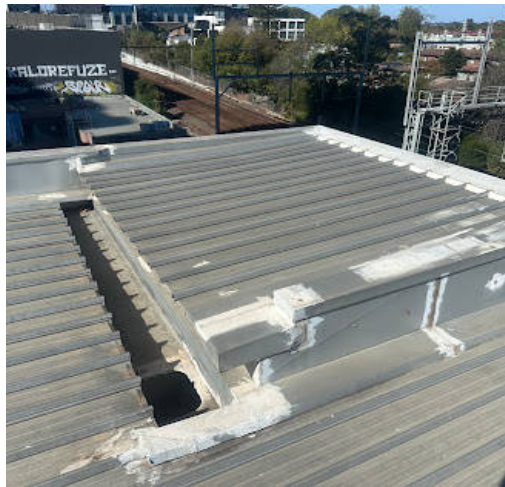
## Left-Hand Side Box Gutter:

- Minimal water flow in this gutter, but debris accumulation and grates reduce efficiency (AS 3500.3:2021).
- Liquid flashing is a temporary fix and not a long-term solution.

- **Description:** Clean gutters thoroughly, remove debris and grates, and apply liquid flashing or anti-corrosion coating.
- **Pros:**
  - Affordable and quick.
  - Reduces immediate risk of blockages.
- **Cons:**
  - Temporary fix, lasting 1–3 years.
  - Does not address structural rust, risking leaks (non-compliant with NCC F1P1).
- **Risks:**
  - Ongoing corrosion and potential gutter failure.
  - Non-compliance with AS 3500.3:2021, risking enforcement.

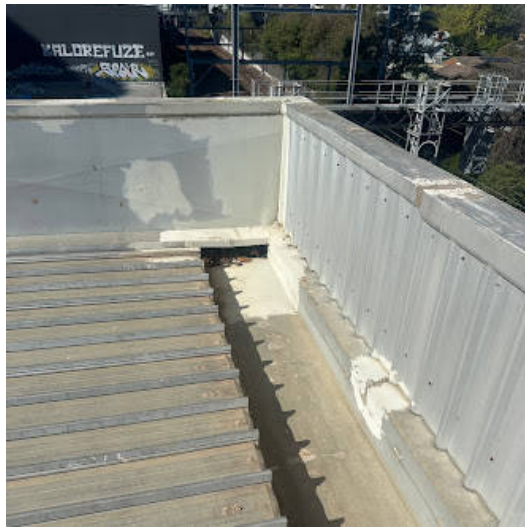
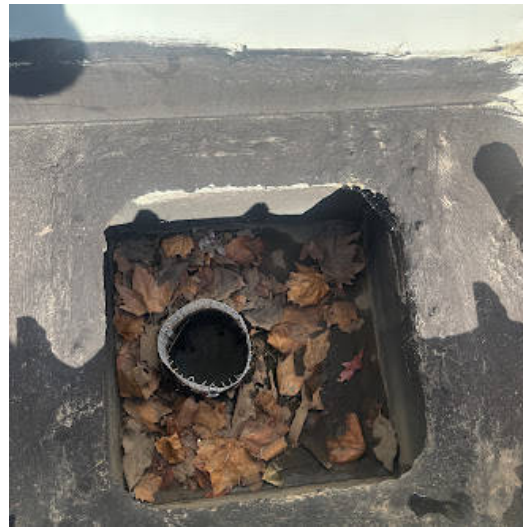
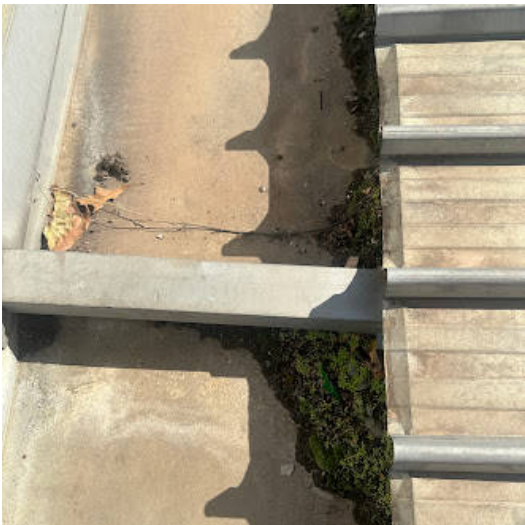
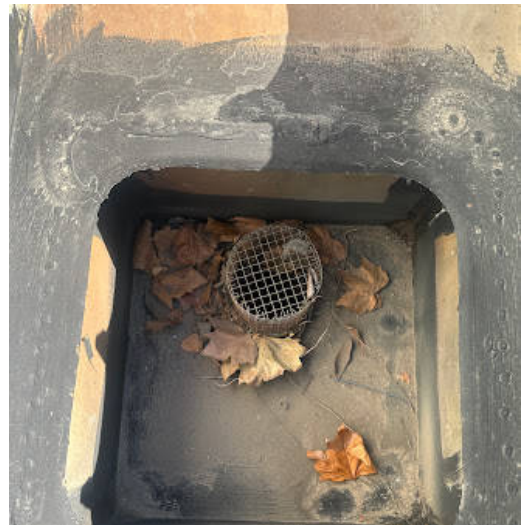
## Main Box Gutter at Rear:

- Significant dirt and rust, exacerbated by undersized overflows and non-compliant sumps (AS 3500.3:2021, Clause 4.2).
- Cooling tower runoff accelerates corrosion, requiring anti-corrosion measures (AS 1562.1:2018).

- **Description:** Replace rusted sheets with Colorbond steel and apply anti-corrosion coating to adjacent areas (AS 1562.1:2018, Clause 2.3).
- **Pros:**
  - Permanent solution, compliant with NCC and AS 1562.1:2018.
  - Prevents further corrosion and leaks.
- **Cons:**
  - High cost and labor-intensive.
  - Requires EWP for safe access.
- **Risks:**
  - Minimal, as this is a comprehensive fix.
  - Delaying action risks widespread corrosion.

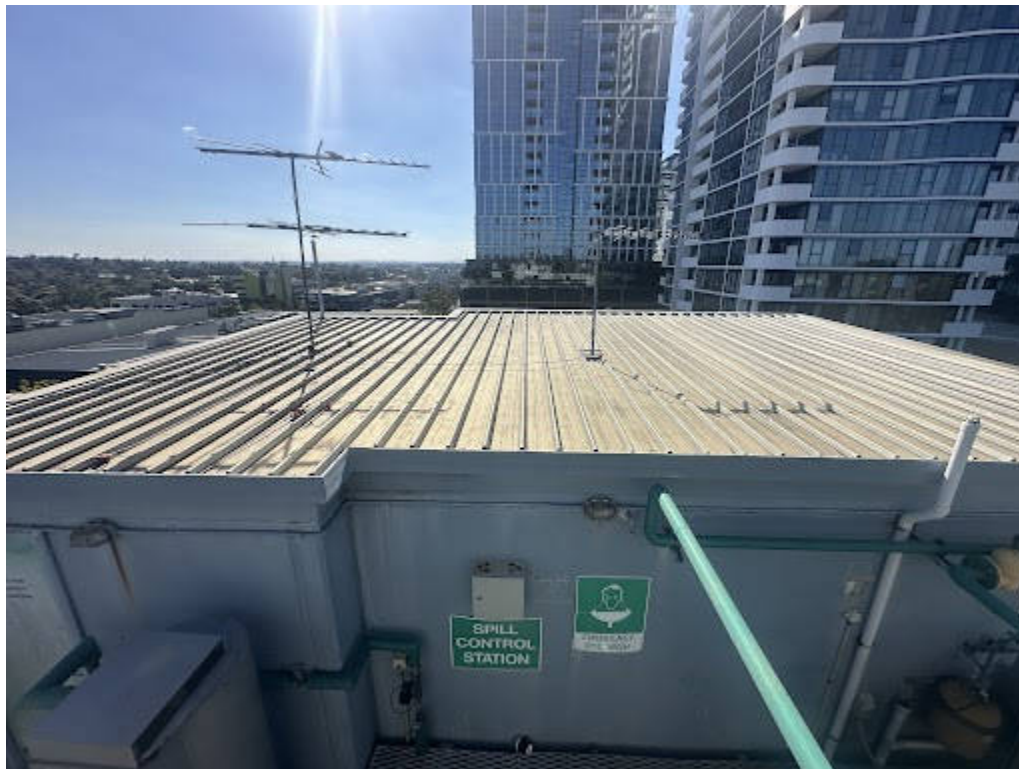
## Stairwell Roof:

- In good condition, with no immediate issues. The simple design ensures compliance with BCA weatherproofing requirements.

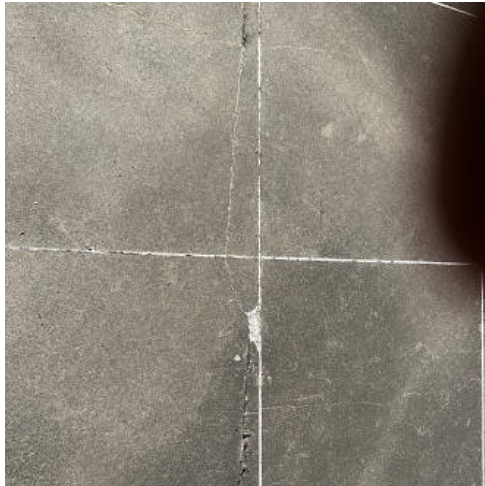
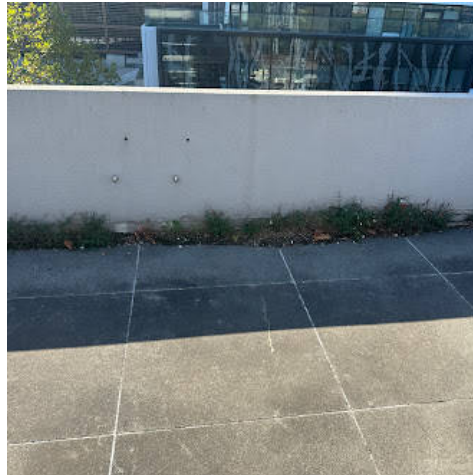
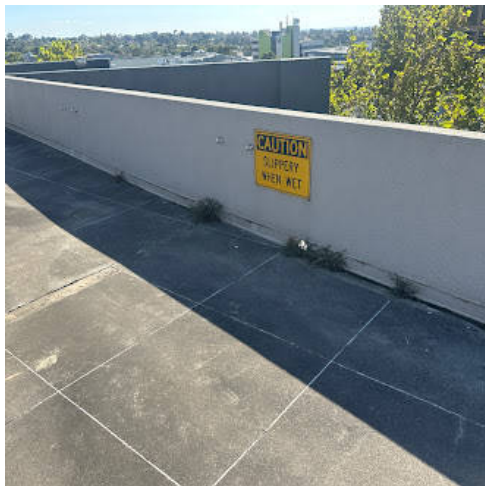
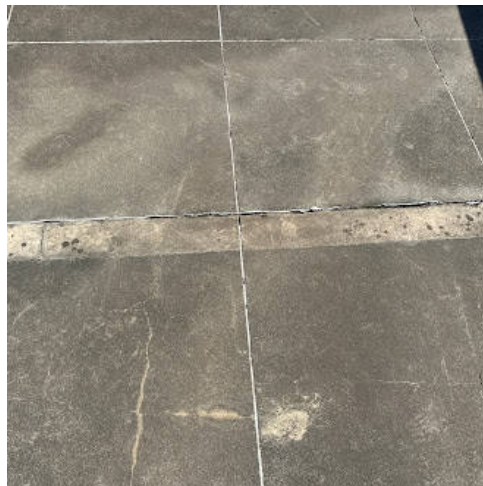
## Balcony at Front of the Building:

- Multiple repair attempts with silicone and epoxy indicate underlying waterproofing issues (AS 3740:2021).
- Cracked tiles, lifting seals, and poor preparation risk water ingress into the structure (NCC F1P1).

- **Description:** Remove tiles, high-pressure clean, apply a two-part epoxy waterproofing membrane (traffickable and UV-stable), and reinstall tiles (AS 3740:2021, Clause 2.4).
- **Pros:**
  - Permanent solution, compliant with NCC F1P1 and AS 3740:2021.
  - Prevents water damage and mould.
  - Enhances balcony aesthetics and value

- **Description:** Replace cracked tiles, clean, and apply a single-coat waterproofing membrane.
- **Pros:**
  - More affordable than full replacement.
  - Extends balcony life by 5–7 years.
- **Cons:**
  - Not as durable as full replacement.
  - May not address underlying membrane issues.
- **Risks:**
  - Future leaks if underlying issues persist.
  - Partial compliance with AS 3740:2021.

- **Description:** High-pressure clean, replace cracked tiles, and reseal joints with silicone.
- **Pros:**
  - Affordable and quick.
  - Temporarily reduces leak risk.
- **Cons:**
  - Lasts 1–3 years, not compliant with AS 3740:2021.
  - Does not address underlying waterproofing failure.
- **Risks:**
  - Ongoing leaks, mould, and structural damage.
  - Non-compliance with NCC F1P1.
