## Roof Plumbing Assessment Report

Property: [REDACTED] South Yarra, Victoria 3141

Date: June 23, 2025

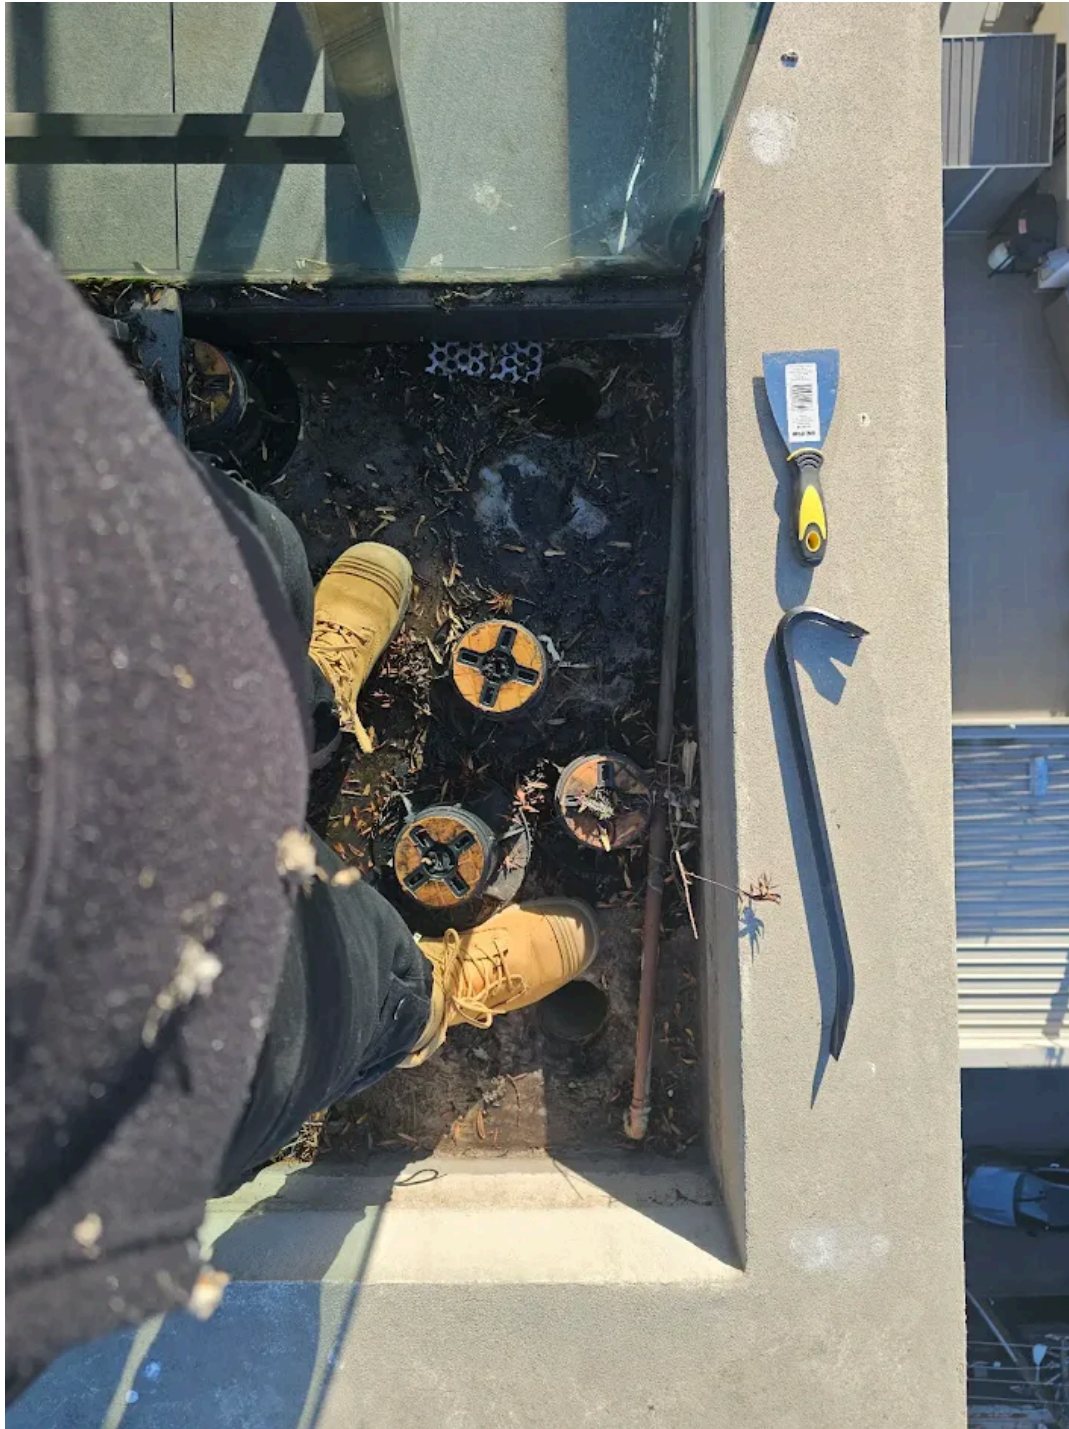
- **Drainage System**: The stormwater drain is accessible via a sump at the top of the building, which we inspected (see attached photo). Each level has inspection openings, allowing access to the drain for cleaning and inspection. The drain appears blocked, as evidenced by water pooling and leakage.

We have checked the sump at the top of the building as per the photo below. We will use this as an entry point to clear the drain. So we will start from the top to clear the drain

**Description:** We will access the stormwater drain via the sump at the top of the building and use a high-pressure water jetter or electric eel to clear the blockage. Following this, a CCTV camera will be inserted to inspect the drain for damage or defects. If issues are identified, we will propose additional repairs.

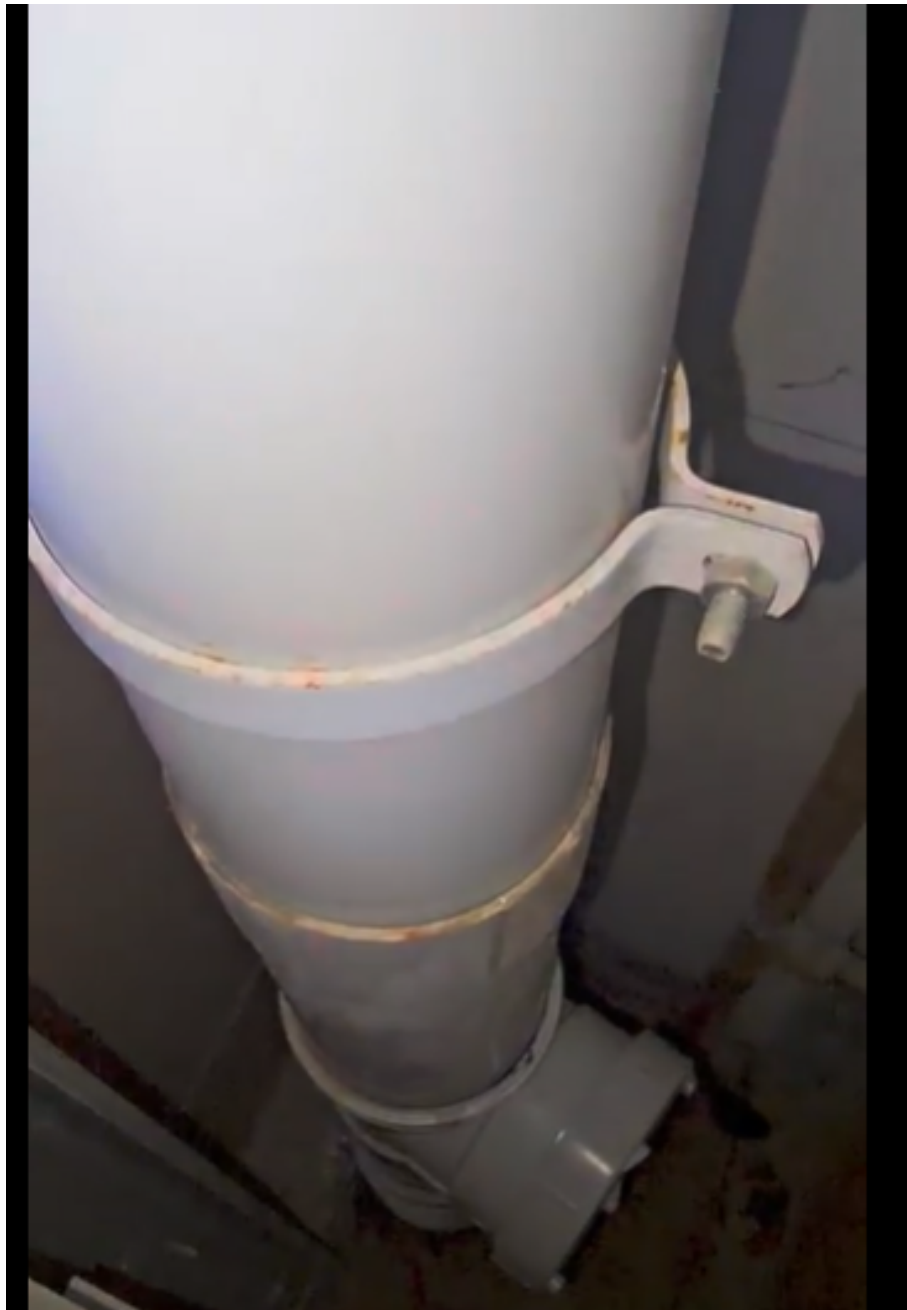
- **Leak Location**: The primary leak is observed three floors below the top apartment, indicating that water is escaping from the stormwater drainage system at or above this level. The leak is causing water damage to internal walls and potentially compromising the building's amenity.

The main leak is coming from 3 floors down on the same apartment

We would need to open the wall to get access to the pipe

This will require us to work around the gas line and emergency water hydrants

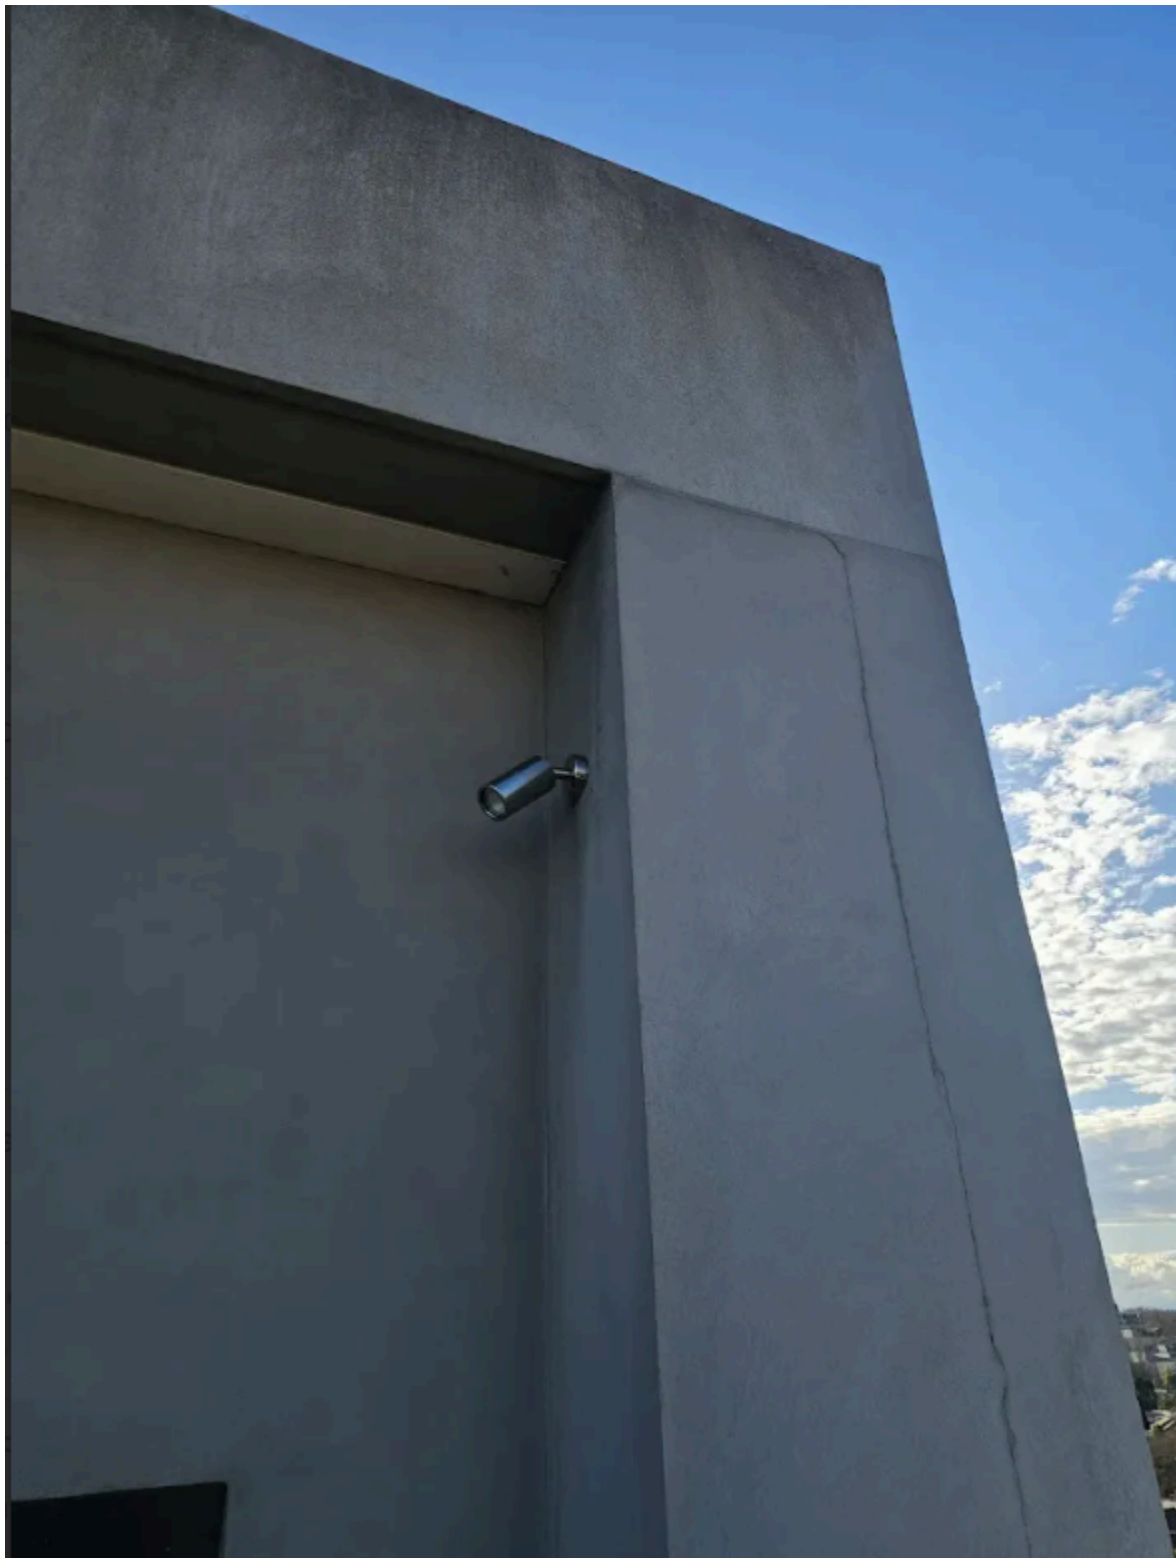
- **Potential Defect**: There is a possibility that the drain on the third level down was not installed correctly, as suggested by the localized leakage. This will require further investigation via CCTV and flood testing.

The drain here feels blocked and is leaking from here

**Description:** After clearing the drain and conducting a CCTV inspection (as in Scenarios 1 or 2), we suspect the drain on the third level down may be incorrectly installed. If confirmed, we will open the wall to access and replace the defective pipe section. A flood test will be conducted to verify the repair. This option involves working around gas lines and emergency water hydrants, requiring coordination with a registered engineer and compliance with safety standards.
