## REPORT

Our Reference: JN 3727

**Echuca Twin Rivers Specialist School  
Gymnasium - External 5299-NewBldg4EXT - Roof Cladding**

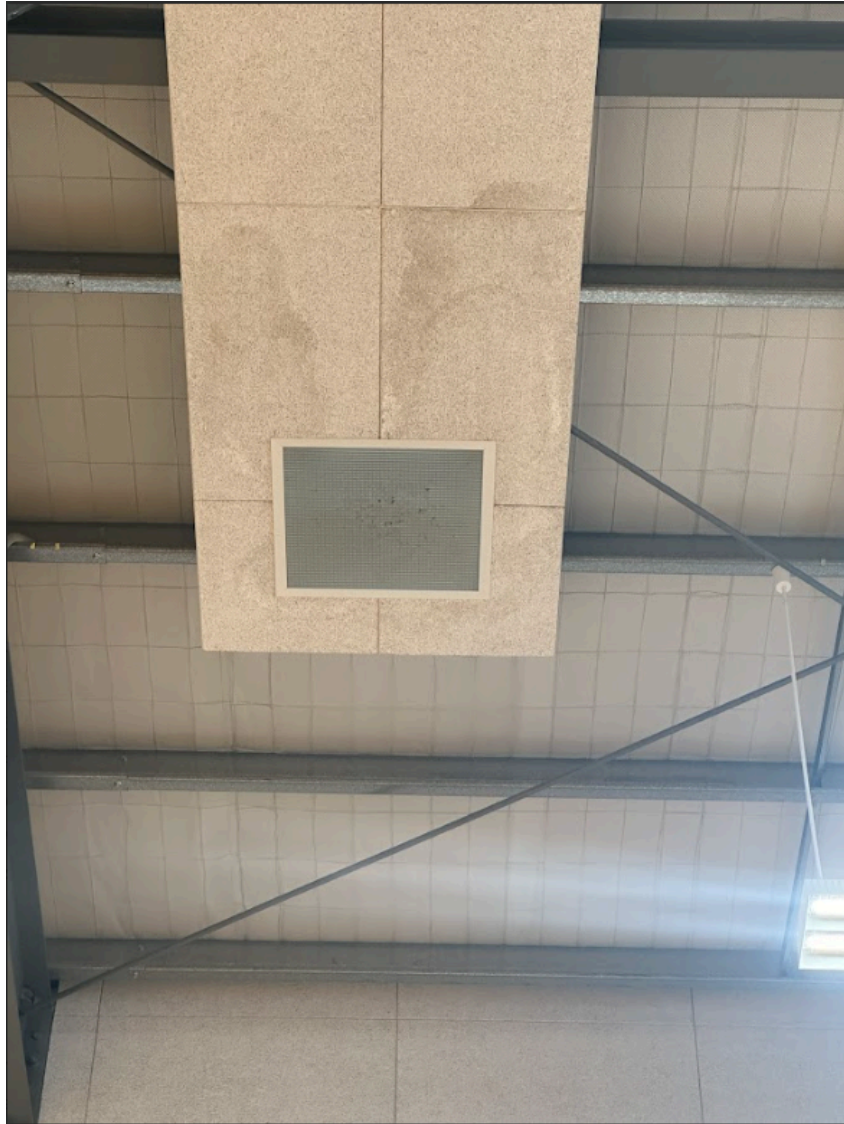
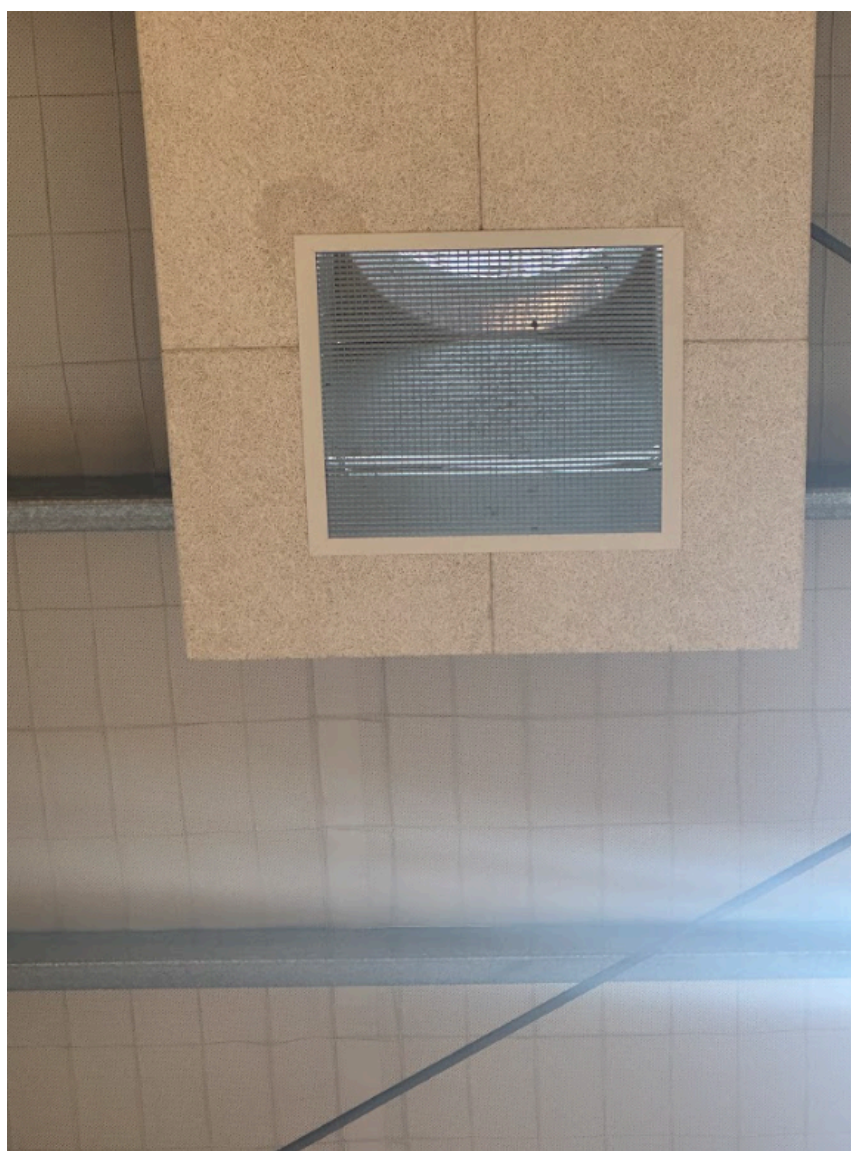
The principal of the school has shown water damage inside the gymnasium. It has been noted this is an historical leak from when the gymnasium was built and has had repairs done at that stage. The damage to the ceiling looks like it is old and is not causing issues at present time. Due to the height of the gymnasium, inspection has been conducted with a drone and no issues were found.

### Ceiling Damage

To monitor the area and take photos after rain events and comparing the photos already taken.

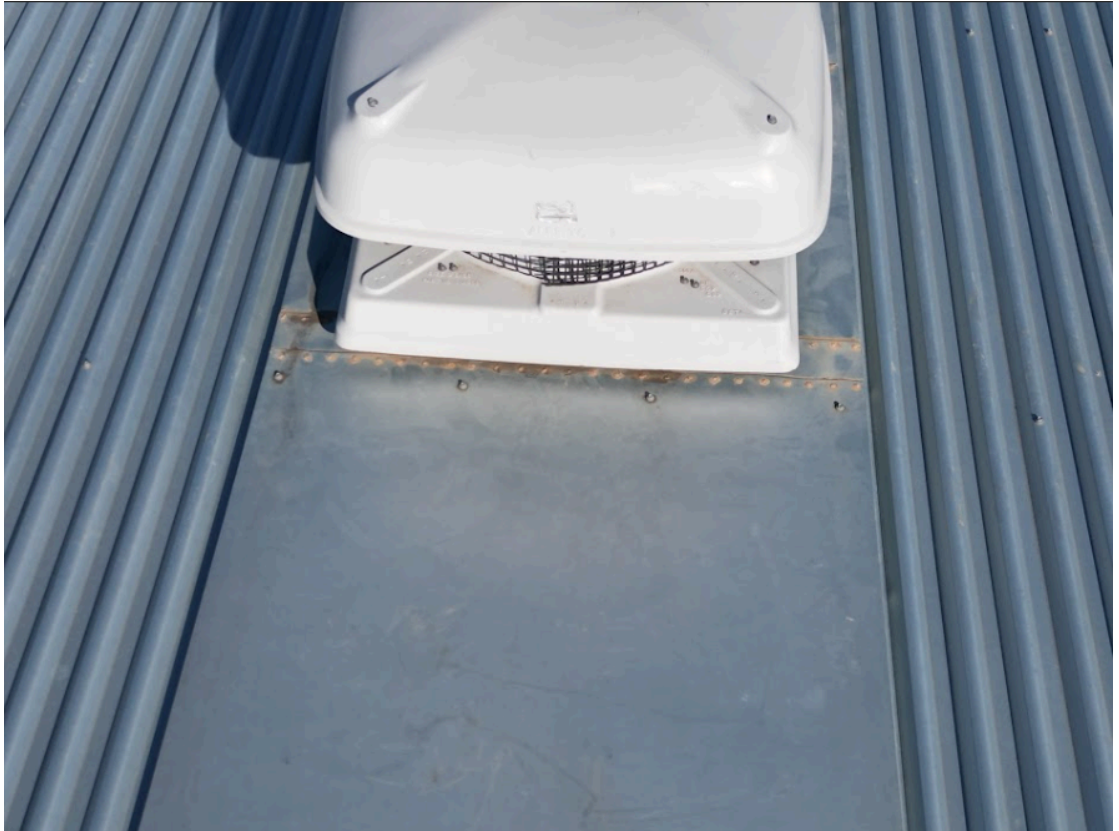
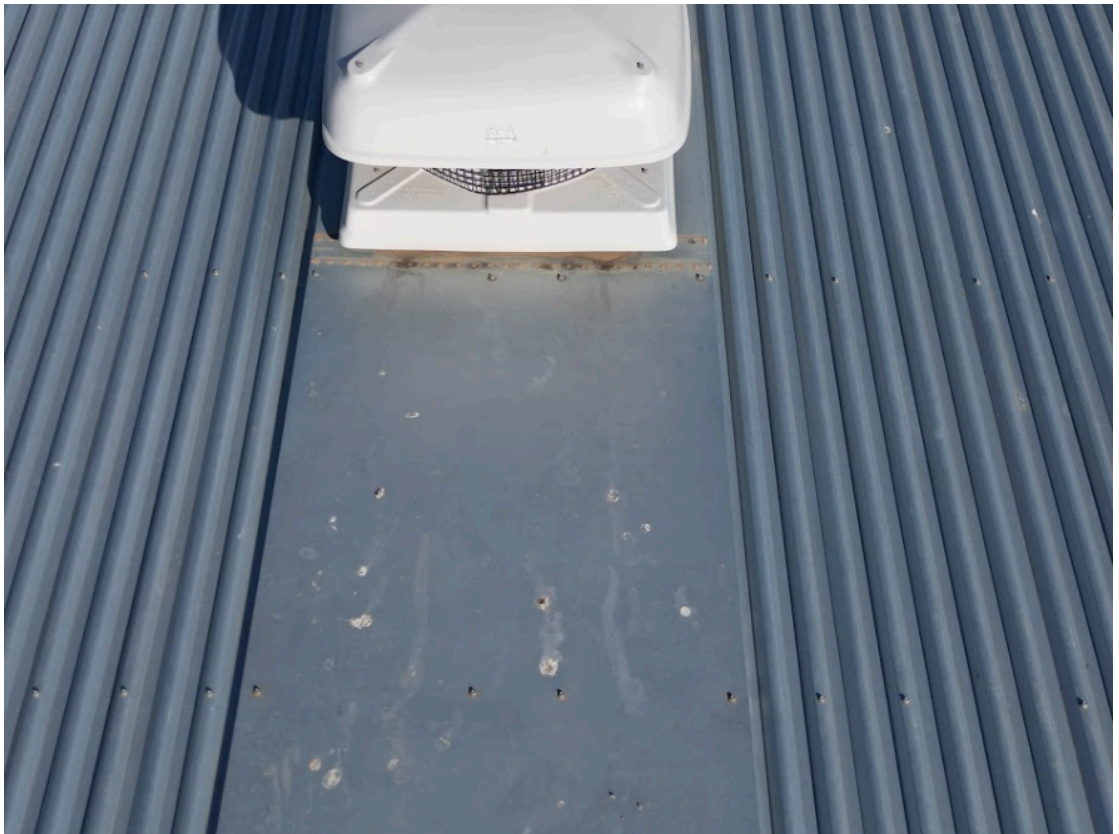
## External Building - Vents Above Water Damage

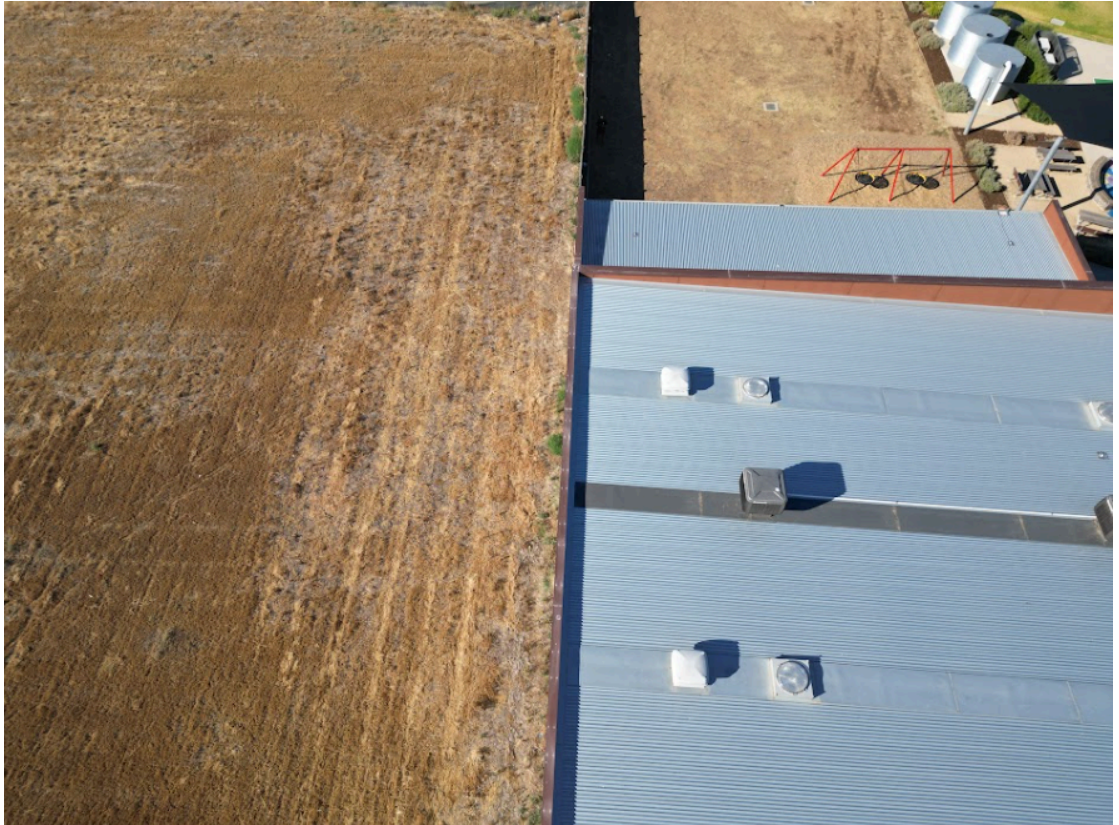
## Overview of Both Vents
