## Roof Inspection and Repair Recommendation Report

**Prepared by:** HolyMess Pty Ltd

**Date of Report:** 05 August 2025

**Property Address:** [REDACTED] Silvan VIC 3795, Australia

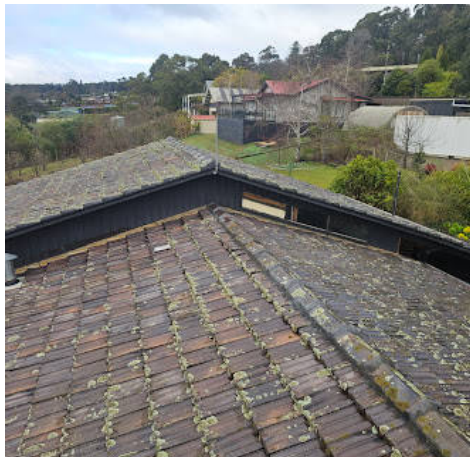
Picture 1: Roof conditions and gable conditions at time of inspection that will require gables to be grounded back and fully repointed.

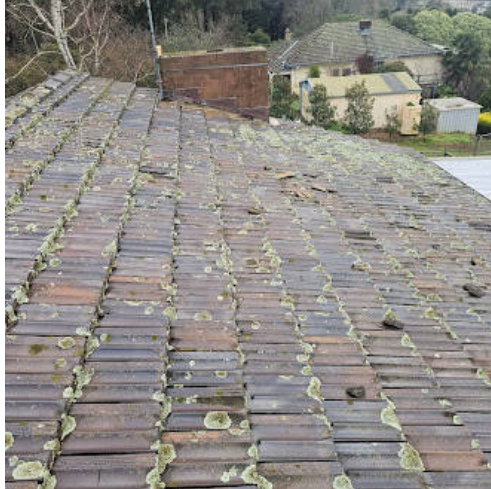
Picture 2: Indicates dirty roof and moss on roof that will require to be hi pressure cleaned rubbish removed and broken tiles changed.

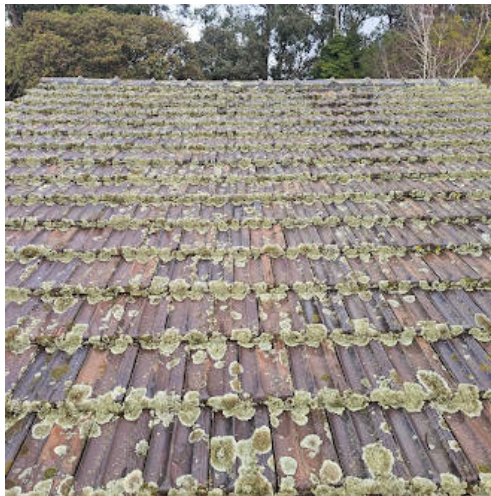
Picture 3: Different angle of roof that shows how dirty the roof is with moss growing on it that will require high pressure cleaning.

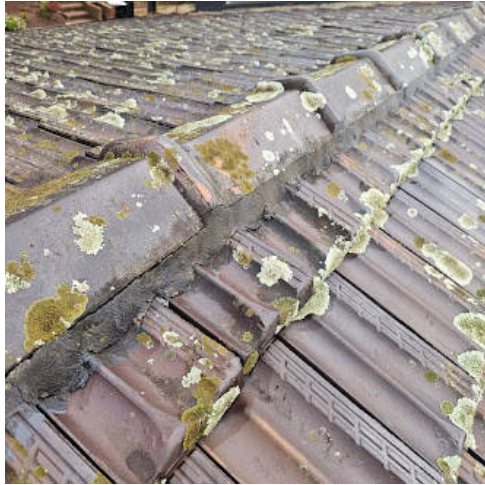
Picture 4: indicates existing conditions of repointing that are in poor condition full of cracks and celebrating from capping and allowing water to come in -this will require to be grinded back and fully repointed.

**Description:** Full clean, replace broken tiles, grind/repaint gables/ridges, readjust/seal flashings. **Why Recommend:** Comprehensive per AS 2049/AS 2050—fixes root causes like poor pointing (Photo 4), preventing water entry. **Pros:** Good balance (\$9,300-\$15,500); 10-15 year durability; enhances property value. **Cons/Risks:** Mid-cost; if budget tight, delays other home needs; minor risk of tile breakage during grinding (mitigated by pros).

- **Mitigations:** Gentle tools; source exact matches; secure with clips (AS 2050).
- **Grind Back Cracked Repointing on Ridges/Gables (6-8 hours, ~150m linear)**

- **Repoint Ridges/Gables (1 day)**
  - Apply flexible mortar (e.g., sand/cement/lime mix); smooth for weatherproofing.
  - **What Could Go Wrong:** Poor adhesion leading to future cracks; uneven application.

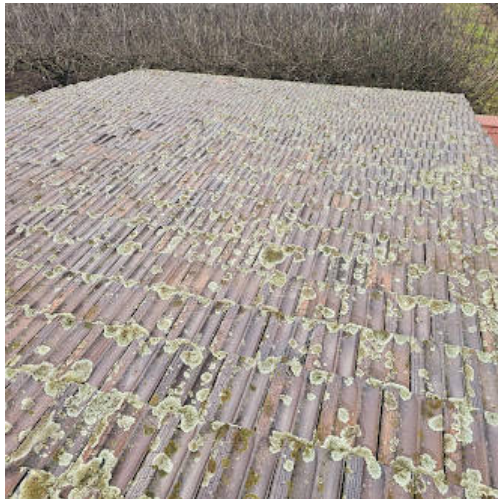
Picture 5: Different angel of roof that shows how dirty the roof is with moss growing on it that will require high pressure cleaning.

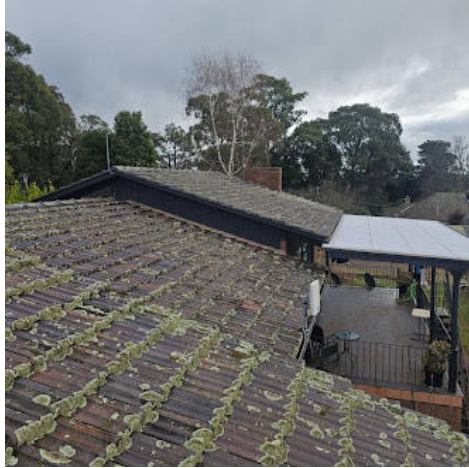
Picture 6: Different angle of roof that shows how dirty the roof is with moss growing on it that will require high pressure cleaning.

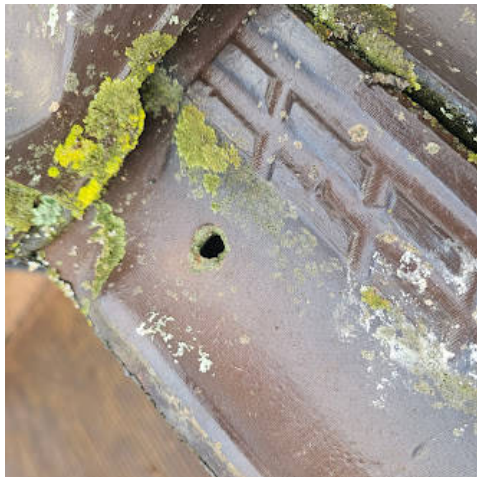
Picture 7: Showing existing poor conditions of some tiles with holes in it that will require to be sealed and water tight.

**Description:** Clean roof/gutters, replace 5-10 broken tiles, seal holes/flashings. **Why Recommend:** Targets visible damage (e.g., holed tiles from Photo 7), complying with BCA Part 3.5.1 for weatherproofing. **Pros:** Affordable (\$4,650-\$7,750); extends life 5-10 years; improves drainage. **Cons/Risks:** Ignores pointing/gutter—cracks worsen, leading to rot/mold; budget option means higher long-term risk of full replacement (\$31,000+).

- Lift affected tiles (e.g., holed ones from Photo 7); replace with matching AS 2049-compliant terracotta.
  - **What Could Go Wrong:** Further breakage; mismatched tiles causing leaks.

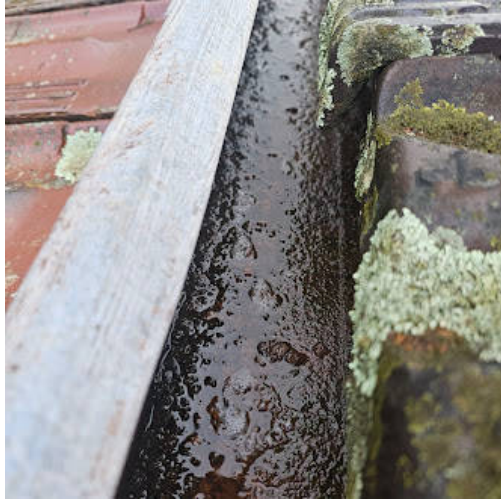
Picture 8: Showing gutters and flashings in poor condition that will require to be changed due to rust and water leaks.

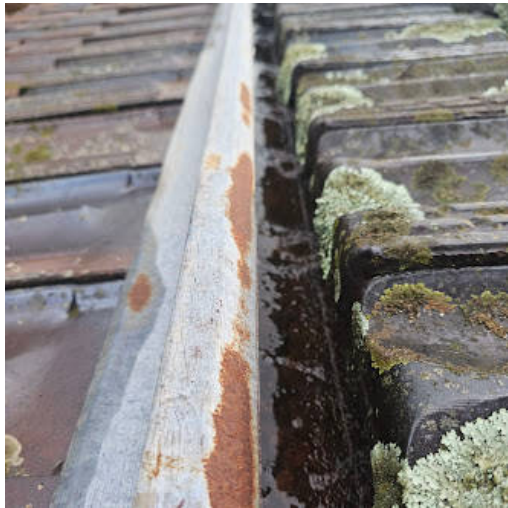
Picture 9: Showing gutters and flashings in poor condition that will require to be changed due to rust and water leaks.

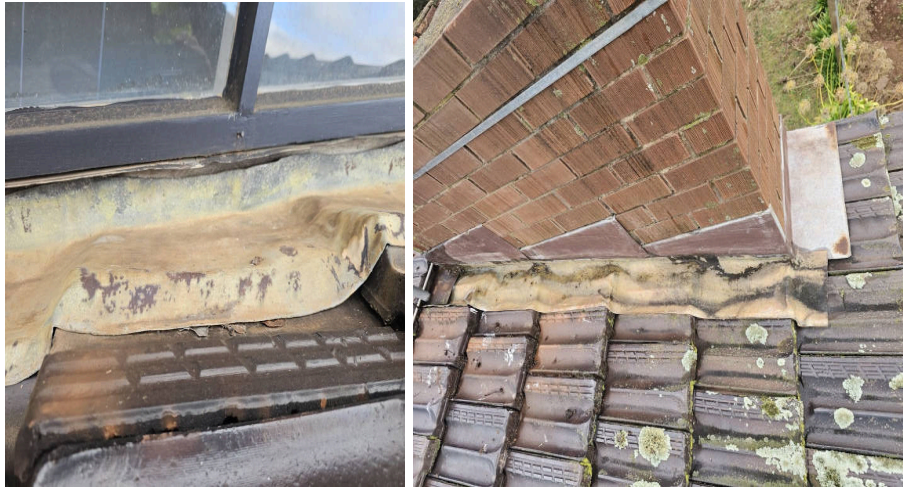
Picture 10 and 11: Showing existing conditions of flashings that will require to be readjusted and sealed

- **Mitigations:** Clean surfaces; use additives for flexibility; quality check (AS 2050 Clause 4.3).
- **Readjust and Seal Flashings (2-4 hours, from Photos 10/11)**

- Realign lead/copper flashings; apply silicone sealant.
  - **What Could Go Wrong:** Incomplete seal causing leaks; material incompatibility.
