HolyMess Pty. Ltd.

Pakenham, [REDACTED] VIC - JN 6139

### Before: Initial Hazardous Condition

## After: Completed Make Safe Repair

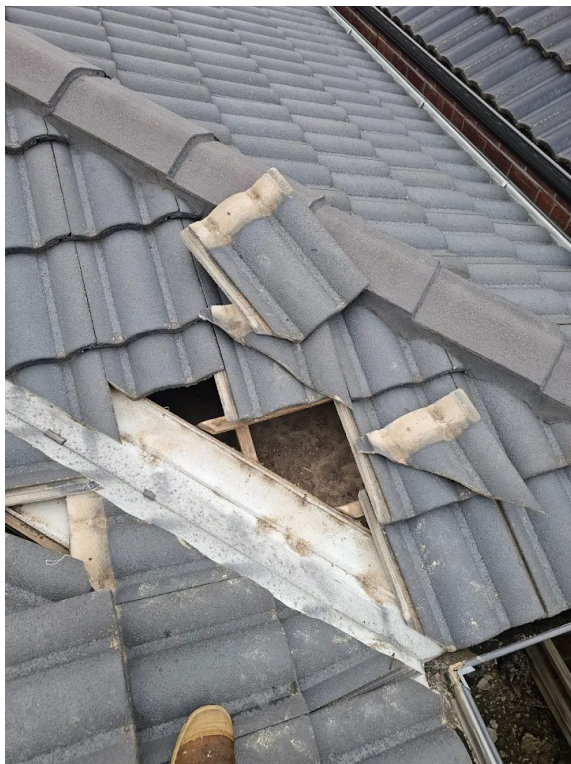
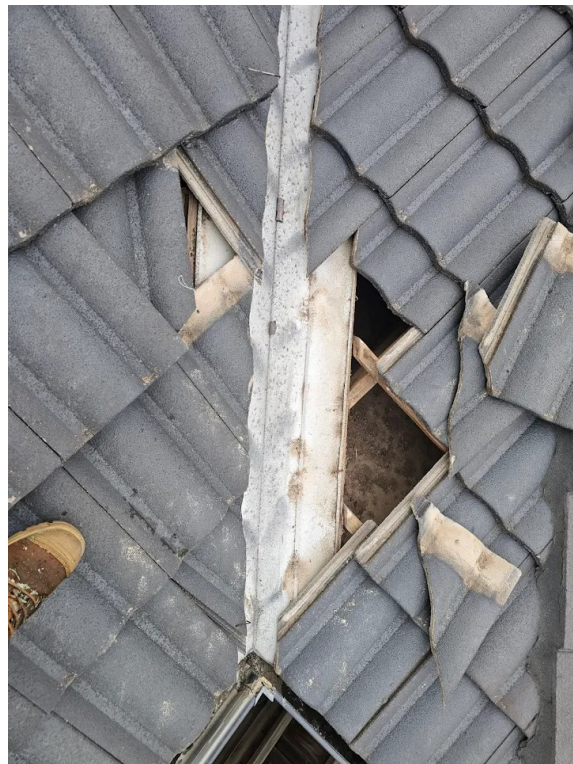
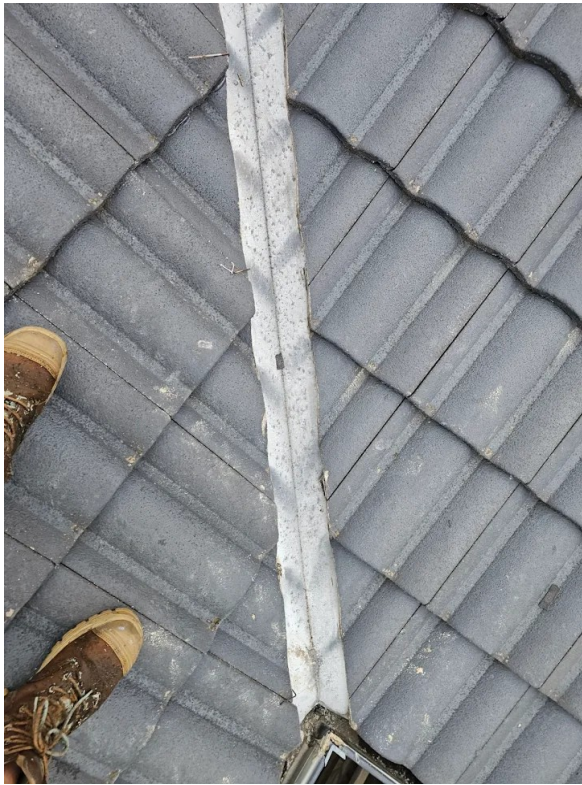
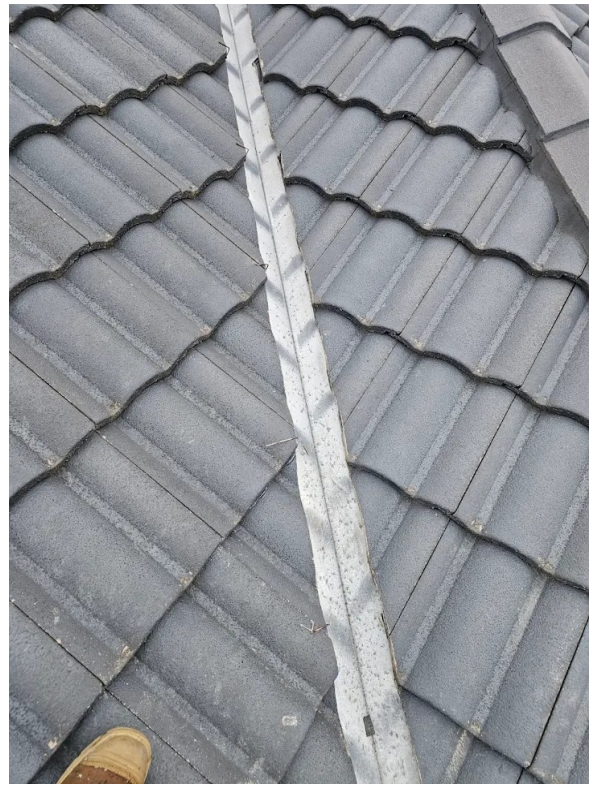
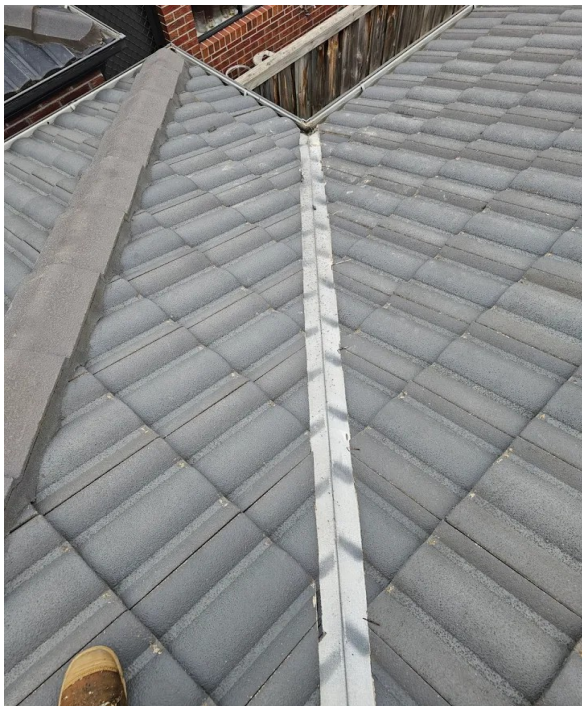
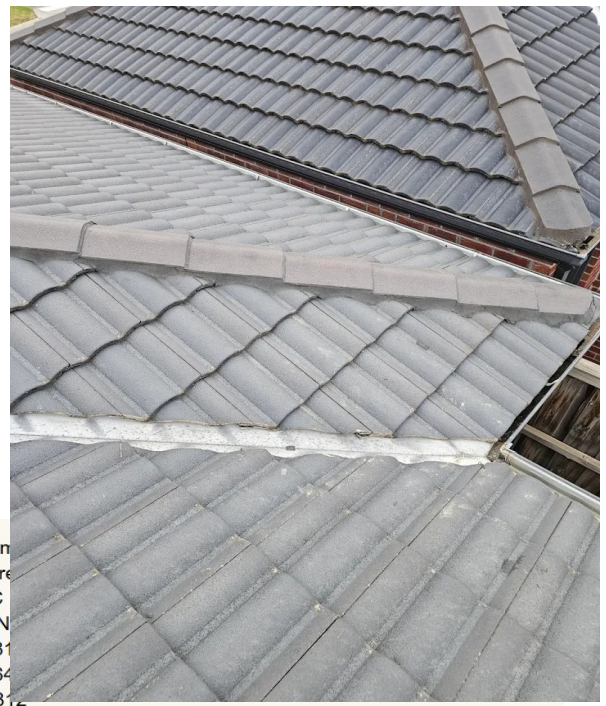
**Description:** These photos provide a high-angle view of the damaged roof section. It shows multiple dark grey concrete roof tiles that have slipped or been damaged along a roof valley. The displacement has created a significant void, exposing the underlying timber roof battens and the soil-like debris within the roof cavity. Several detached tile pieces are resting haphazardly on the remaining tiles. This condition constitutes an immediate risk of water ingress and further damage to the internal structure of the property.

**Description:** These photos show the same roof valley following the make safe intervention. The slipped and damaged concrete tiles have been removed or realigned, and new or sound tiles have been professionally fitted along the entire length of the valley. A new, clean metal valley flashing has been installed, and the surrounding tiles have been neatly point-cut to sit correctly. The void is completely sealed, and the ridgeline has been restored with ridge caps and fresh bedding mortar, rendering the roof watertight and secure.

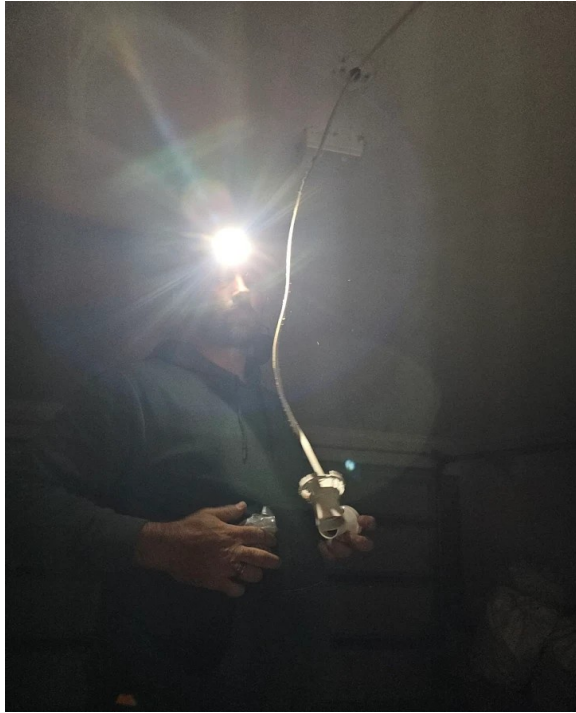
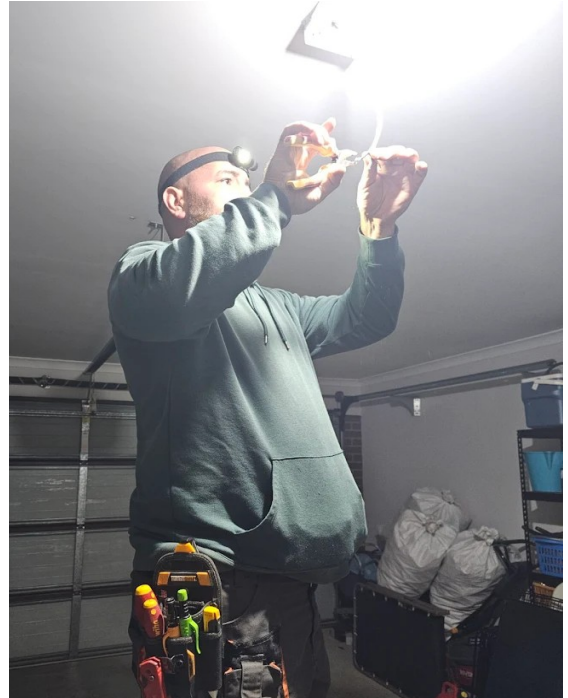
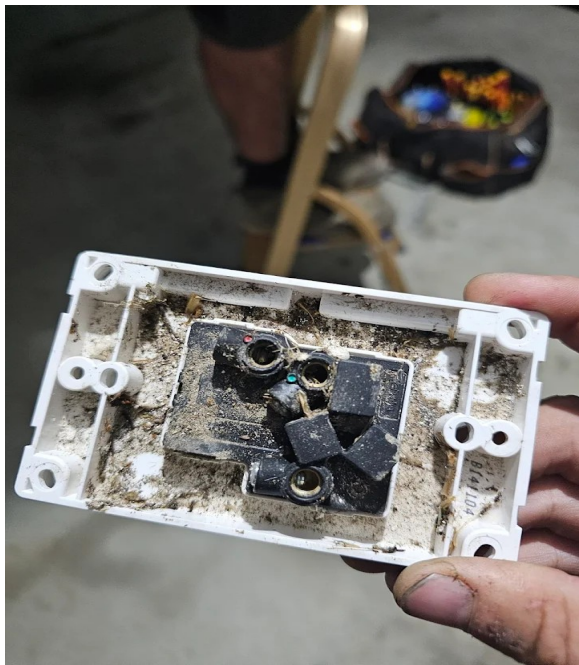
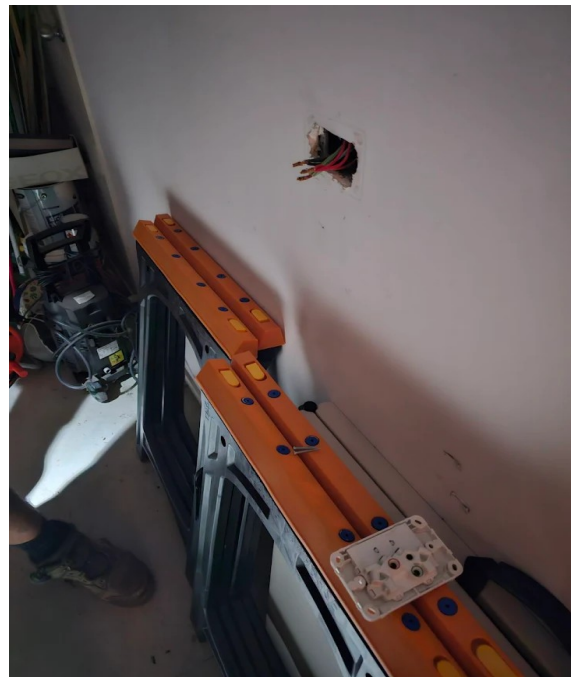
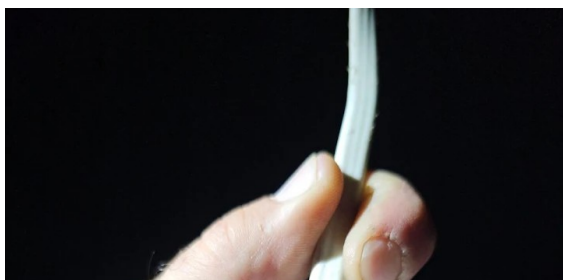
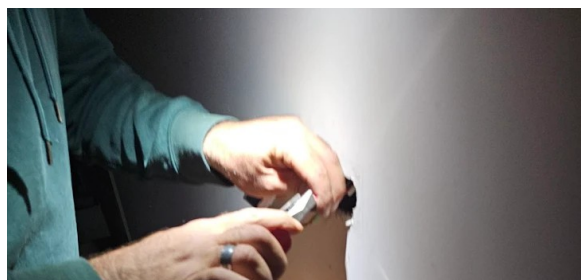
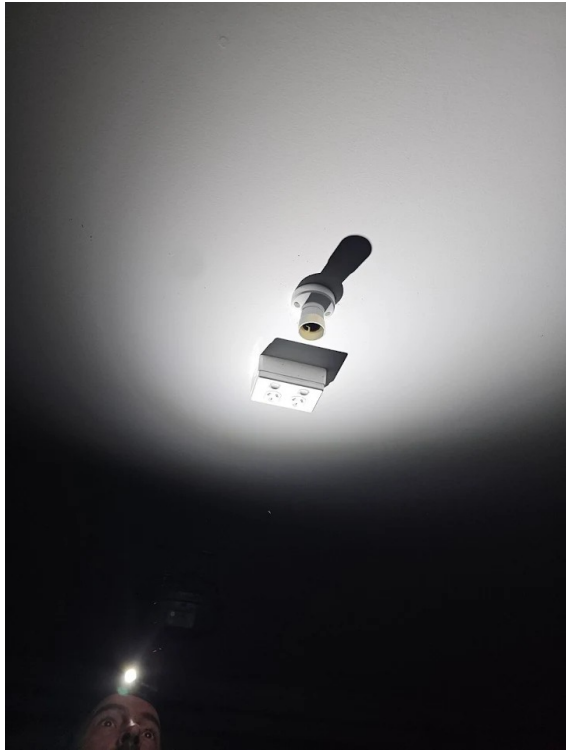
**Electrical Inspection:** A qualified technician inspecting internal wiring and light fittings to ensure no damage occurred due to the roof leak.

**Component Replacement:** View of a discarded, dust-impacted power outlet housing. Replacing these components ensures the internal electrical system meets safety standards following the external repair.

In addition to the roof works, internal electrical components were inspected and secured to address any potential hazards caused by moisture or wear.
