## **HolyMess Repairs – Forensic Structural Roof Assessment & Rectification Quotation**

**Job Reference:** JN 6222 – Vermont South Roof Leak Repair & Full Maintenance

**Date:** Sunday, 17 May 2026

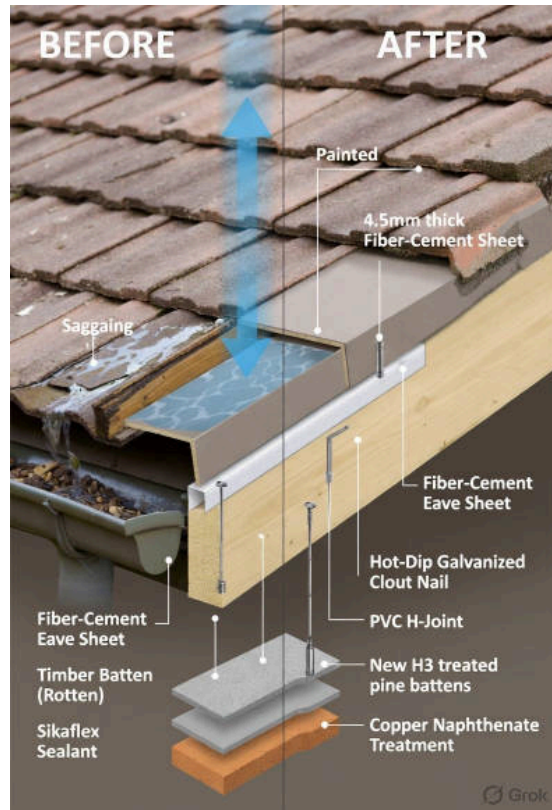
#### **Diagram 1: Explaining the Job – Cross-Section of Garage Eave Lining Replacement**

- <https://x.com/victorchandra09/status/2055619085703286963?s=20> and <https://x.com/victorchandra09/status/2055618996024852600?s=20> (**Visual Assets 1 & 2 – Garage eave**): These images show heavy water staining, swelling, localised rot, sagging fiber-cement eave sheets, and open joints on the approximately 3 m garage side section caused by chronic gutter overflow. This confirms the eave lining cannot be patched and must be structurally replaced, directly justifying Option 1.

**Option 1: Garage Eave Lining Replacement (~3 m lateral section)** – \$1,716 including GST (7-year structural/workmanship warranty) – Realistic duration: 1.5 days

**OPTION 1: Garage Eave Lining Replacement (~3 m lateral section)** – \$1,716 including GST (7-year structural/workmanship warranty) – Realistic duration: 1.5 days (2 technicians + 1 supervisor, total ~24 technician hours + 12 supervisor hours including all downtime)

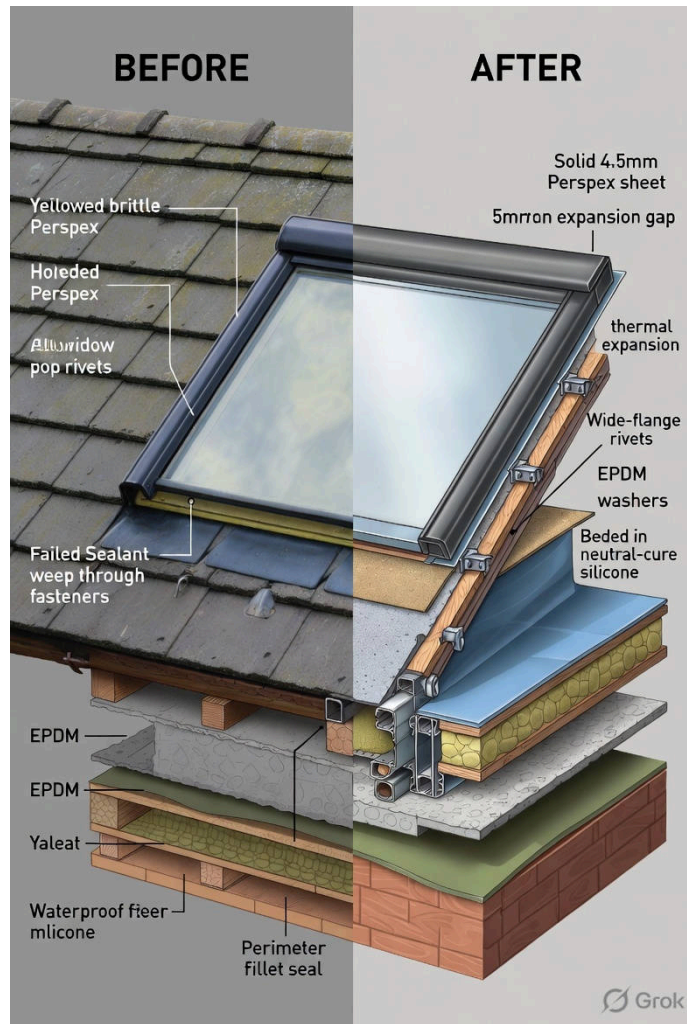
**Diagram 1: Explaining the Job – Skylight Perspex Retrofitting Cross-Section**

- <https://x.com/victorchandra09/status/2055618592797040671?s=20> (**Visual Assets 3 & 4 – Skylight**): These images display severe yellowing, micro-fracturing, embrittlement of the hollow-core plastic glazing, corroded and loose aluminum pop rivets, and completely desiccated sealant. Water is weeping through fastener penetrations, justifying Option 2 (upgrade to solid impact-resistant Perspex with proper sealing).

**OPTION 2: Skylight Perspex Retrofitting** – \$786.50 including GST (5-year watertightness warranty) – Realistic duration: 0.5 days (1 technician + 1 supervisor)

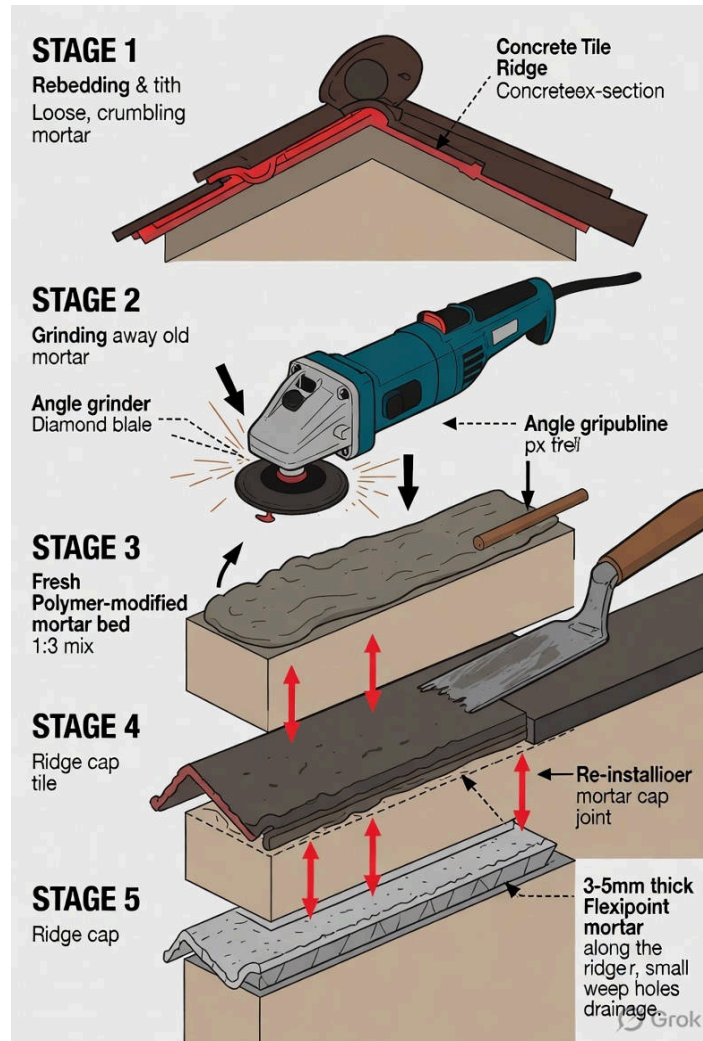
#### **Diagram 1: Explaining the Job – Ridge Rebedding & Repointing Process**

**5–8 – Tiles & ridges**): These images document slipped and fractured concrete roof tiles near the front-door leak path, crumbling ridge-cap bedding mortar, complete loss of mortar on corner hips, and severely fractured flexible pointing. These are the primary vectors of the ceiling breach, justifying Option 3.

**OPTION 3: Change Broken Tiles + Ridge Rebedding (Where Required, Mainly Corners as They Are Completely Broken) & Full Repointing of the Whole House** – \$5,148 including GST (10-year structural integrity warranty) – Realistic duration: 3 days (2 technicians + 1 supervisor)
