# HOLYMESS REPAIRS

## QUOTATION FOR ROOF LEAK RECTIFICATION

[REDACTED] Albert Park VIC 3206

[REDACTED] thank you for having us on the roof at [REDACTED]. This is an 1890 Victorian terrace in Albert Park — the kind of building that looks beautiful from the street and hides its real problems in the box gutters, parapets and chimney junctions that you cannot see from the footpath.

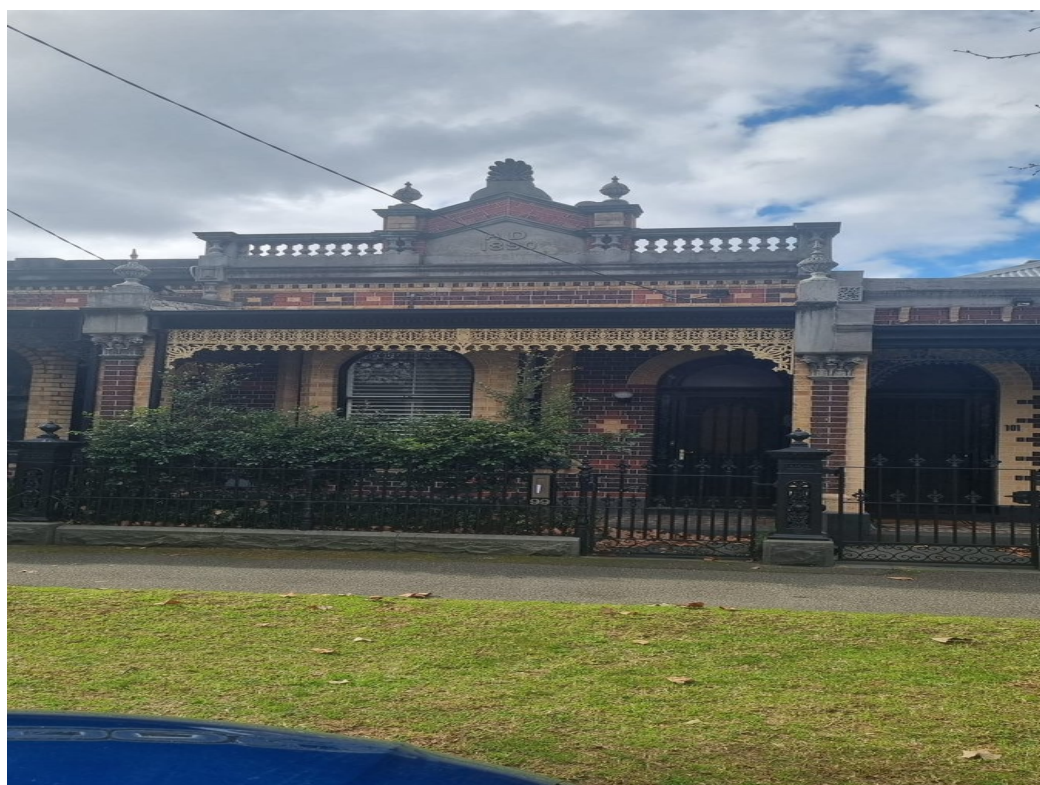
### Photo set 1 — street elevation and identity of the building

The facade is a polychrome-brick Victorian terrace with an 1890 pediment, balustraded parapet, urns and cast-iron lace. That matters for two reasons. First, the roof is hidden behind a masonry parapet, which is why box gutters exist here at all — water has nowhere to throw to the street. Second, the building is contributory heritage fabric. Any repair that changes the terracotta appearance or the chimney would fight Council policy. Our options keep the look.

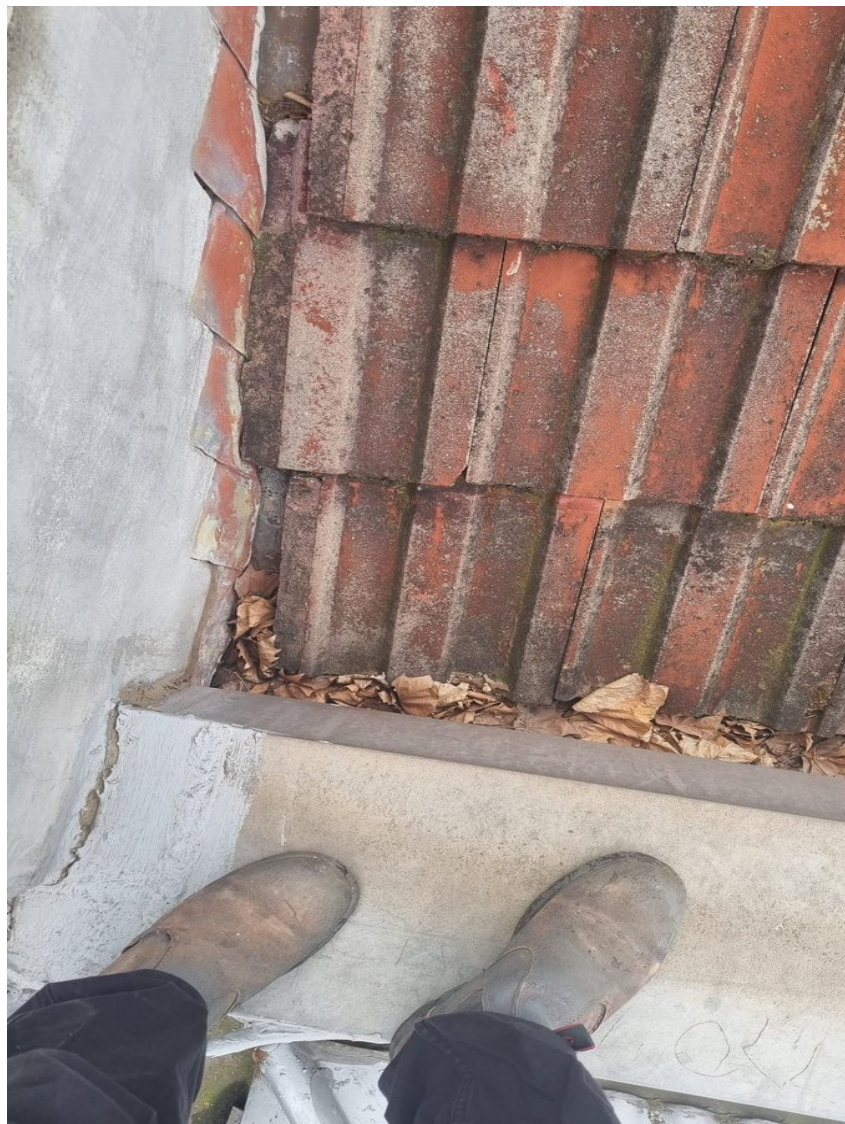
### **Photo — box gutter packed with leaves at the front parapet**

This is the most important still on the job. At the front parapet abutment the tiles drop into a narrow box/valley line that is full of dry leaves. The tile next to the wall is cracked. There is no visible designed overflow. AS/NZS 3500.3 treats a box gutter as a high-risk element because it sits over rooms. A blocked box gutter does not “drip picturesquely off the fascia”. It fills, overtops the upstand and runs into the ceiling space of 101 and potentially 99. This photo alone justifies cleaning as a minimum and a compliant rebuild if you want the leak to stay gone.

3. Replace the cracked tiles immediately beside the front parapet (visible in the leaf-gutter photo) with matching profile tiles so the abutment is no longer an open hole.

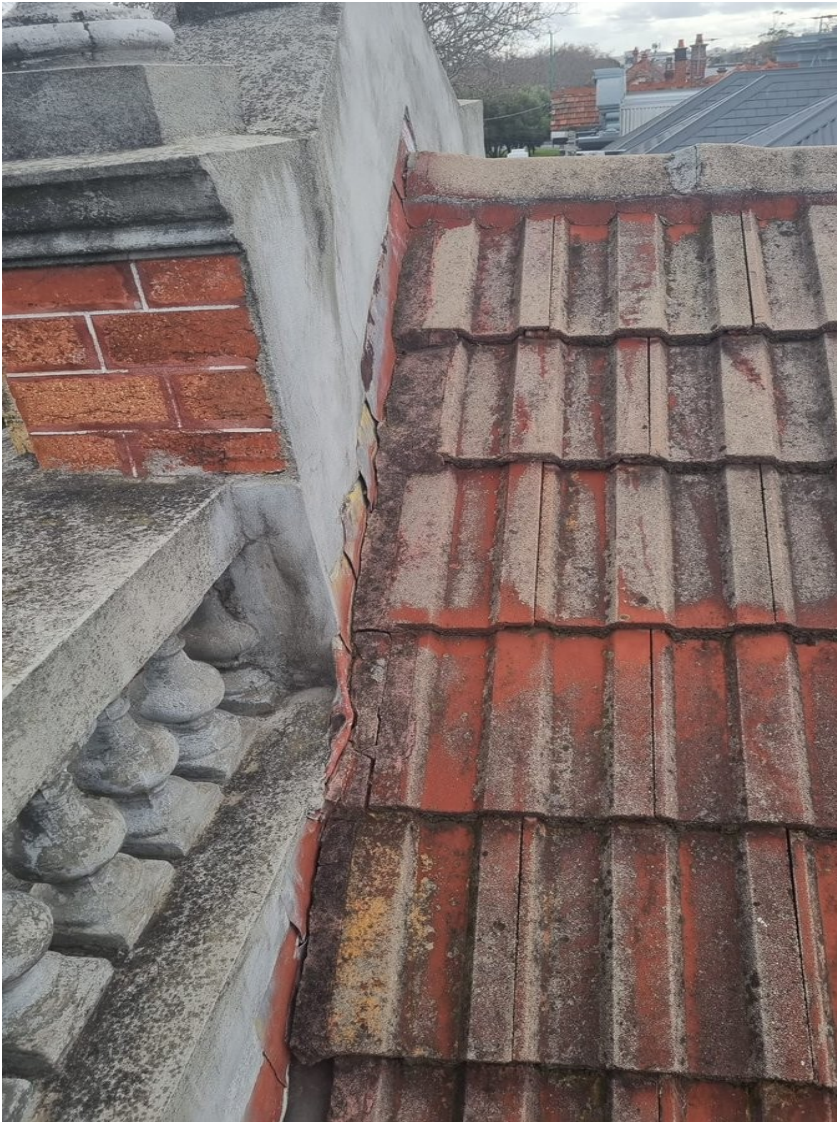
**Photo — gap where tiles meet the front parapet / chimney mass**

There is a visible open joint between the last course of tiles and the rendered/brick parapet. Render has cracked. This is a classic capillary and wind-driven rain path on terraces. Silicone smeared over it lasts a season. The compliant repair is an apron or soaker flashing turned into the masonry, with tiles dressed over, plus a mortar/flexible fillet that can move. This photo is why Options 2-5 all include parapet abutment flashing rather than “a tube of sealant”.

4. Apply a temporary but professional seal at the open tile-to-parapet joint (parapet gap photo) and at the cracked capping smear (parapet crack photo) using a high-grade polyurethane compatible with masonry and terracotta. This is a holding seal, disclosed as such.

4. Install a proper abutment flashing at the front parapet (the gap in the parapet-gap photo): metal or approved flexible soaker/apron turned up the masonry, tiles dressed over, flexible pointing fillet. This replaces the open joint.

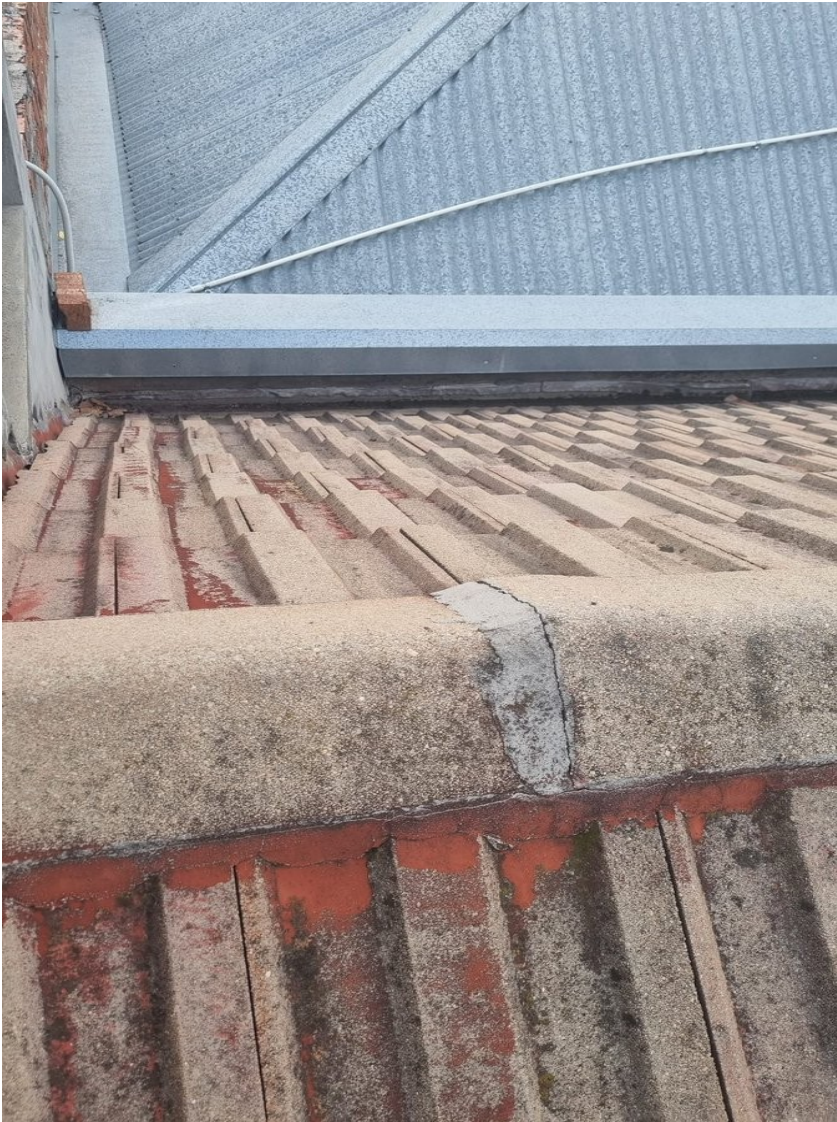
**Photo — cracked cement capping on the party parapet**

The concrete/cement capping on the party wall is cracked and has been previously patched with a grey smear. Behind it is the neighbour's metal roof discharging toward the same line. A cracked cap lets water into the masonry core. Once the brickwork is wet, it can transfer into both ceilings. This is a shared-structure problem. Patching the crack with more cement without flashing the abutment is how this roof has been "fixed" before.

8. Seal the cracked party-wall cap with a flexible masonry compound and dress a short cover flashing where the cap meets the tile/gutter line, after notifying No. 99.

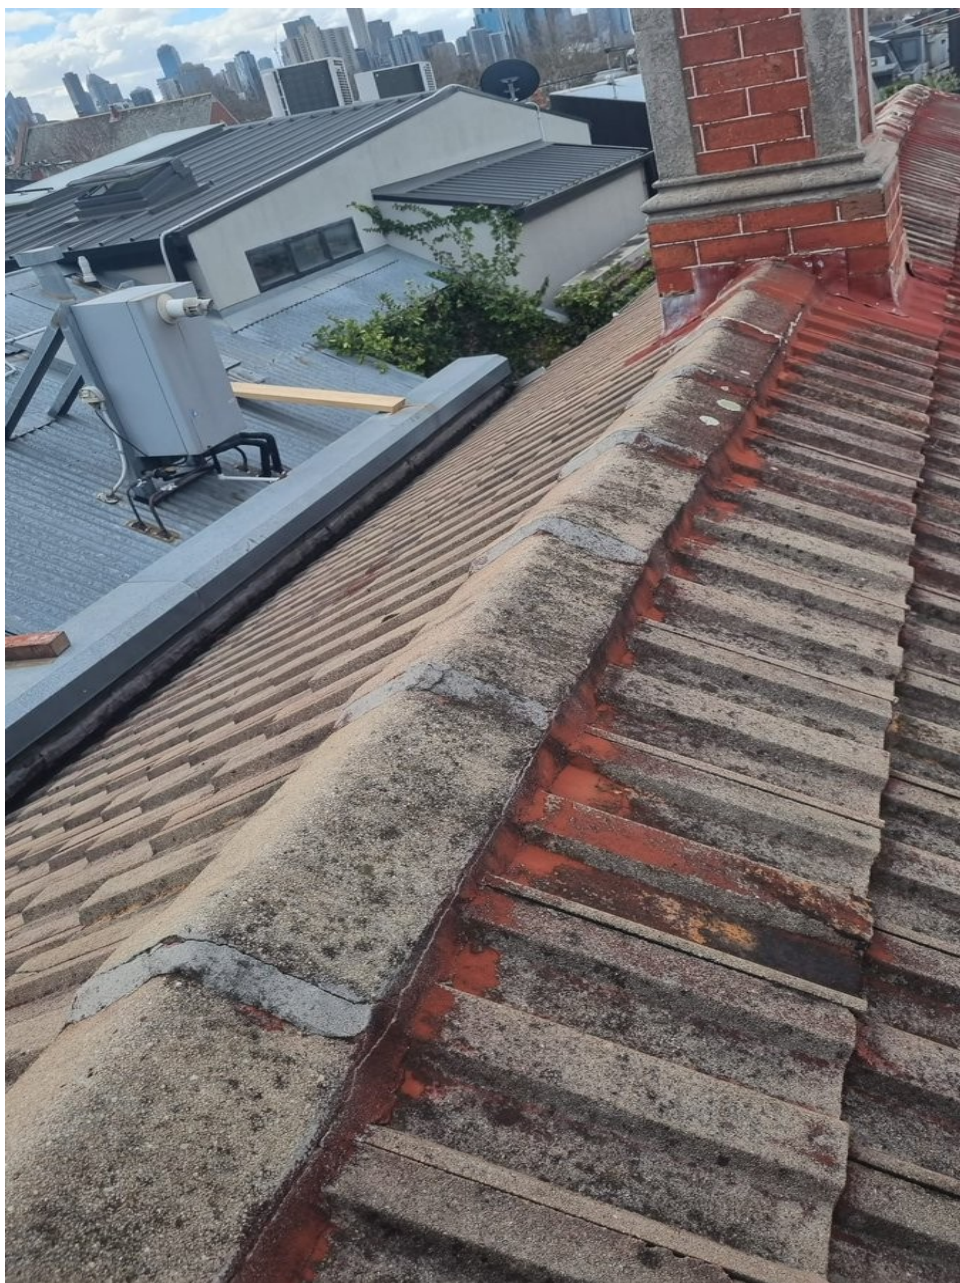
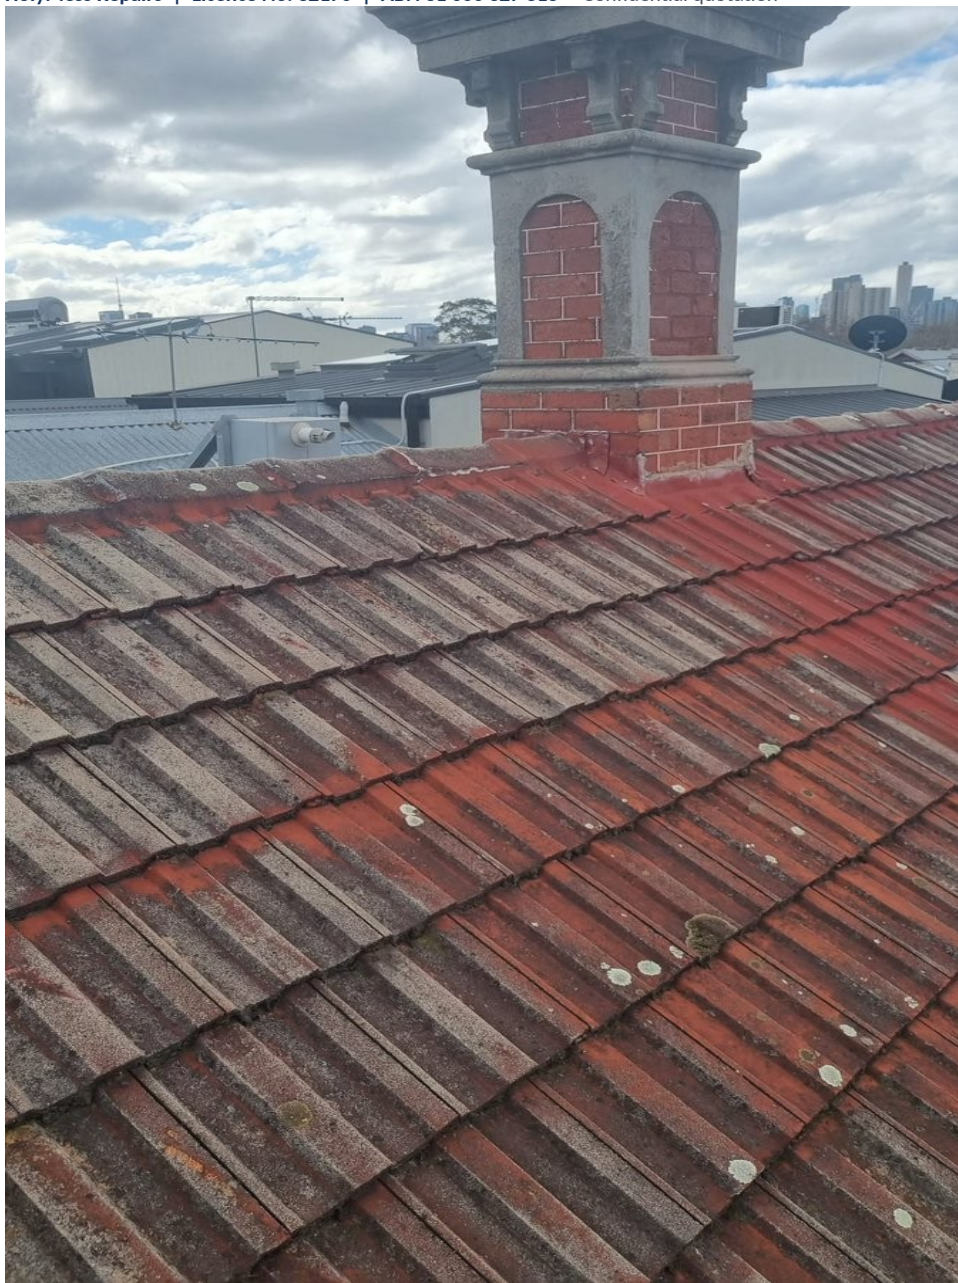
**Photo — ridge pointing failure and chimney base**

The ridge bedding is weathered, split and missing in sections. Red slurry has been brushed over tiles around the chimney — a common cheap disguise, not a flashing. Chimney-to-tile junctions need soaker and apron flashings (lead or approved flexible alternative) stepped into the brickwork. Painted slurry washes off and the leak returns. Port Phillip and VCAT treat this chimney as heritage fabric, so we reflash it; we do not remove it.

6. Re-bed and flexibly point the ridge length on 101 (ridge pointing photo and Video B 2:00–2:22). Replace any cracked ridge tiles.
7. Strip the failed white tape from the skylight (skylight photo; Video B 3:52–4:29) and install new soakers / apron / head flashing compatible with the existing unit. If the unit itself is cracked we will photograph it and price a replacement as a variation before touching it.

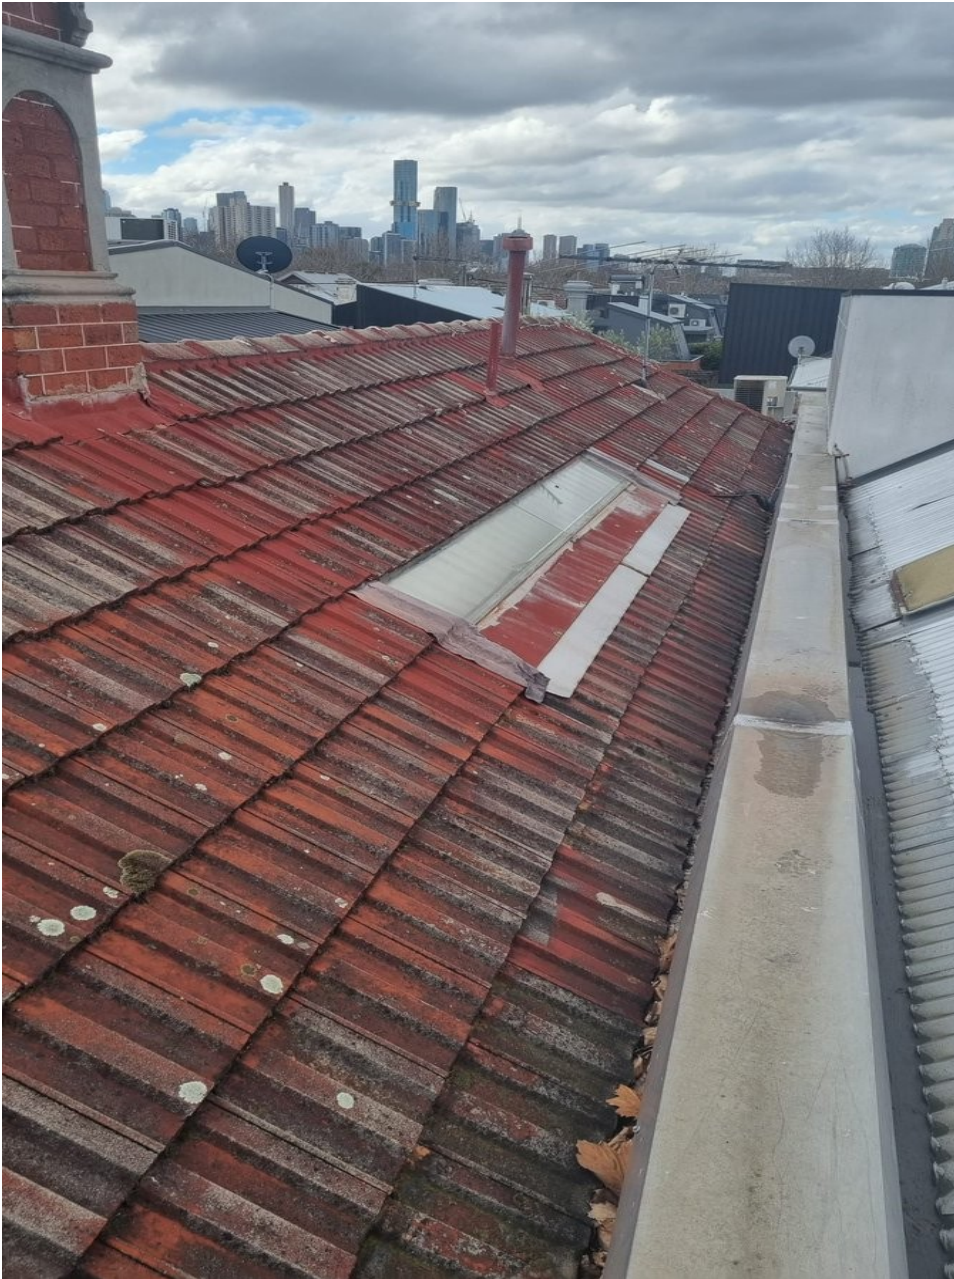
## Photo — failed skylight flashing

Mid-pitch there is a skylight with white tape/membrane patches and uneven soakers. That is a previous leak repair that has already failed. Water follows the tile laps down to the box gutter and also tracks sideways under the flashing. Any option that ignores this unit is guessing.

4. Strip and reflash the skylight with new soakers, apron and head flashing. If the unit is failed beyond flashing, we photograph and price a matching replacement as a variation before ordering.

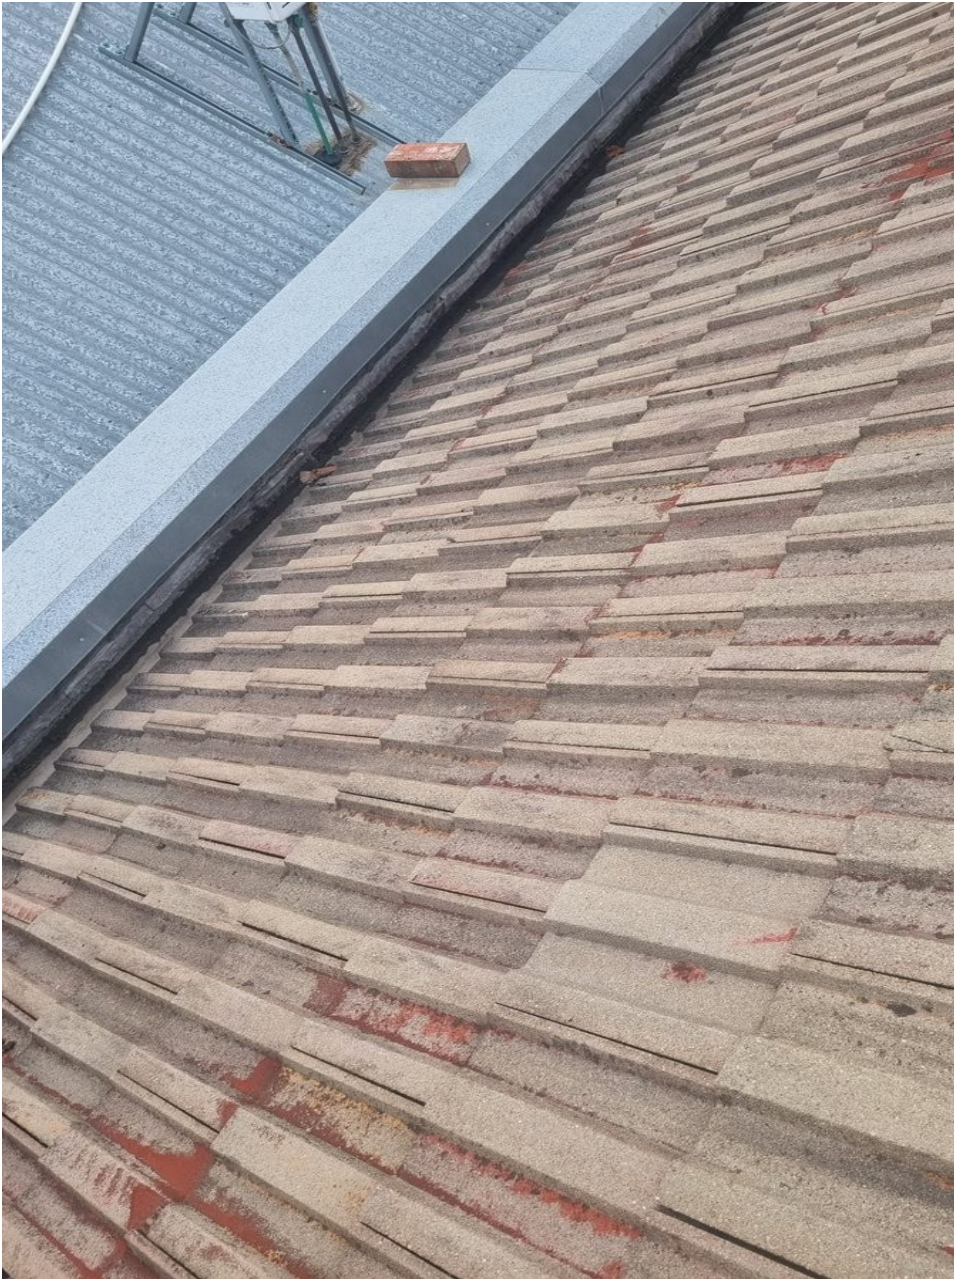
**Photo — tile plane: porosity, displacement, biological growth**

The tile field is original or near-original terracotta profile. Tiles are porous, lichen-spotted, and some courses have crept. Porous tiles do not usually cause a concentrated indoor leak by themselves, but they feed the box gutter with extra water and they hide cracked tiles. This is why a “replace three tiles and leave” quote often fails after the next southerly.

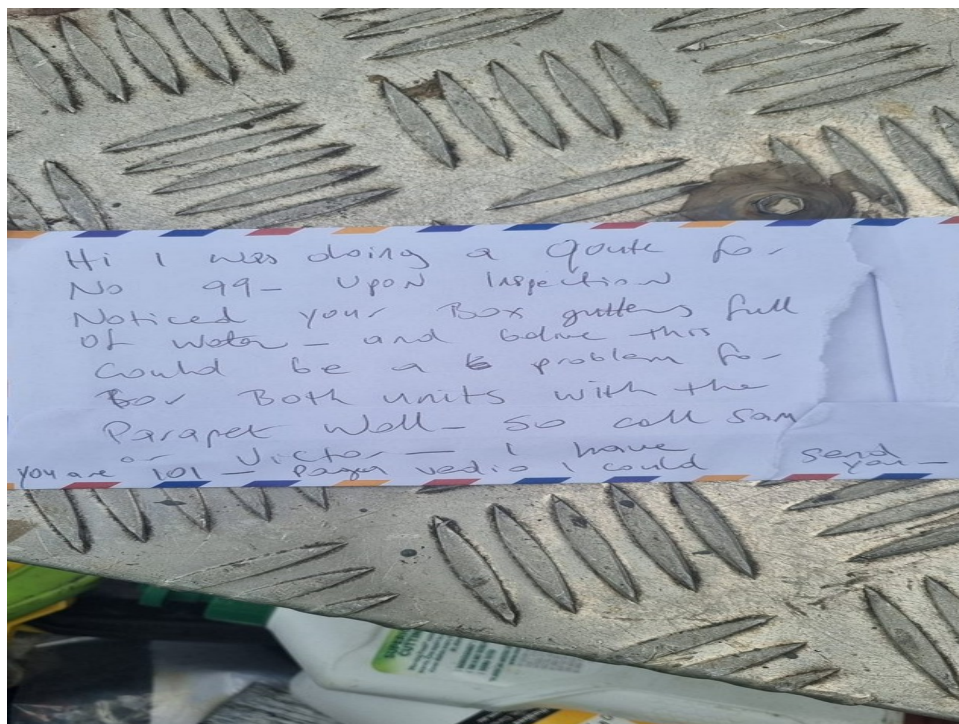
## Photo — the note we left for No. 99

Handwritten on site: box gutters full of water, believed to be a problem for both units with the parapet wall, and a request to call Sam or Victor. You are 101. That note is our paper trail that this is a shared drainage risk, not a private cosmetic issue.
