# HOLYMESS REPAIRS

## ROOF INSPECTION & RECOMMENDATION REPORT

Ringwood VIC 3134  
Units 1, 4, 5 & 6 (Combined roof area  $\approx$  350 m<sup>2</sup>)

Inspection Date: Sunday, 16 August 2026  
Report Date: Sunday, 16 August 2026

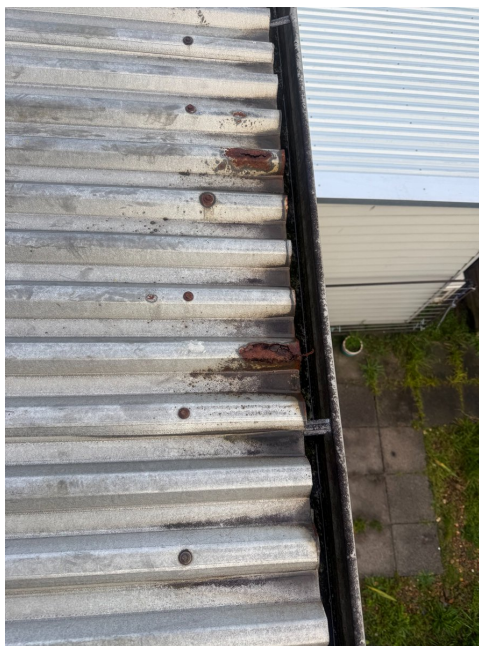
The roof cladding is traditional corrugated galvanised steel. Surface condition varies from heavily weathered grey oxide to areas of active red rust, particularly at cut edges, around fasteners and at penetrations. Large sections of the roof sheets show missing or completely corroded screw fixings. In places entire runs of corrugations have no remaining fasteners, allowing the sheet to lift under wind suction and creating gaps for water entry. This is a fundamental non-compliance with the fixing requirements of AS 1562.1 and manufacturer recommendations for

*Photo: Typical roof sheet condition – missing/rusted fasteners and surface corrosion (inspection media folder 1).*

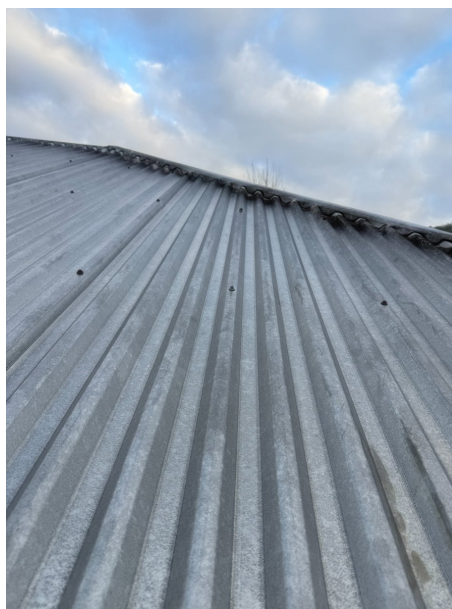
On-site verbal assessment and photographic evidence confirm that large areas of the roof have either never been adequately fixed or the original fasteners have corroded to the point of failure. Remaining screws show advanced rust heads and, in many cases, loss of the sealing washer. Missing fasteners allow differential movement, noise, and progressive opening of side-laps and end-laps, accelerating water ingress.

*Photo: Ridge and sheet fixings – sparse and corroded (inspection media folder 4).*

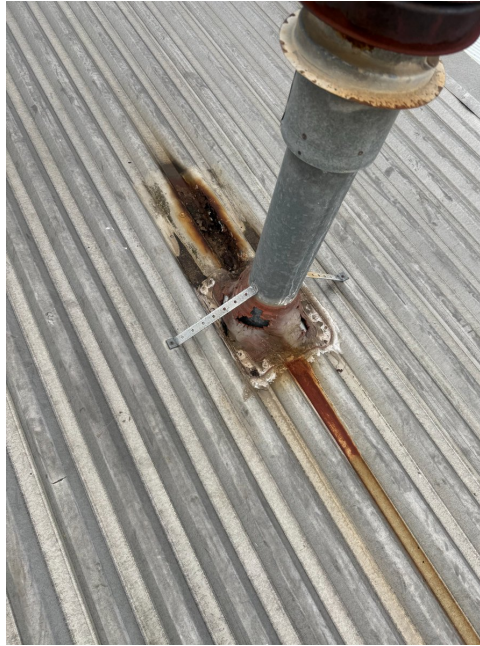
Pipe penetrations (vent pipes, flues) show classic failure of the original rubber boots / flexible flashings and any subsequent silicone. Active rust staining radiates from the base of penetrations down the corrugations. Debris and organic matter have accumulated in the low points around the collars, holding moisture against the metal. These are high-probability leak sources and match the pattern of water entry reported into the units.

*Photo: Severely corroded penetration collar with failed sealant and active rust run-off (inspection media folder 2).*

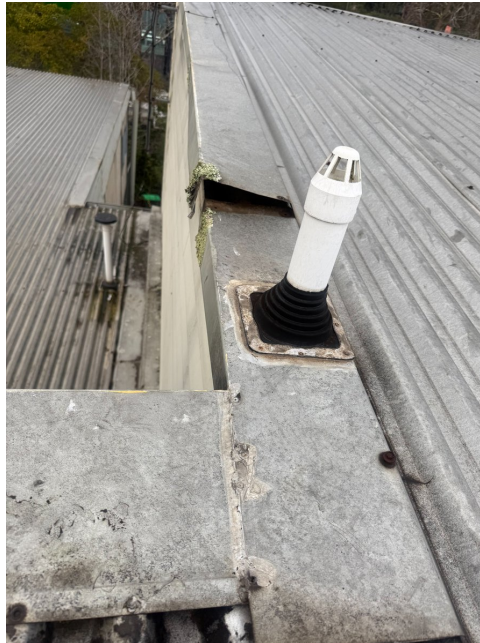
*Photo: Vent pipe with moss growth and compromised flashing interface (inspection media folder 2).*

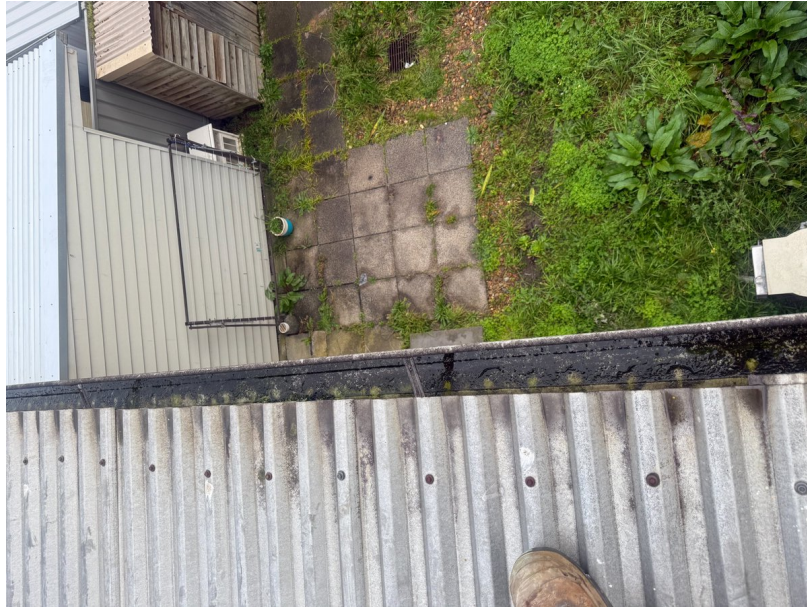
Gutters contain significant organic debris and show surface corrosion. The roof-to-gutter interface and barge/eaves flashings exhibit moss growth and, in places, open joints. Wall-to-roof apron flashings (where the roof meets vertical walls or cladding) show lichen and potential capillary paths. These details are critical to weatherproofing under NCC Volume Two / Housing Provisions and SA HB 39.

*Photo: Gutter line and roof edge condition from above (inspection media folder 2).*

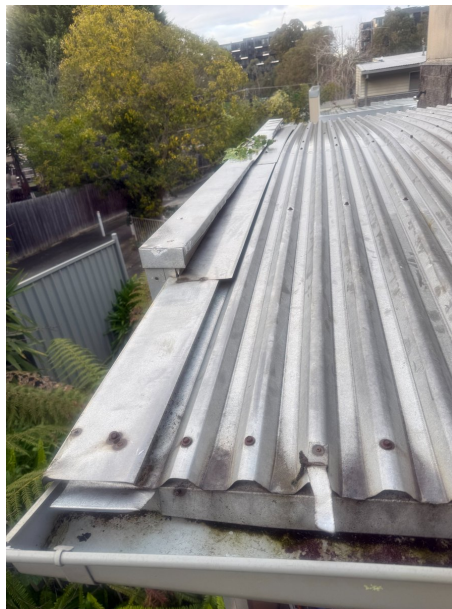
*Photo: Edge detail, barge and gutter junction (inspection media folder 5).*

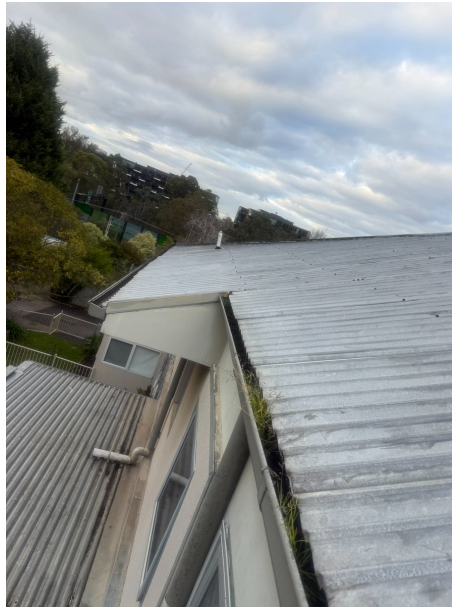
Newer roof areas (presumed Units 2 & 3) visible in the inspection media show clean, fully fastened Colorbond-type sheeting with modern detailing. The contrast highlights how far the subject roofs have deteriorated and supports the planning rationale that the remaining units should be brought to the same standard.

*Photo: Overall roofscape showing older and newer roof areas in context (inspection media folder 4).*
