# Roof Inspection Report

**Property Address:** [REDACTED] Lindenow VIC 3865 (Lindenow Primary School)

**Prepared By:** Holymess Repairs

**Date:** 17-April- 2025

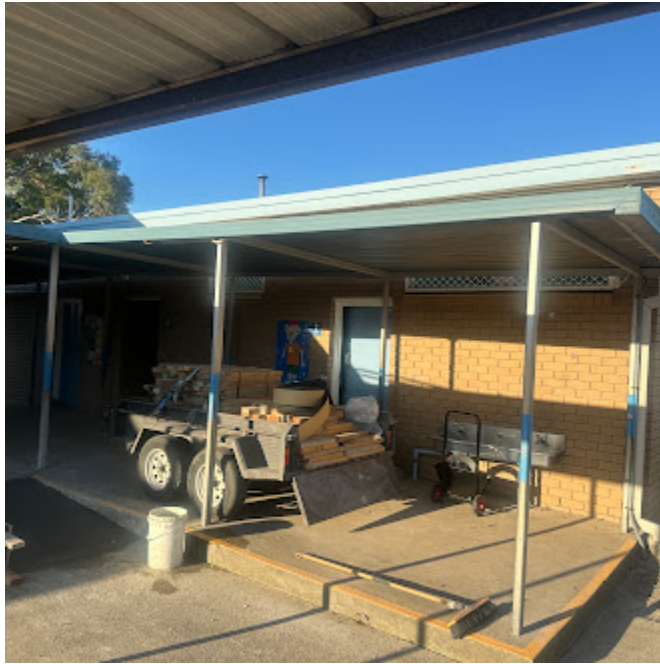
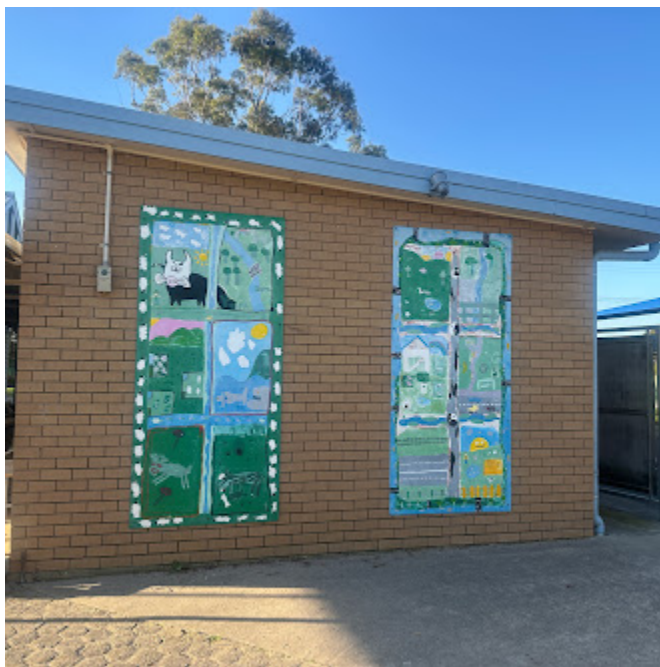
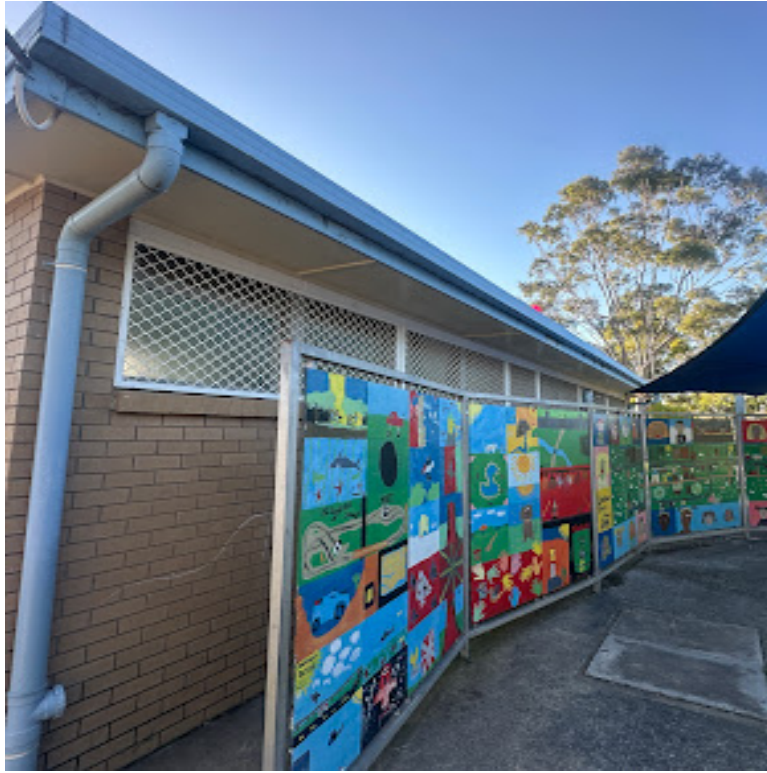
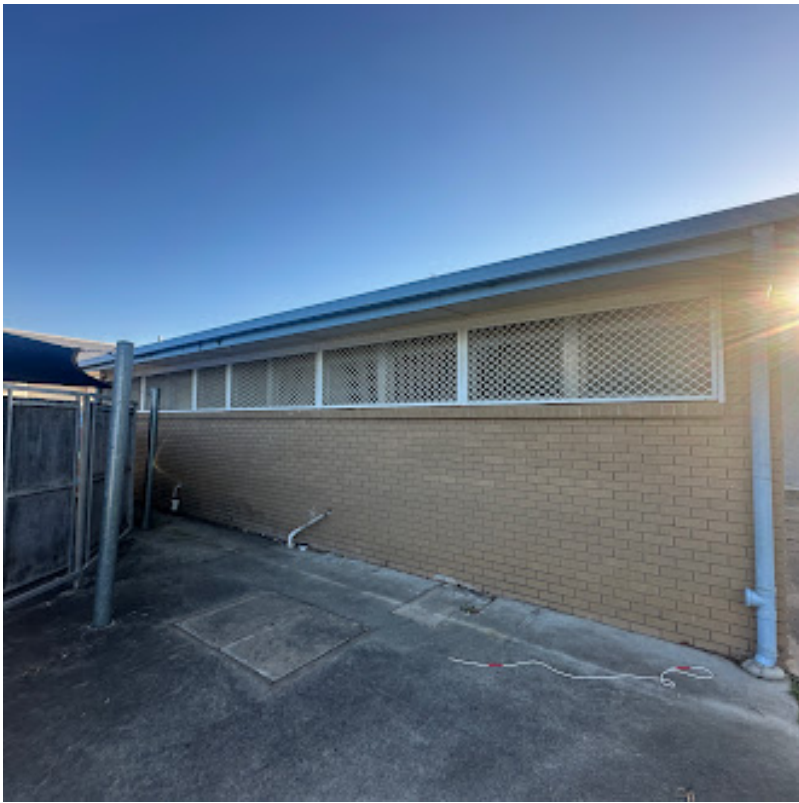
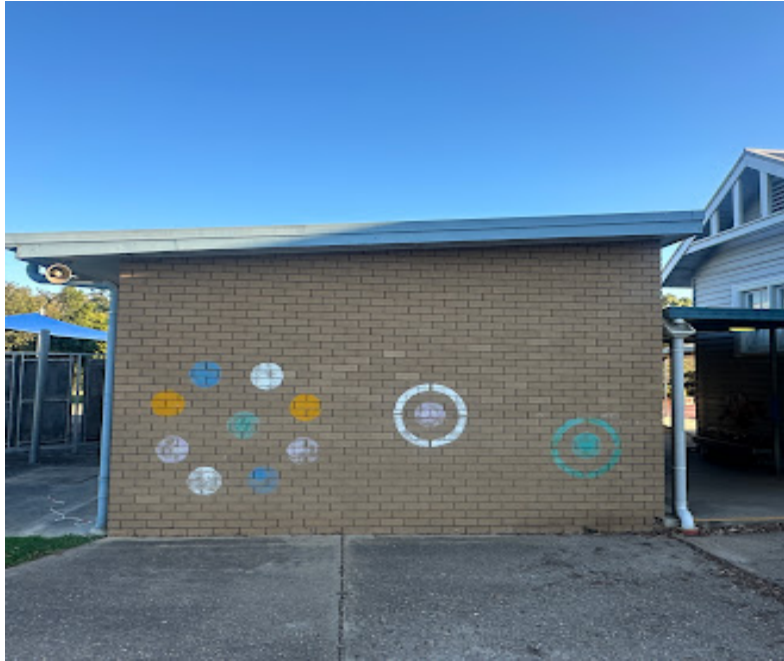
### Overview Video:

The toilet block at Lindenow Primary School features a lean-to roof attached to a brick building. The roof has a single pitch, sloping from a high end to a low end, draining into an external square-line gutter with two 100 mm downpipes. The surrounding environment includes large gum trees, contributing to significant leaf and debris

accumulation in the guttering system. The roof appears to be an older metal roof with multiple patches and penetrations, showing signs of rust and deterioration.

- **Guttering:** Evidence of frequent overflows, staining, and damage to the fascia due to blockages and inadequate overflow provisions.
- **Roofing:** Extensive rust, poorly executed repairs, and non-compliant modifications (e.g., grinding of sheet ends), leading to leaks and reduced roof lifespan.
- **Fascia and Paintwork:** Damage from water overflow, with signs of rot and peeling paint, some timbers previously replaced.

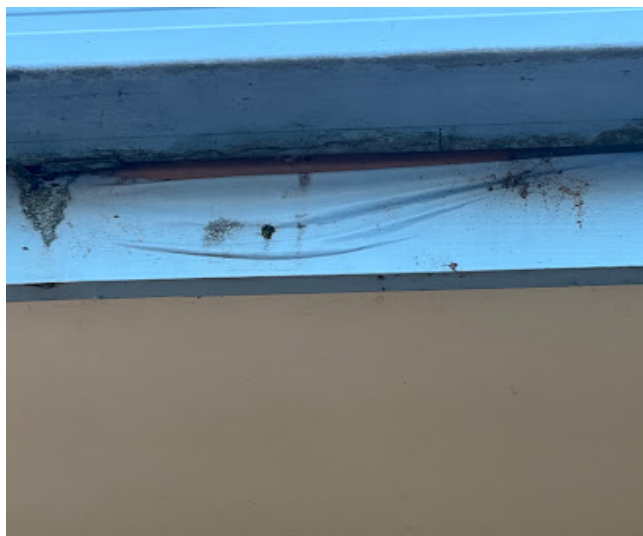
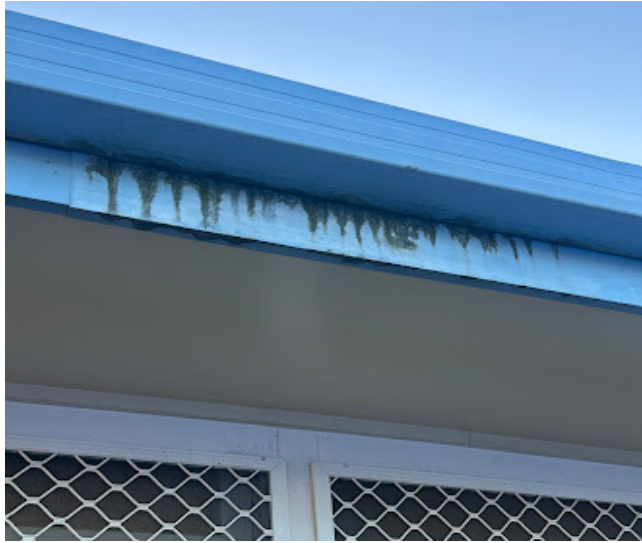
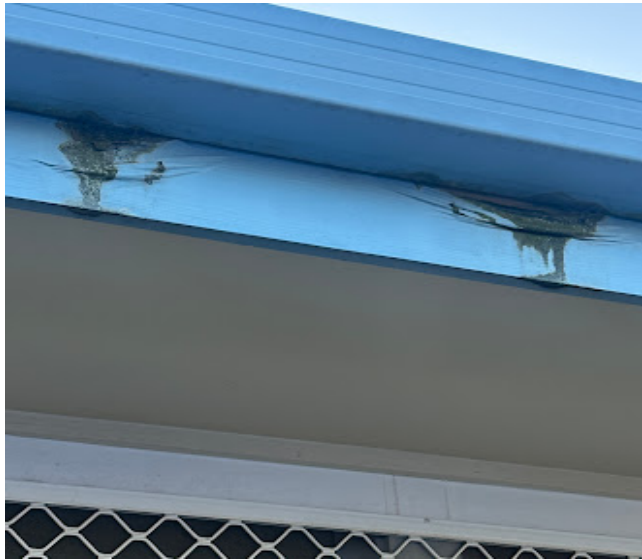
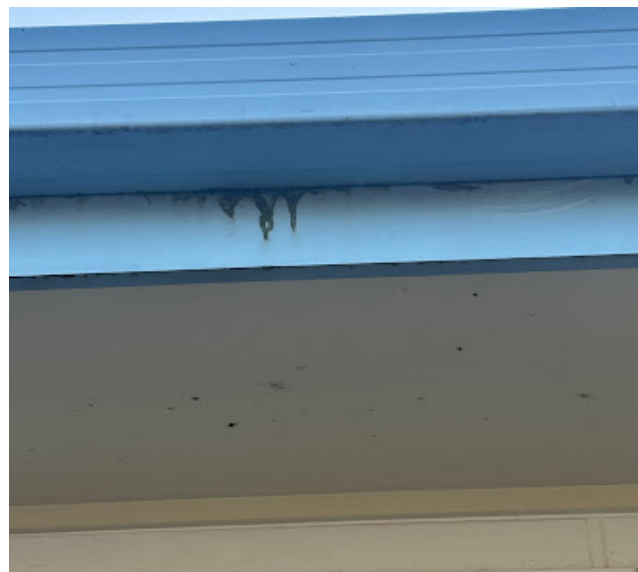
#### Guttering Video:

The guttering system is a square-line gutter with two 100 mm downpipes, which is appropriately sized for the roof's catchment area per **AS 3500.3**. However, several critical issues were identified:

- **Overflow Evidence:** Staining, peeling paint, and fascia damage indicate frequent overflows, particularly at the low end near the downpipes. This is likely due to blockages from leaves and debris, exacerbated by nearby gum trees.
- **Lack of Overflow Provisions:** The gutter lacks overflow slots or high-fronted designs, violating **NCC Part 3.5.2**, which requires measures to safely redirect excess water during heavy rain.
- **Fascia Damage:** Water has penetrated behind the paint, causing rot and necessitating prior timber replacements. The current paint application (up to the gutter edge) allows water to seep behind, accelerating deterioration.
- **Inadequate Leaf Protection:** Existing leaf guards have small openings (100 mm x 75 mm), which block easily, contributing to overflows.

**Description:** Replace the existing metal roof with a 0.48 mm thick flat-tray roofing profile (e.g., Clip Lock or Trimdek) and install a new overflow gutter system with leaf eaters. Repaint or cover the fascia before installation to prevent future water damage.

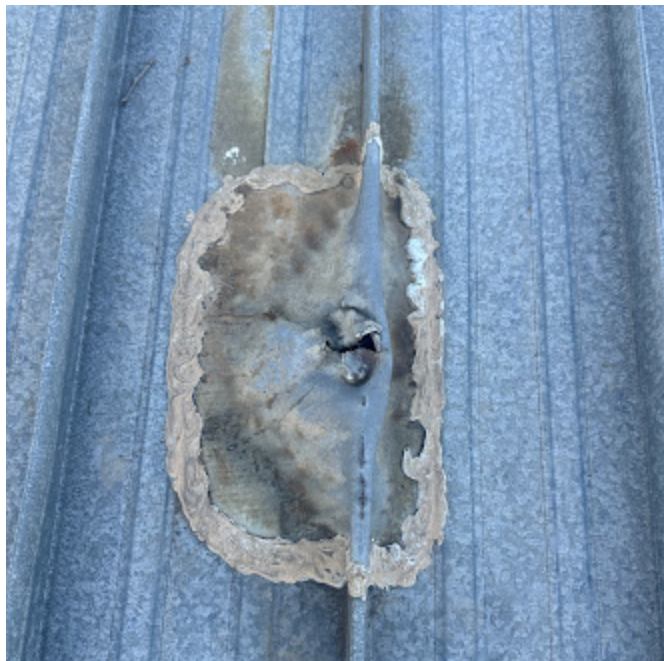
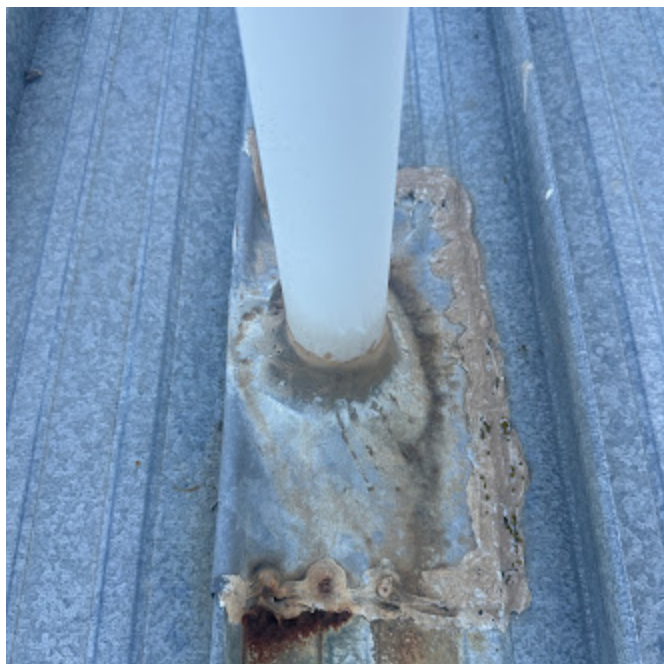
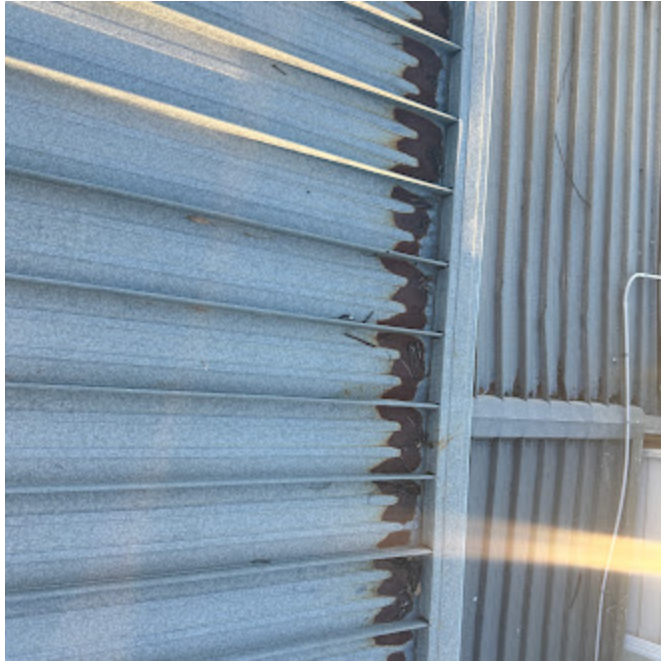
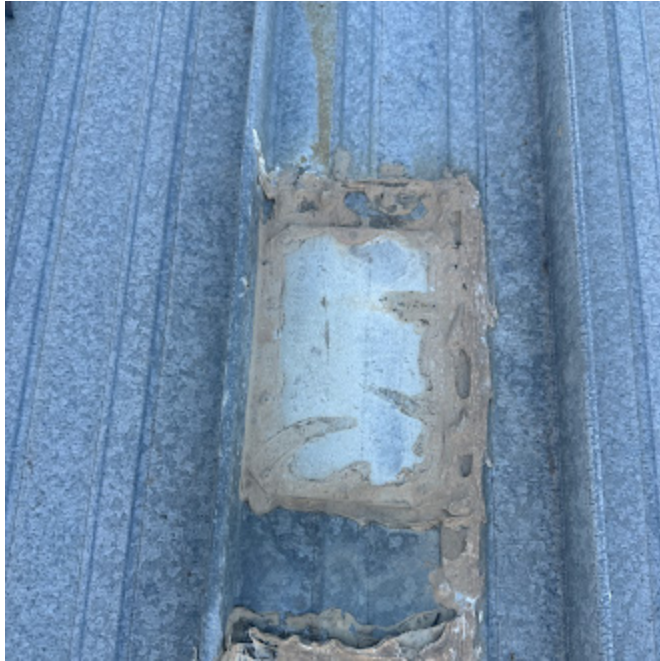
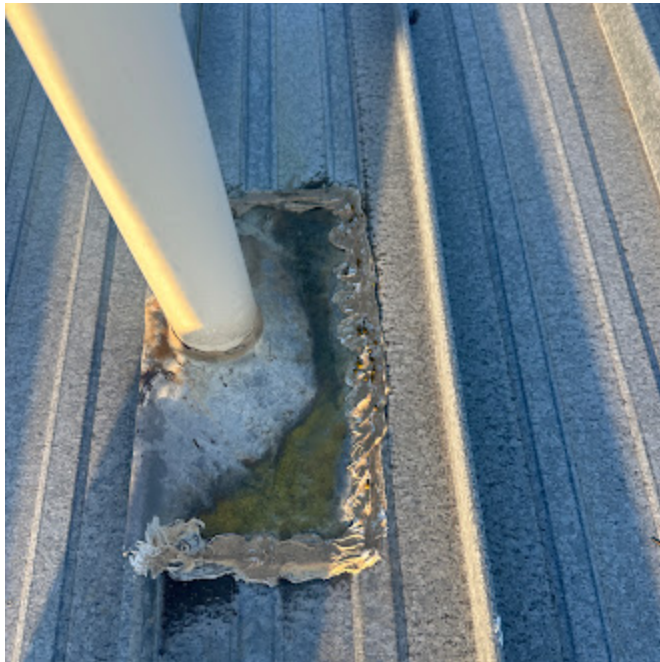
### Roofing Video:

Non-compliance, such as the grinding of roof sheet ends observed on this roof, violates **AS 1562.1** and accelerates corrosion, posing safety risks (sharp edges) and reducing the roof's lifespan. All recommendations in this report are designed to restore compliance with these standards while addressing the specific issues identified.

The metal roof exhibits significant deterioration, compromising its functionality and compliance with **AS 1562.1**:

- **Rust and Corrosion:** Extensive rust is present, particularly at the bottom of sheets and around penetrations. This is accelerated by non-compliant modifications, such as grinding the sheet ends, which removes protective coatings and exposes raw metal to moisture.
- **Poor Patching:** Multiple patches, primarily lead-based, are cracked or deteriorating. Some penetrations lack proper back flashing, allowing water ingress.
- **Improper Sheet Termination:** The grinding of sheet ends prevents proper folding or capping, causing leaks and fascia damage. This practice is illegal under **AS 1562.1** due to its impact on roof integrity and safety (sharp edges pose risks during maintenance).
- **Debris Accumulation:** Debris buildup under cappings and in valleys contributes to rust and water pooling, further reducing the roof's lifespan.

**Description:** Patch existing roof leaks with compliant back flashing and sealants, replace damaged roof sheets where rust is severe, and install a new overflow gutter with leaf eaters. Repaint the fascia to protect against water ingress.
