**Quote No: HMR-ACT-ROOF-260526**

**Subject: Roof Water Ingress Repair Quote – [REDACTED] Curtin ACT 2605**

### **Our independent site analysis of YOUR photos (taken by Victor C on site):**

## FAULTY ROOF TRANSITION

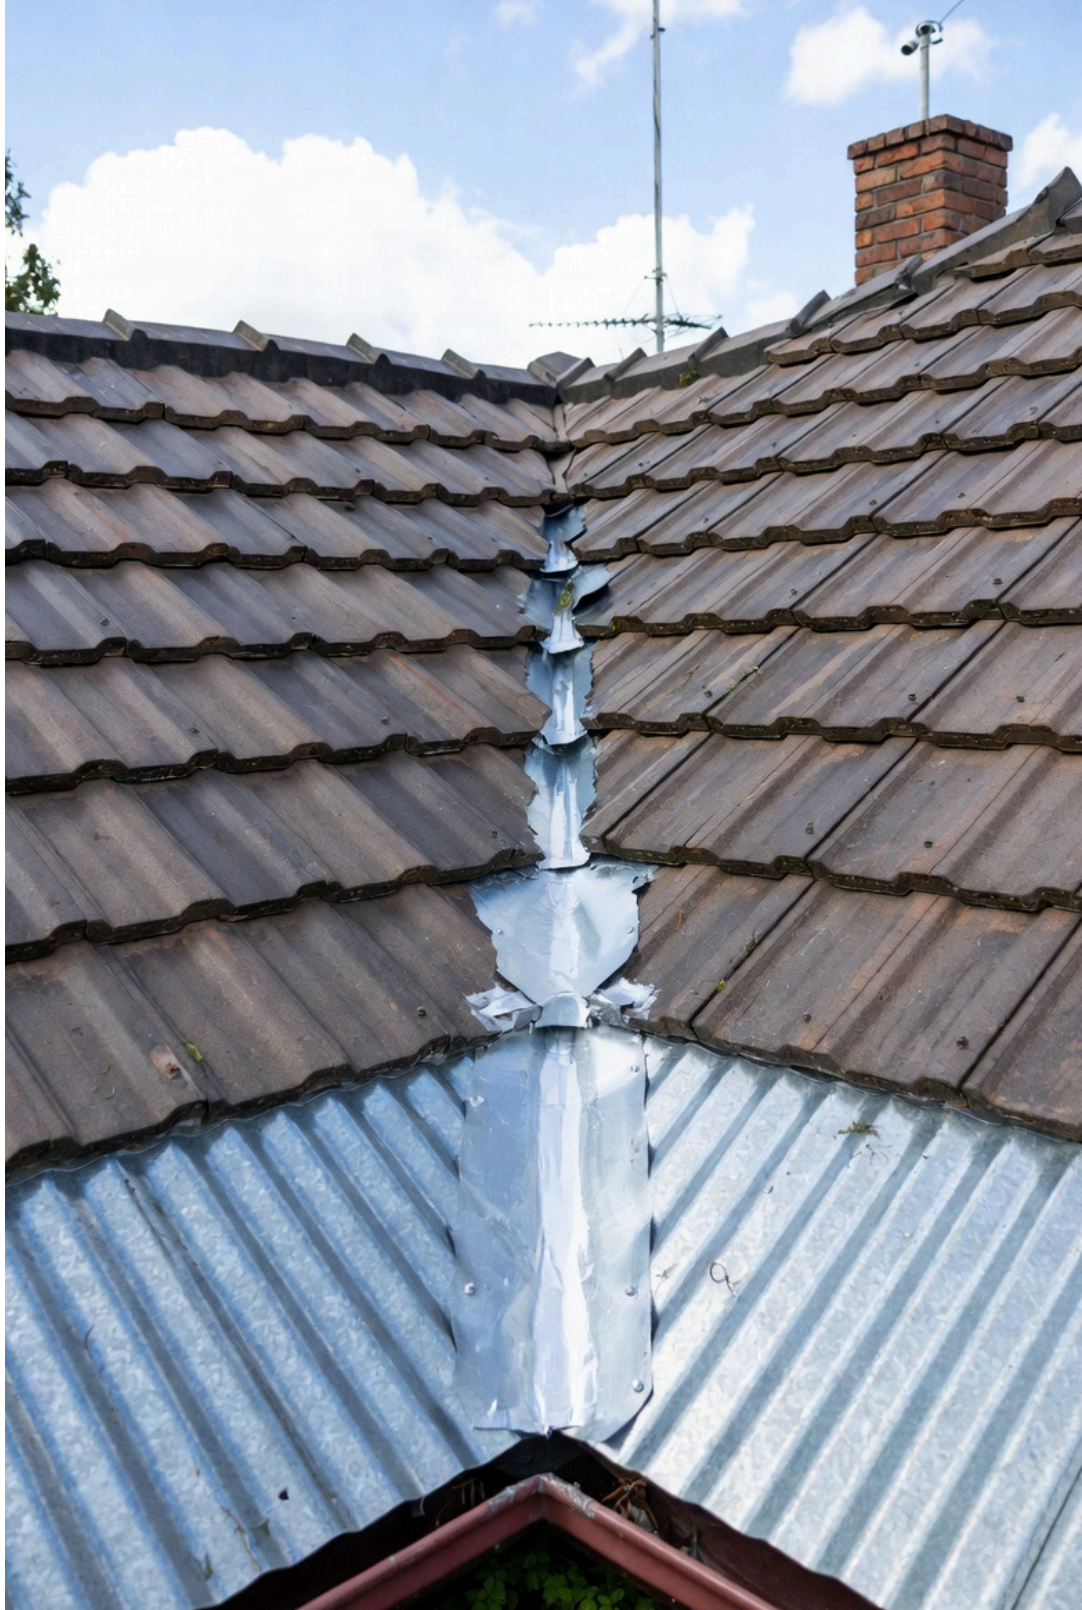
against the corrugated metal roof. Debris buildup and the visible flashing lip prove the pitch change prevents proper overlap – exactly as Ausnorth described.
