# Roofing Inspection Report

**Property:** Bairnsdale Primary School, [REDACTED] Bairnsdale, VIC 3875

**Prepared by:** Holymess Repairs

**Date:** 17 April 2025

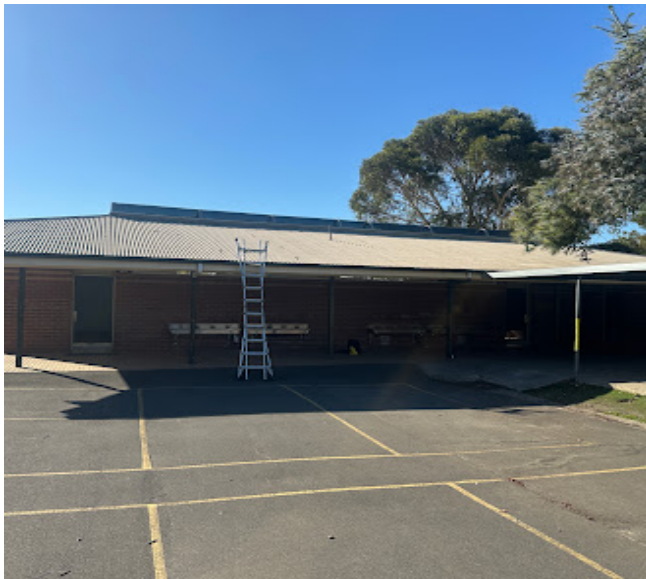
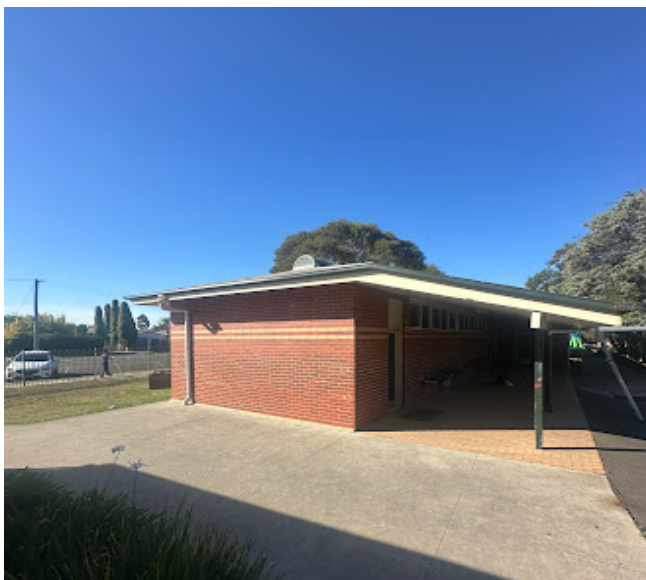
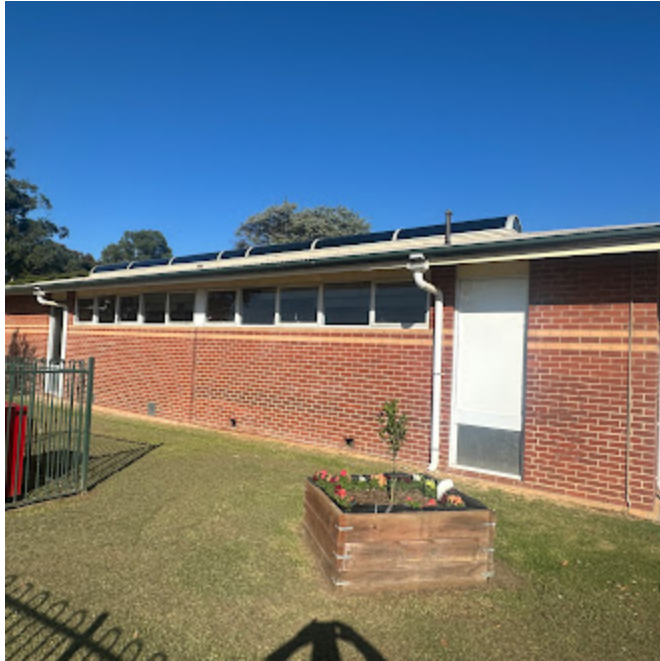
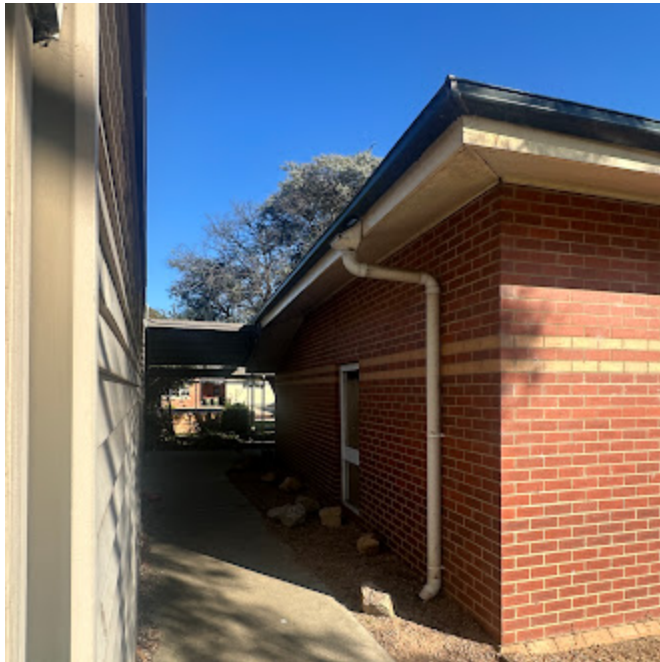
The inspection revealed several areas requiring attention, including rusted gutters, dislodged gutter brackets, missing downpipe components, dented roof sheets, rusted screws, and damaged roof vents. While the roof is generally in fair condition for its age, proactive maintenance is necessary to ensure compliance with regulatory standards and to prevent costly damage.

- **Rusted Gutter Section:** A corner section of the gutter is rusted, likely due to water pooling from inadequate falls or blockages [,].
- **Dislodged Gutter Brackets:** Gutters on one side have detached from their brackets, possibly due to improper securing or disturbance during cleaning. This has caused misalignment and ineffective water flow.
- **Leaf Eater System Issues:** While leaf eaters are installed to reduce debris, one downpipe pop is missing, and some are undersized (90 mm pop into a 100 mm pipe), reducing efficiency.
- **Lack of Overflow Provisions:** The gutters lack overflow mechanisms, which is non-compliant with *AS/NZS 3500.3* and increases the risk of water ingress during heavy rain [,].
- **Tree Debris:** Overhanging gum and pine trees contribute to significant leaf litter, exacerbating blockages and requiring regular maintenance.

- **Dented Roof Sheets:** Roof sheets along the ridge line are dented, likely from children climbing or throwing objects. This poses a safety risk if sheets dislodge or debris falls [].
- **Rusted Screws:** Many screws show surface rust, indicating potential long-term corrosion. The screws are a different color from the roof, suggesting past repairs or painting.
- **Damaged Vents:** Two roof vents have missing or damaged cowls, allowing vermin ingress and reducing ventilation efficiency [].
- **Debris on Roof:** Rocks and other debris on the roof pose a safety hazard and could damage the roof surface if not removed.
- **Skylight Seals:** Rubber seals on the skylights show signs of shrinkage and moss buildup, indicating potential future leaks if not resealed.
