## Roof Inspection Report

**Property Address:** [REDACTED] Box Hill VIC 3128

**Date of Inspection:** 08 May 2025

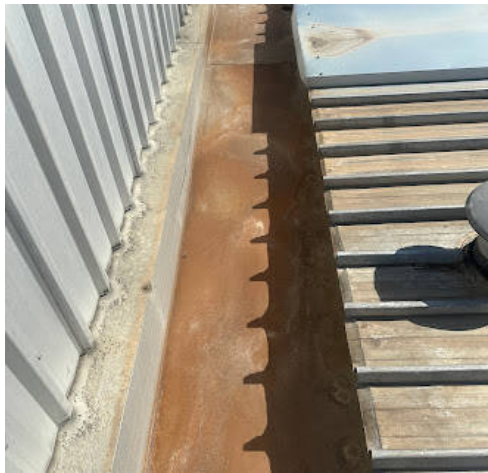
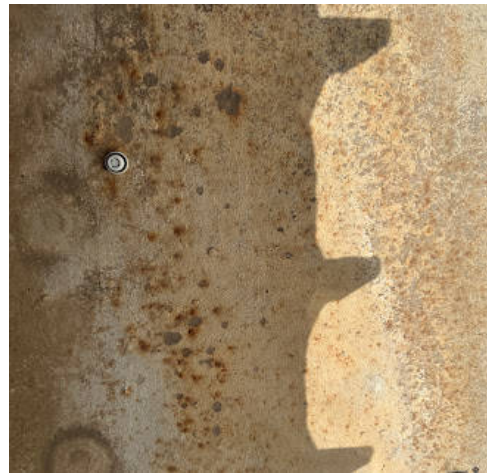
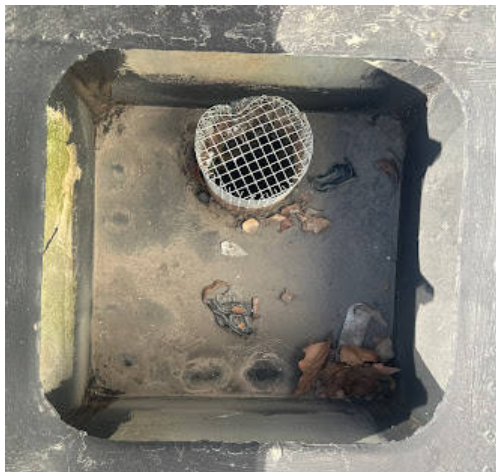
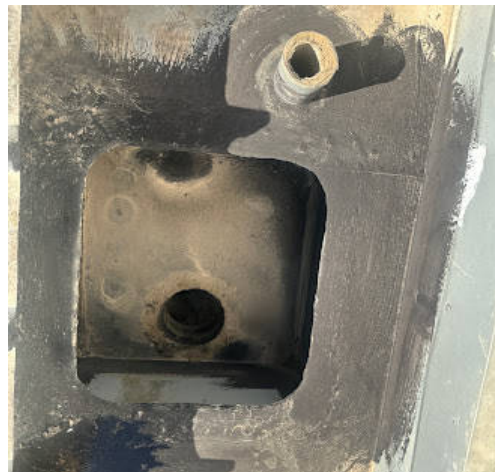
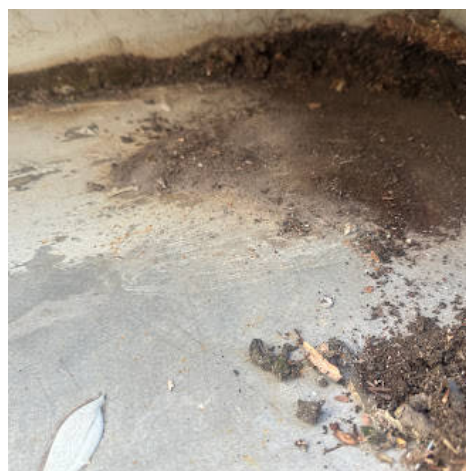
- In good condition, with no immediate issues. The simple design ensures compliance with BCA weatherproofing requirements.

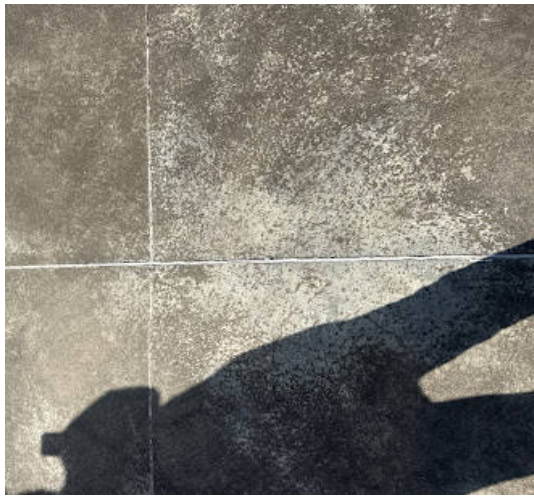
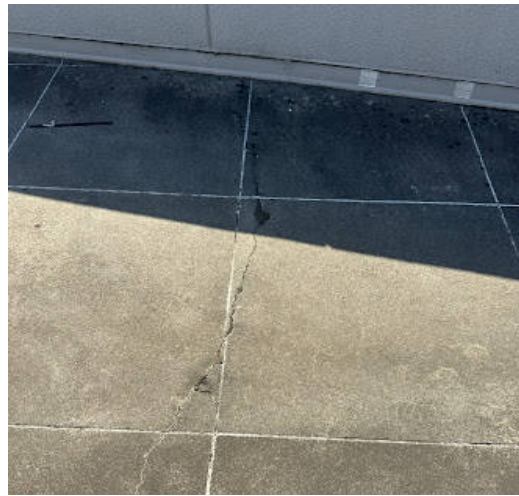
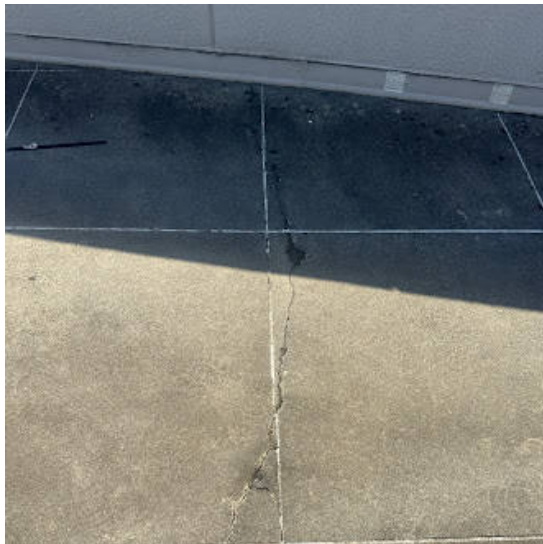
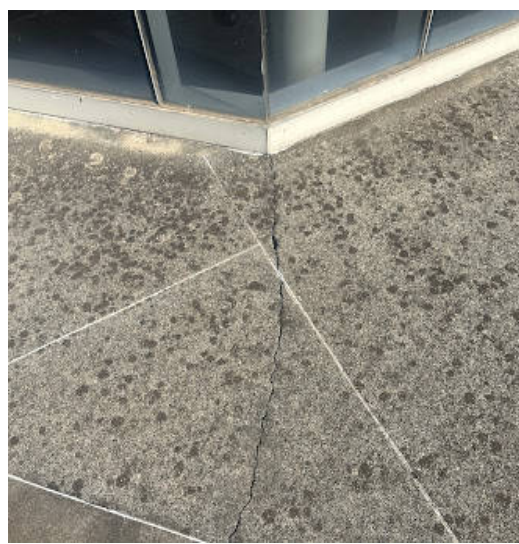
- Multiple repair attempts with silicone and epoxy indicate underlying waterproofing issues (AS 3740:2021).
- Cracked tiles, lifting seals, and poor preparation risk water ingress into the structure (NCC F1P1).
