# HOLYMESS REPAIRS

## QUOTATION FOR ROOF LEAK RECTIFICATION

[REDACTED] Albert Park VIC 3206

[REDACTED] thank you for having us on the roof at [REDACTED]. This is an 1890 Victorian terrace in Albert Park — the kind of building that looks beautiful from the street and hides its real problems in the box gutters, parapets and chimney junctions that you cannot see from the footpath.

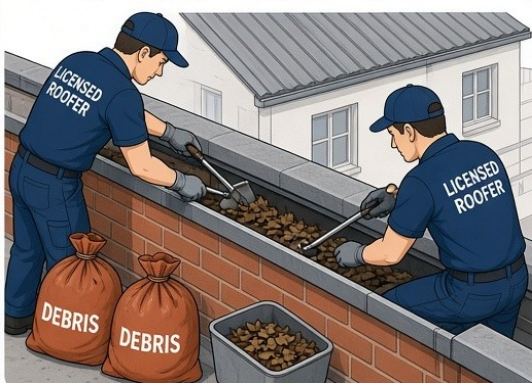
### 1 Empty the blocked box gutter so water can leave

Clear dry leaves and silt from the narrow box gutter behind the parapet.

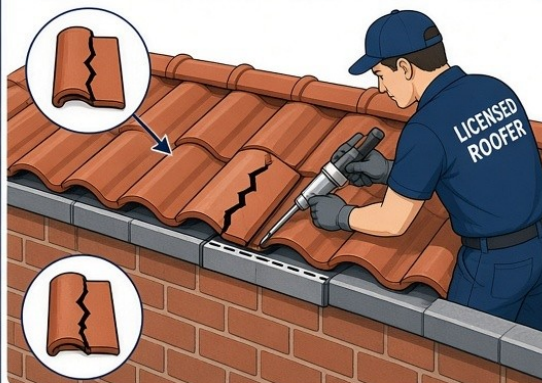
### 2 Hold the open joints before the next rain.

Seal the open tile-to-parapet joint and replace the cracked tile.

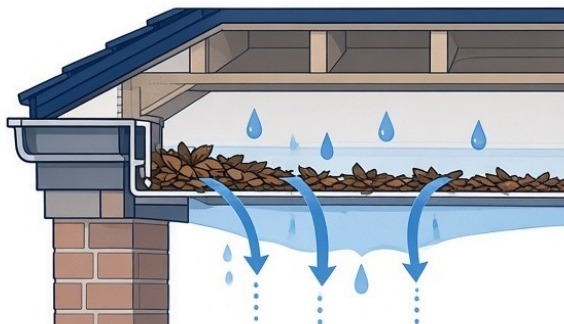
### blocked gutter

**Blocked gutter = indoor leak**

**A clear box gutter keeps water moving away from your home.**  
Clearing it now prevents indoor damage and gives you time before the next storm.

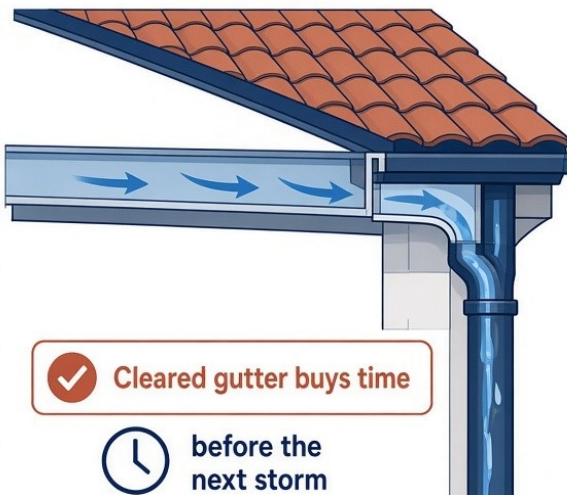
### cleared gutter

**Cleared gutter buys time**

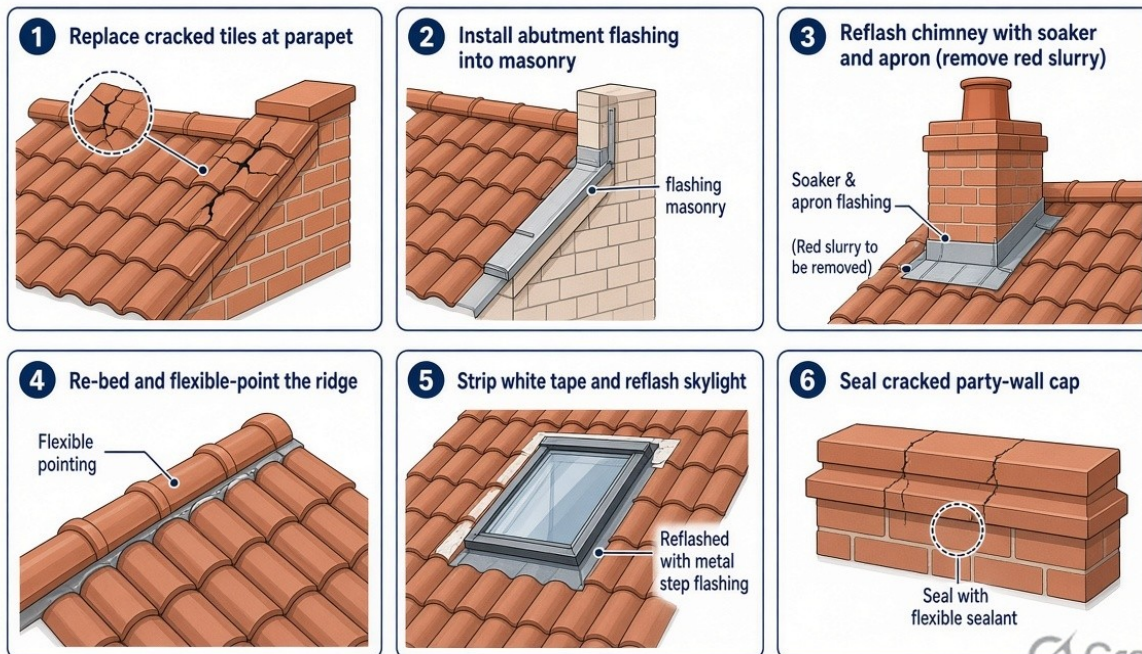
Option 2 process — the six junctions we will physically rebuild on 101: tiles, abutment flashing, chimney soakers, ridge pointing, skylight flashing, party-wall cap.

3. Replace all cracked and broken tiles identified on the 101 plane (front abutment, mid-pitch and any others found when tiles are lifted). Matching terracotta profile. Bed and clip as required.

4. Install a proper abutment flashing at the front parapet (the gap in the parapet-gap photo): metal or approved flexible soaker/apron turned up the masonry, tiles dressed over, flexible pointing fillet. This replaces the open joint.

6. Re-bed and flexibly point the ridge length on 101 (ridge pointing photo and Video B 2:00–2:22). Replace any cracked ridge tiles.
7. Strip the failed white tape from the skylight (skylight photo; Video B 3:52–4:29) and install new soakers / apron / head flashing compatible with the existing unit. If the unit itself is cracked we will photograph it and price a replacement as a variation before touching it.

8. Seal the cracked party-wall cap with a flexible masonry compound and dress a short cover flashing where the cap meets the tile/gutter line, after notifying No. 99.

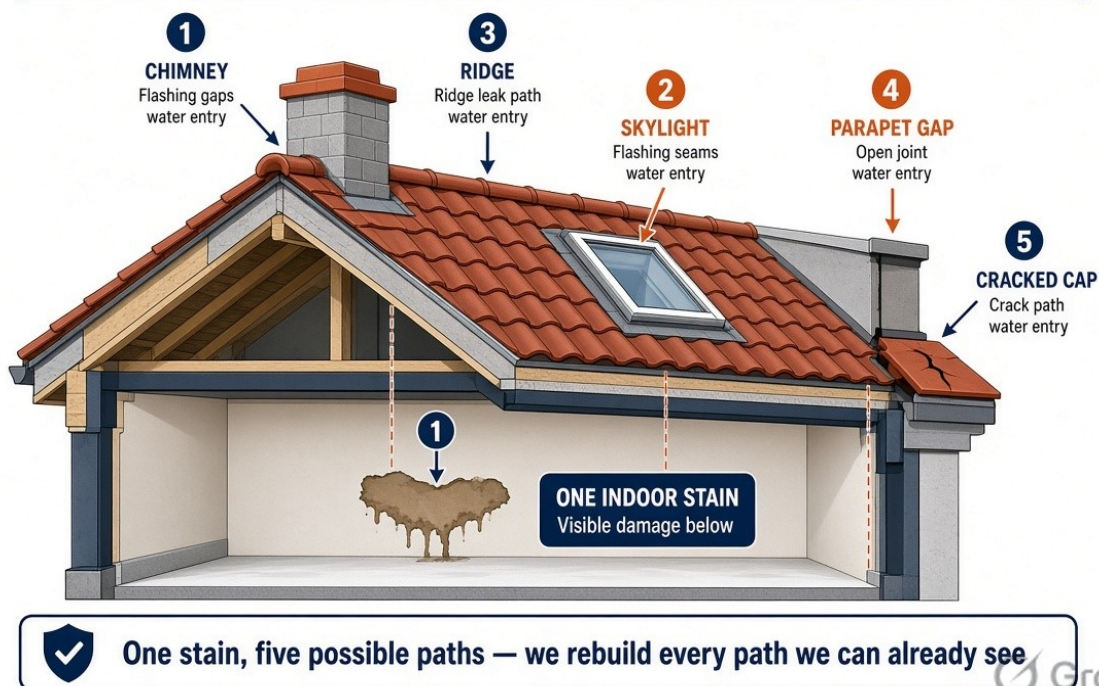
Option 2 why — one indoor stain can be fed by five paths we already photographed. We repair each path rather than guessing the loudest one.

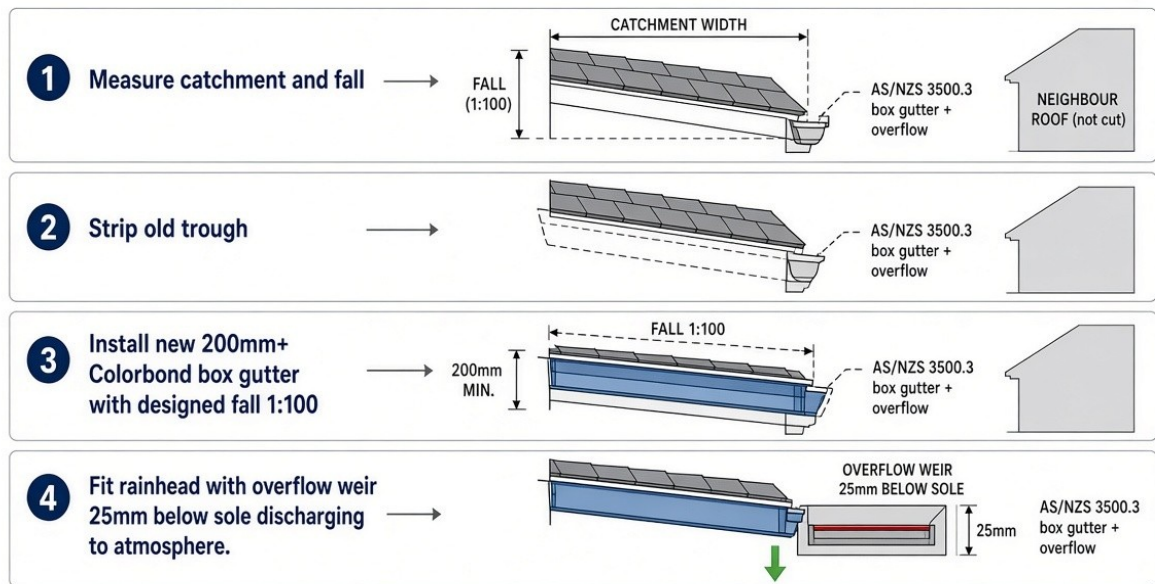
Option 3 process — measure, strip, install a 200 mm+ gutter at designed fall, then fit a rainhead overflow 25 mm below the sole as AS/NZS 3500.3 requires.

All work to comply with:  
**AS/NZS 3500.3 box gutter + overflow**

Designed fall 1:100 ensures self-cleansing flow and prevents ponding.

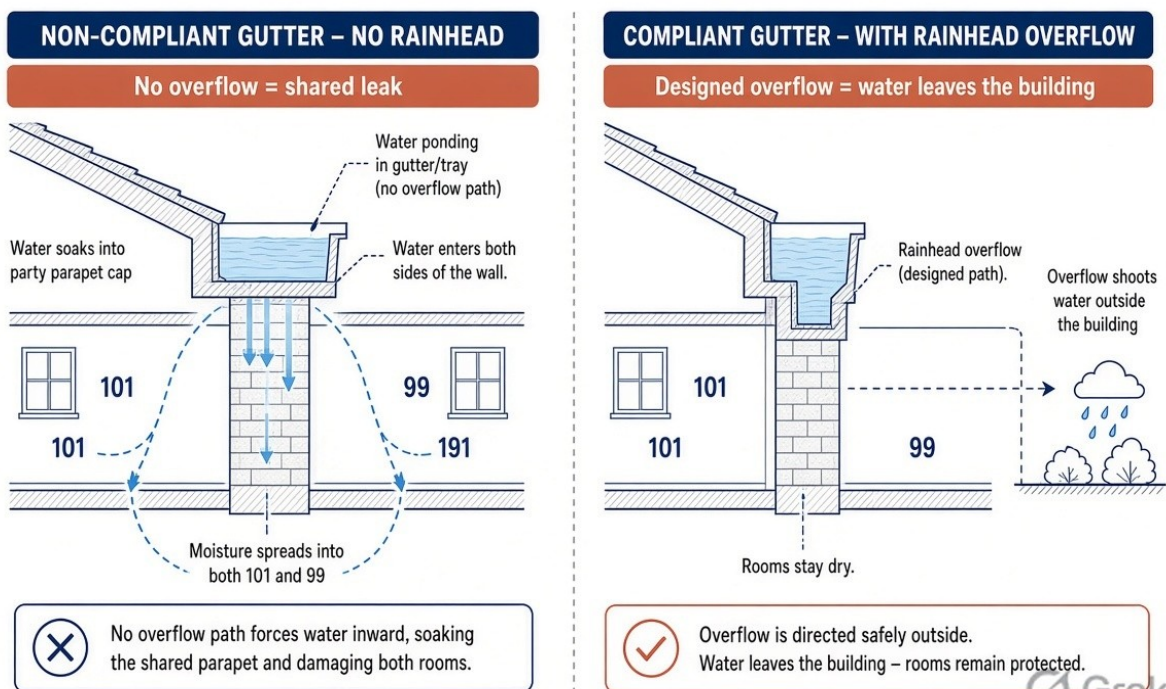
Option 3 why — a new tray with no overflow still soaks the shared parapet and can wet both 101 and 99. The overflow is the legal part of the job.

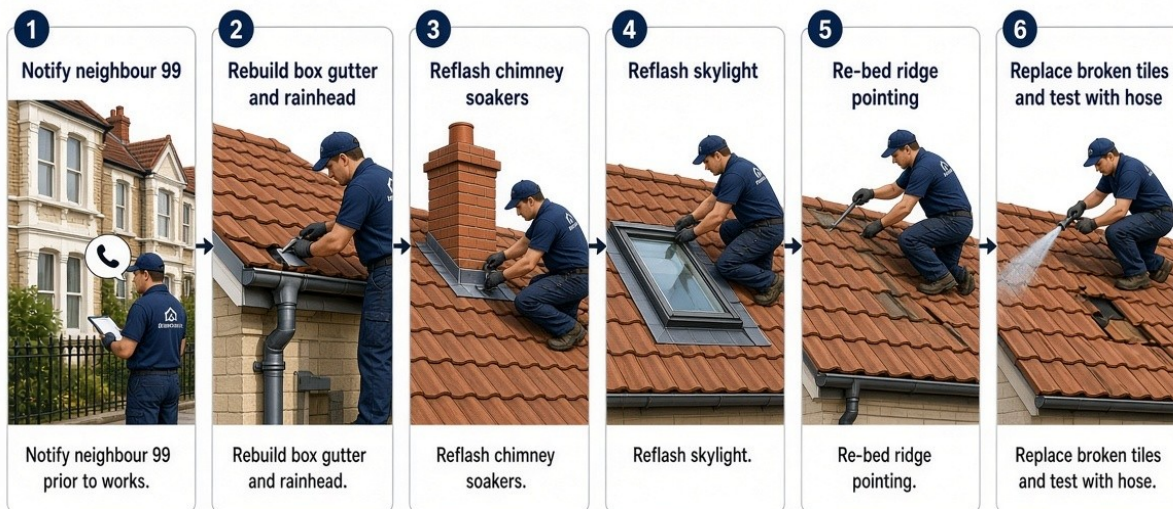
Option 4 process — neighbour notice, box gutter rebuild, chimney soakers, skylight reflash, ridge re-bed, tile replacement and hose test. One sequence, one system.

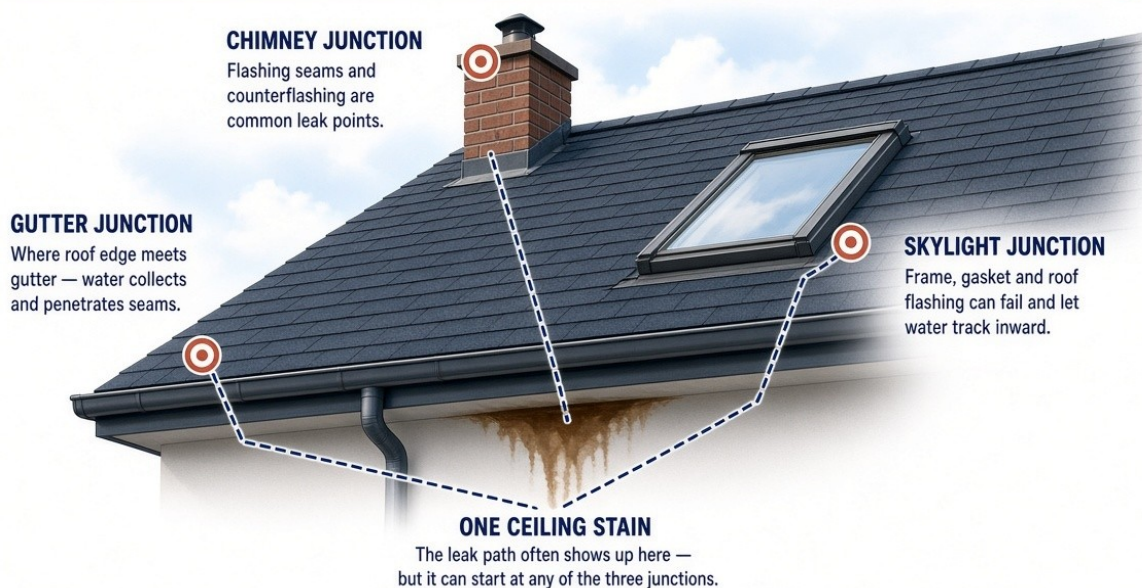
Video on site held all three in one frame — repairing only one sends you back after the next front
