## Roof Inspection Report

**Address:** [REDACTED] Amaroo ACT 2914

**Inspection Date:** 11 April 2025

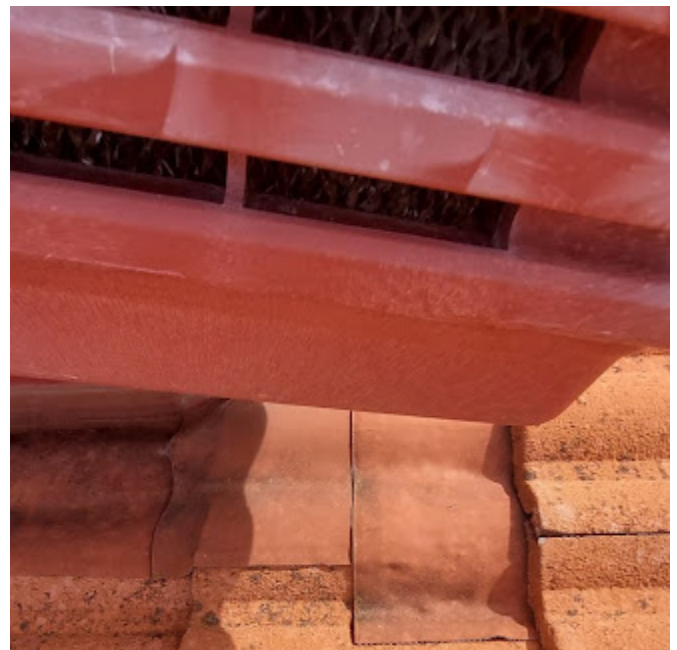
### ***1. Damaged Tiles Under Flashing (Photo 1)***

Photo 1 shows several tiles beneath the flashing that are cracked or displaced. As a roofer, I see this often when tiles shift or break due to thermal expansion, foot traffic during past maintenance, or simply age. The gaps allow water to seep under the flashing, which is likely causing the leak near the wall in your living area. The flashing itself looks intact, but the tiles underneath are the weak point.

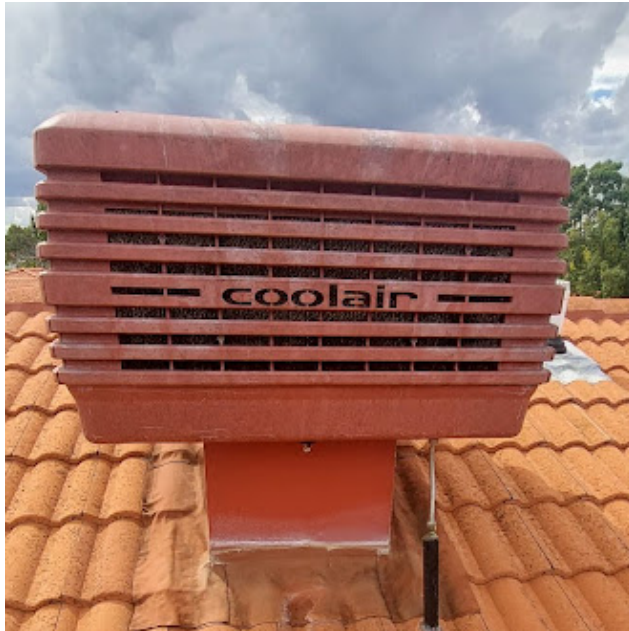
### ***4. Damaged Flashing Around Vent Pipe (Photo 2)***

Photo 2 shows a vent pipe with a square metal flashing base. The flashing is rusted, and there are gaps at the edges where it meets the tiles. This is another common issue I see—rust and poor sealing create entry points for water, which could contribute to existing leaks or cause new ones if not addressed.
