**HolyMess Pty. Ltd.**

## **Service Report: Roof Maintenance & Emergency Weatherproofing**

**Date:** March 9, 2026

**Service Type:** Emergency Roof Repair & Leak Prevention

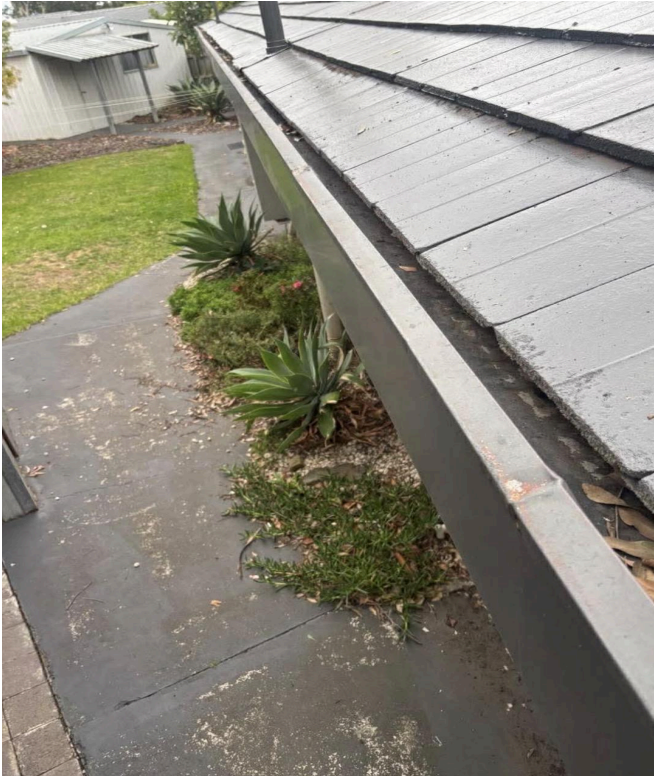
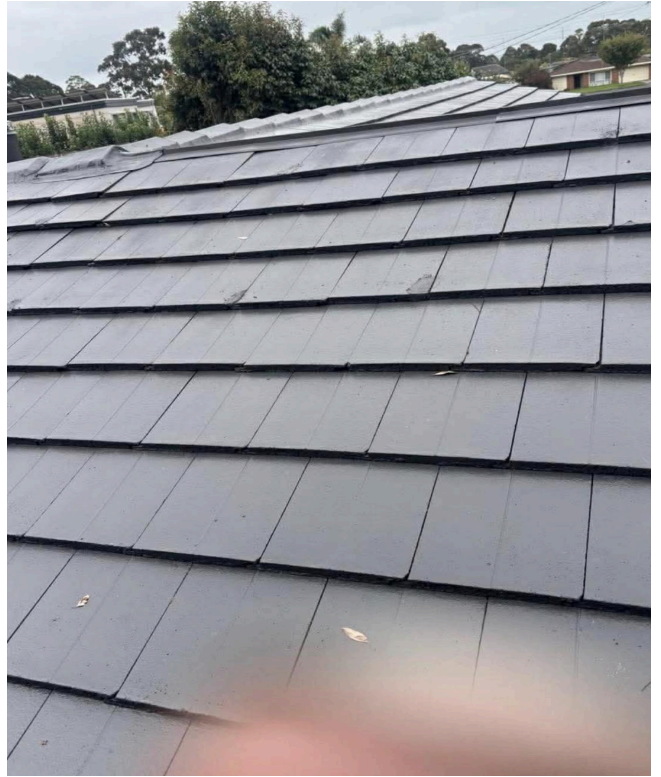
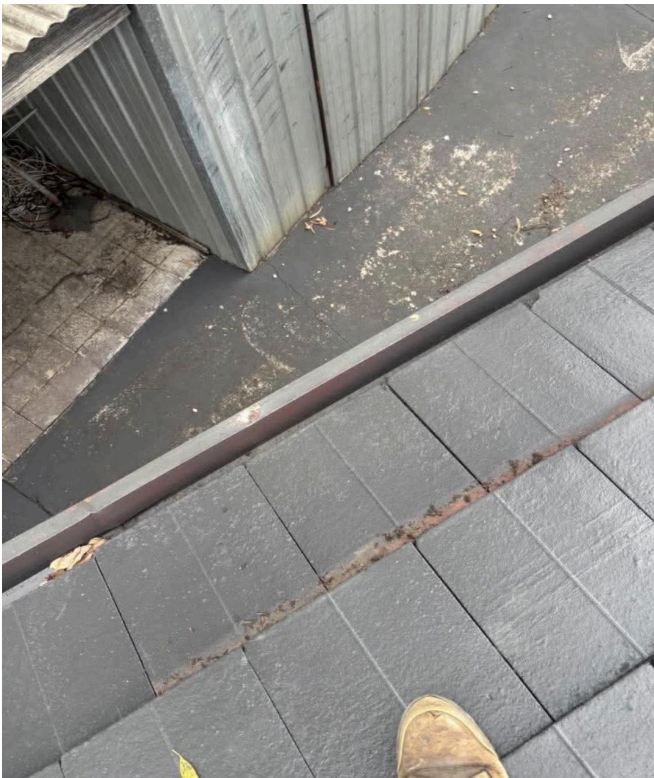
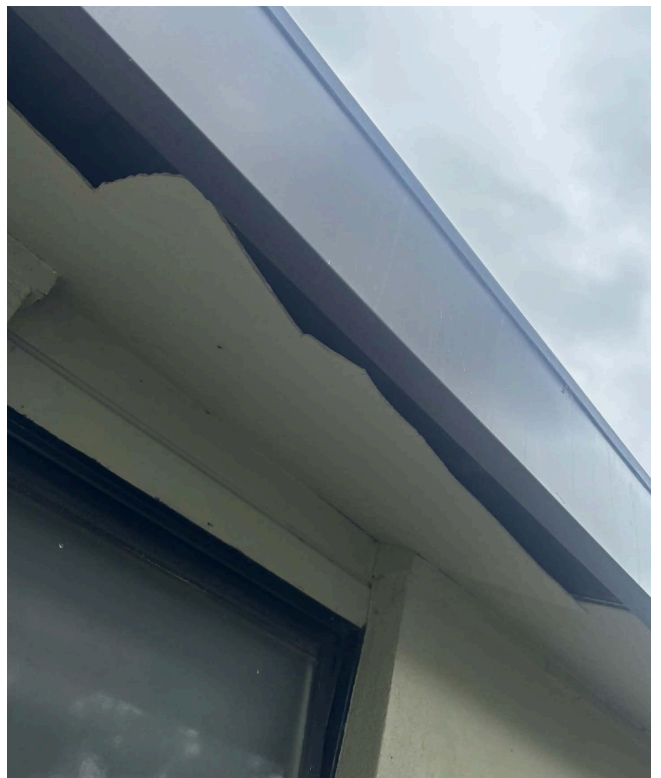
### **1. Site Assessment & Identified Issues**

Upon arrival, a manual inspection of the roof was conducted. The following issues were identified as the primary sources of potential water ingress:

- **Displaced Tiles:** Multiple tiles had shifted out of alignment, breaking the water-tight seal of the roof courses.
- **Structural Damage:** Several tiles were found with broken corners/lugs, preventing them from interlocking correctly.

- **Tile Realignment:** Displaced tiles were repositioned where possible to close large gaps.
- **Emergency Weatherproofing:** A 3.6m x 3.6m industrial-grade tarp was installed over the most compromised section of the roof.
- **Securing:** The tarp was battened/secured to withstand wind and prevent any further water entering the roof cavity.
