## EMERGENCY MAKE SAFE REPORT

Date: 02/03/2026

Property Address: [REDACTED] Bonnie Brook VIC 3335

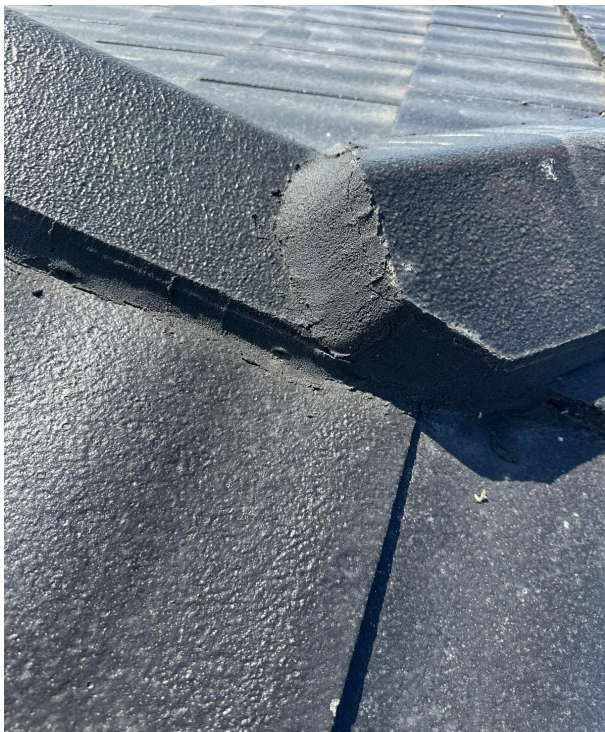
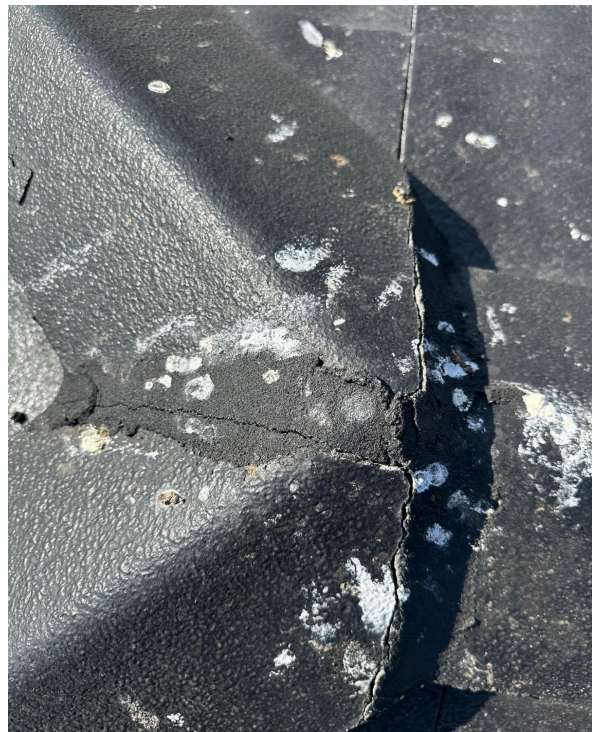
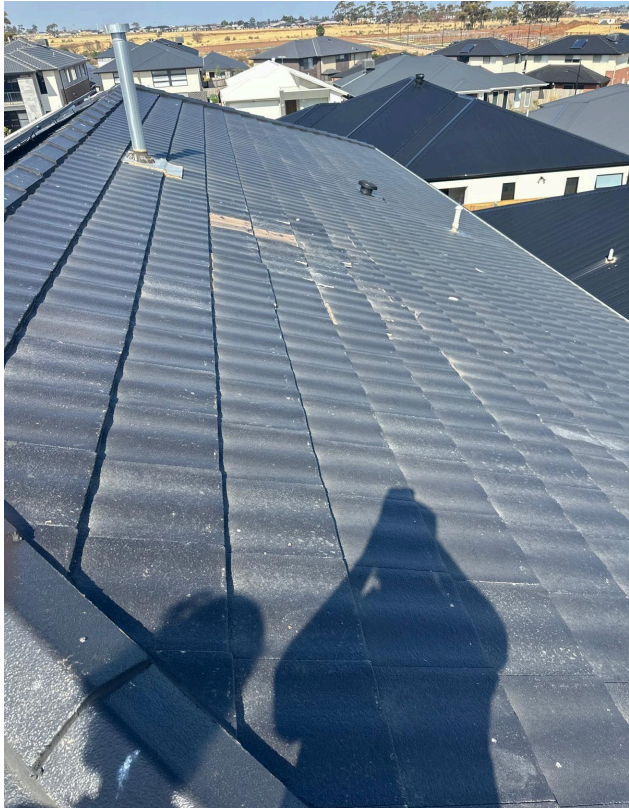
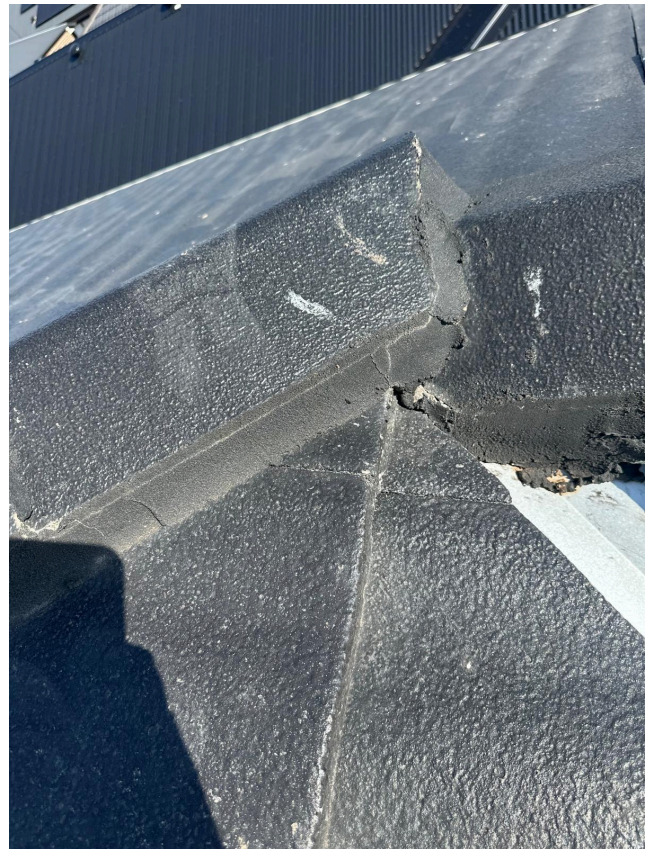
### 1. BEFORE: Initial Hazardous Condition

Ridge Capping & Tiles: Inspection of the ridge capping revealed visible signs of damage, specifically cracked and missing mortar (pointing).

Water Entry Points: These gaps in the capping were identified as the primary source of water ingress during rain events.

**Tarp Installation:** A heavy-duty waterproof tarp was supplied and installed directly over the identified leak area.

**Water Runoff:** The tarp has been positioned to allow for appropriate water runoff, ensuring the affected section is adequately covered.

**Securement:** The tarp was secured to the roof structure and weighted with high-density sandbags to prevent movement or lifting in windy conditions.

Please be advised that this is a temporary measure designed to reduce further internal water damage. While the area is currently watertight, permanent repairs to the ridge capping and mortar are required to fully rectify the issue.

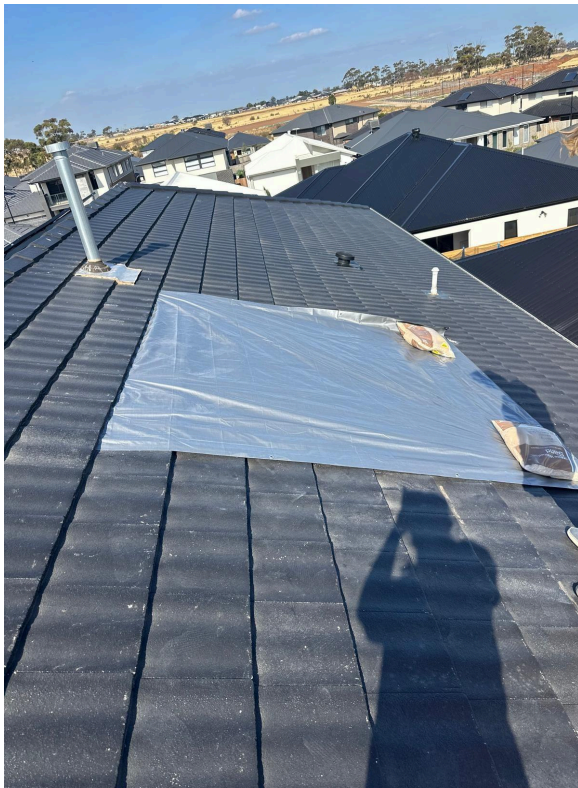
*Completed make safe. Heavy-duty tarp secured with sandbags to prevent further water ingress*
