Newborough , [REDACTED] Newborough  
VIC - JN 6151

## Status: Temporary Mitigation Completed / Permanent Repairs Pending

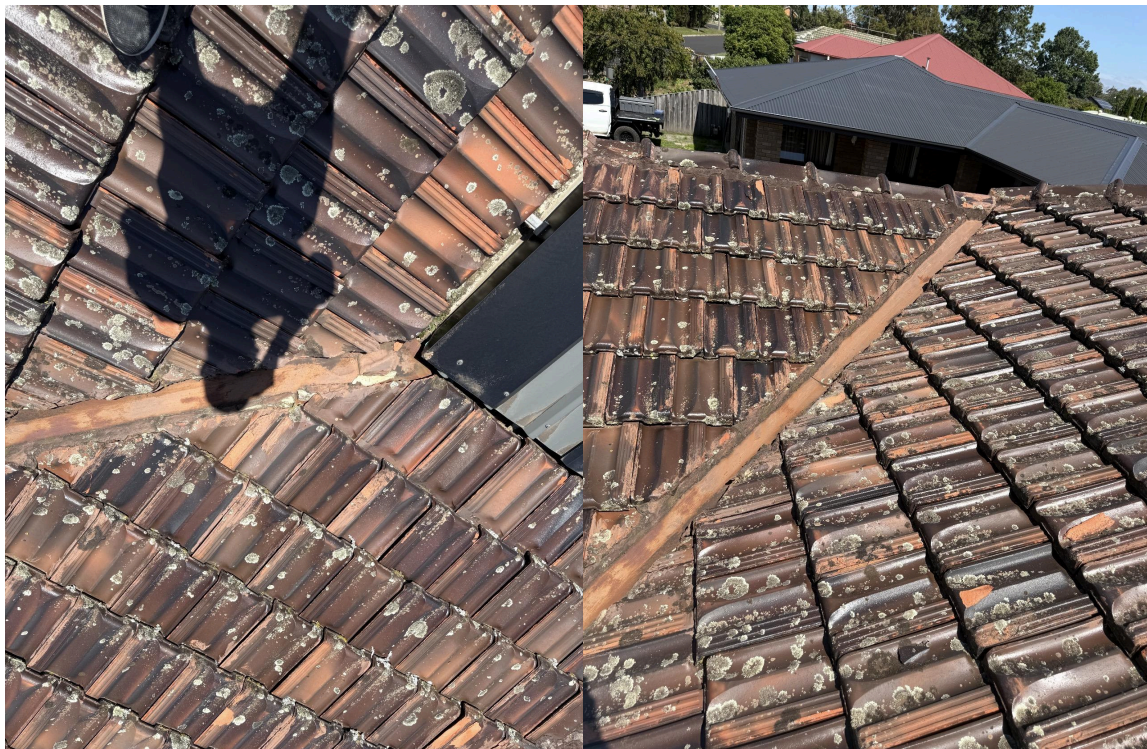
## Before Photos

- Porous Roof Tiles: The tiles above the hallway have become porous, allowing moisture to seep through the material.
- Damaged Sarking: The protective sarking layer beneath these tiles is torn and contains multiple holes (as seen in images IMG\_3326 and IMG\_3330), failing to act as a secondary water barrier.
- Valley Blockage: A roof valley was found to be "over-bedded" with excess mortar. This created a damming effect, causing water to pool and backflow under the tiles during heavy rain.

1. **Valley Restoration:** Excess bedding was manually removed from the valley to clear the drainage path.
2. **Storm Sealing:** The area was storm-sealed to ensure water flows correctly toward the guttering and cannot become entrapped.
3. **Emergency Tarping:** A heavy-duty blue tarp was installed over the affected hallway section (see image IMG\_3337) to provide immediate protection against upcoming weather events.

- **Tile Replacement:** Removal of porous tiles and installation of new, non-porous matching units.
- **Sarking Repair:** Replacing the damaged section of sarking to restore the home's secondary waterproof membrane.
- **Final Pointing:** Professional repointing of the valley and ridge caps to ensure long-term structural integrity.
